1124 AND 1124A WESTWIND SERVICE BULLETIN INDEX

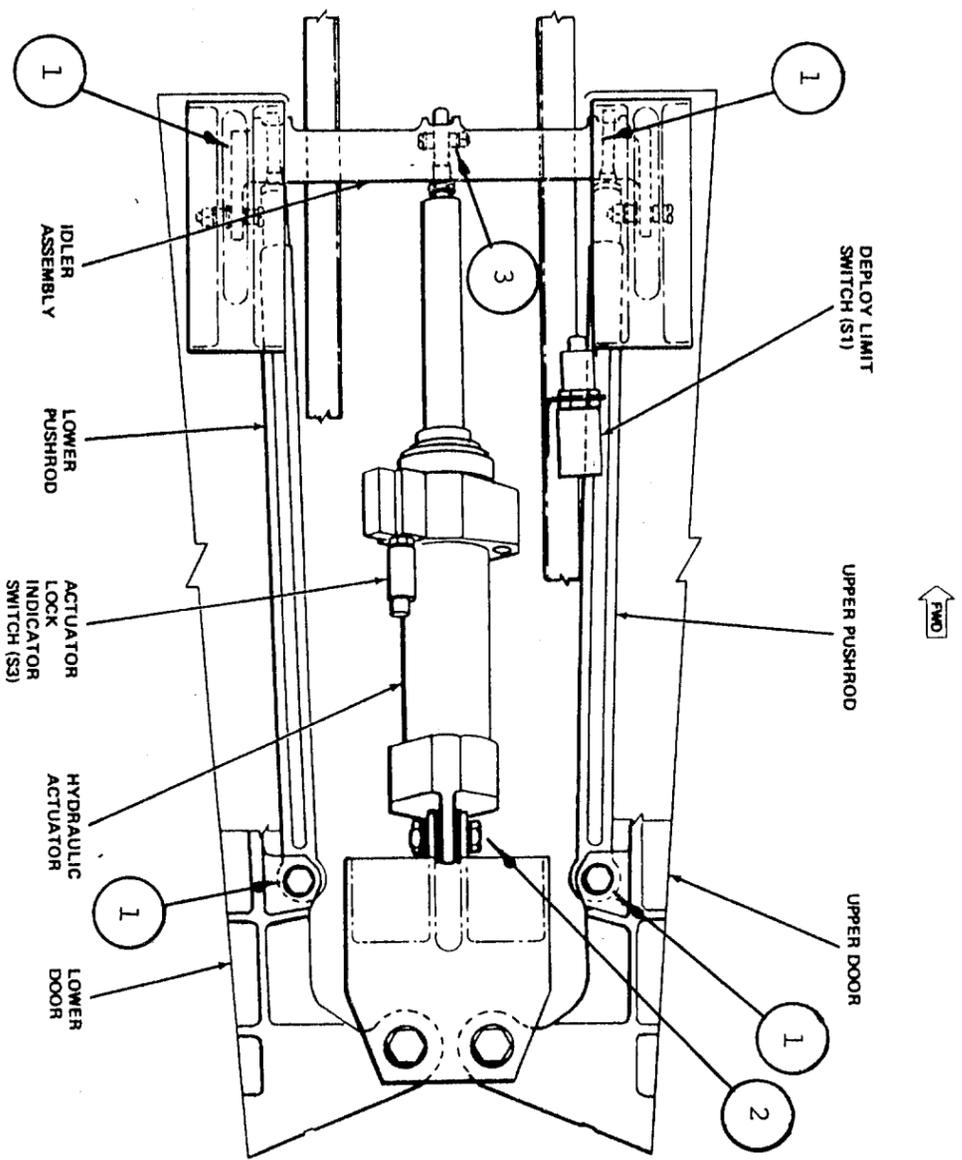
bolts replacement on thrust reverser controls installation.

2. On idler assembly, for left and right nacelles, replace GB511DAS-15 bolt with GB511BG5-15A bolt in two places. (SEE FIGURE 1)
3. On actuator rod end, for left and right nacelles, replace NAS1107-15D bolt, AN960-716L washer (under bolt head) and AN960-716L washer (under nut) with GB511BG7-15A bolt, MS20002C7 countersunk washer (under bolt head) and AN960-716L washer (under nut) (2 pcs.). MS17826-7 nut and MS24665-302 cotter pin. (SEE FIGURE 1)

4. On door assembly push rod attachment, for left and right nacelles, replace GB511DA5-15A bolt with GB511BG5-15A bolt. (SEE FIGURE 1)
5. On actuator head end, for left and right nacelles, replace NAS1107-15D bolt and AN960-716L (2 pcs.) washer, with GB511BG7-15A bolt, MS20002C7 washer (under bolt head) and MS960-716L washer (under nut), MS17826-7 nut and MS24665-302 cotter pin. (SEE FIGURE 1)

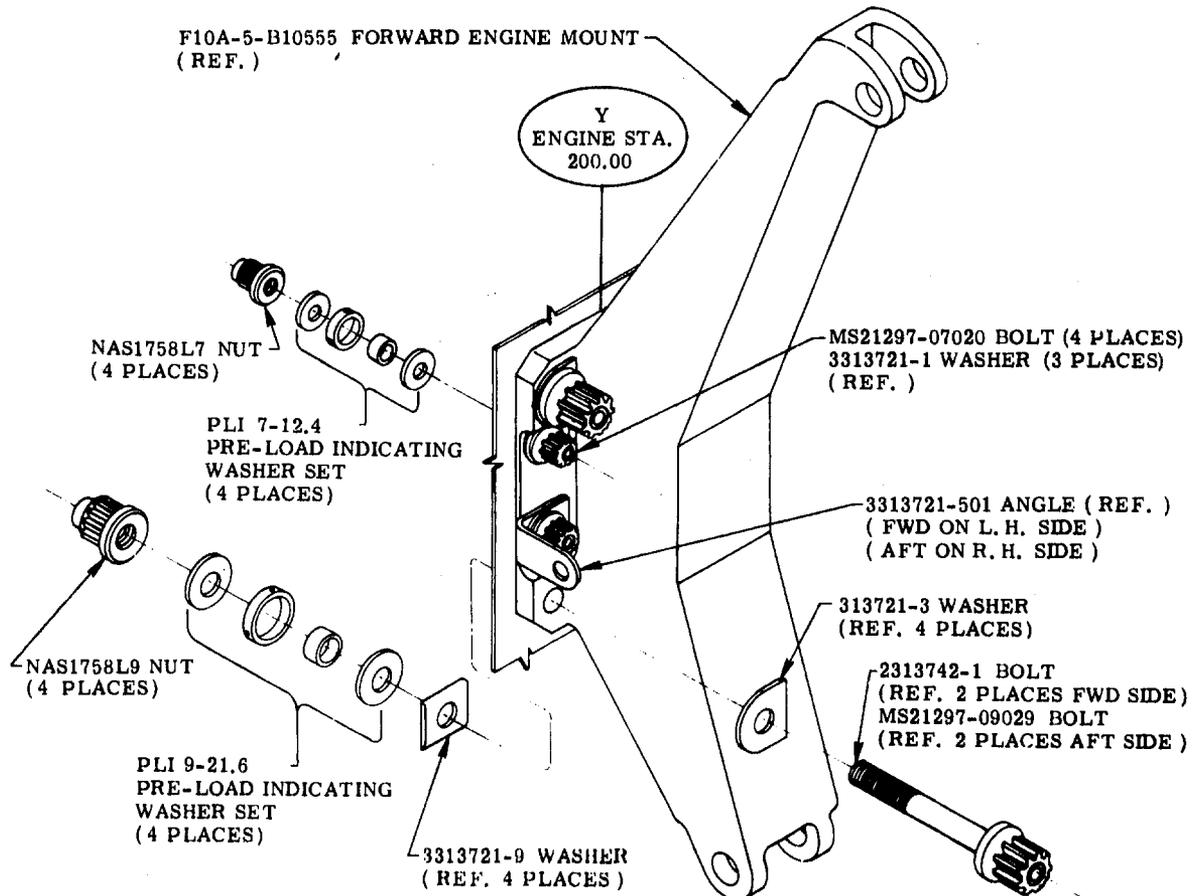
FIGURE 1

INSTALLATION OF PRE-LOAD INDICATING WASHERS ON FORWARD ENGINE MOUNT ATTACHMENT BOLTS

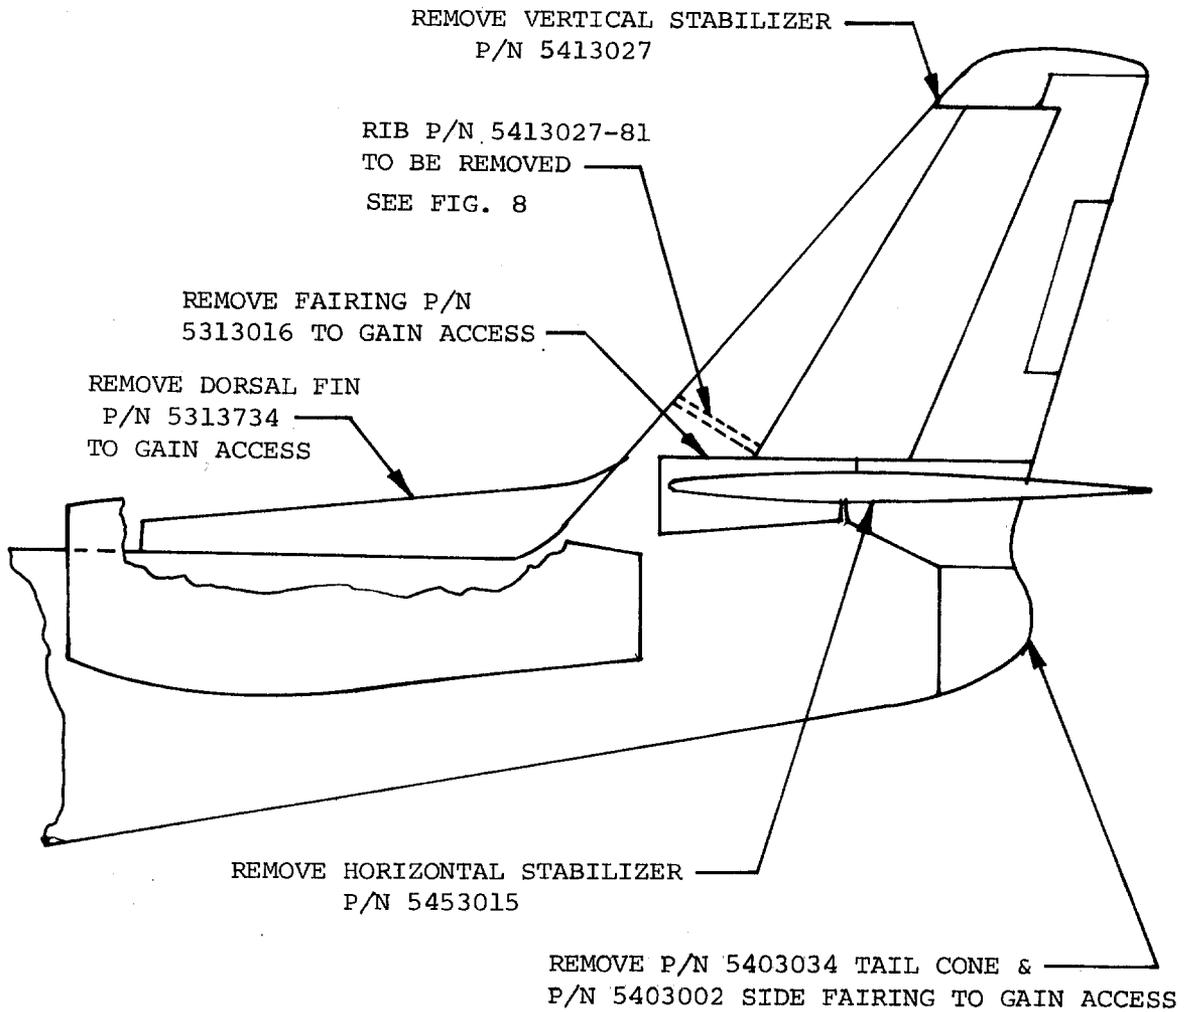
FIGURE 1

VIEW SHOWING PARTS TO BE REMOVED FROM A/C

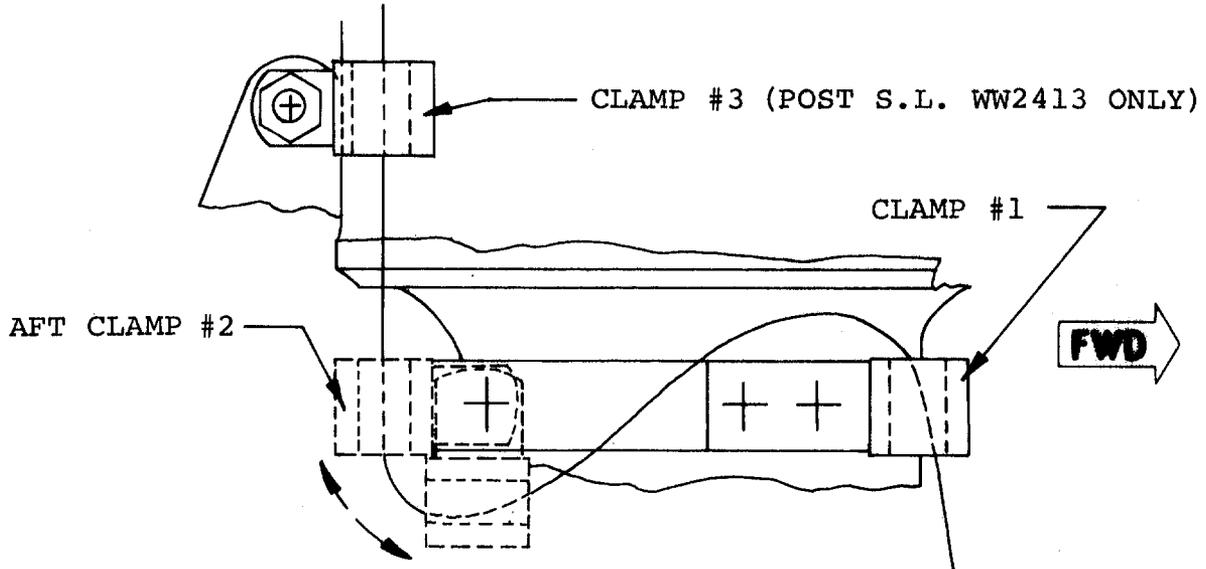
FIGURE 1: EXISTING INSTALLATIONS

NOTE: CLAMP #2 WILL BE FOUND IN EITHER POSITION AS SHOWN, ON EXISTING INSTALLATIONS.

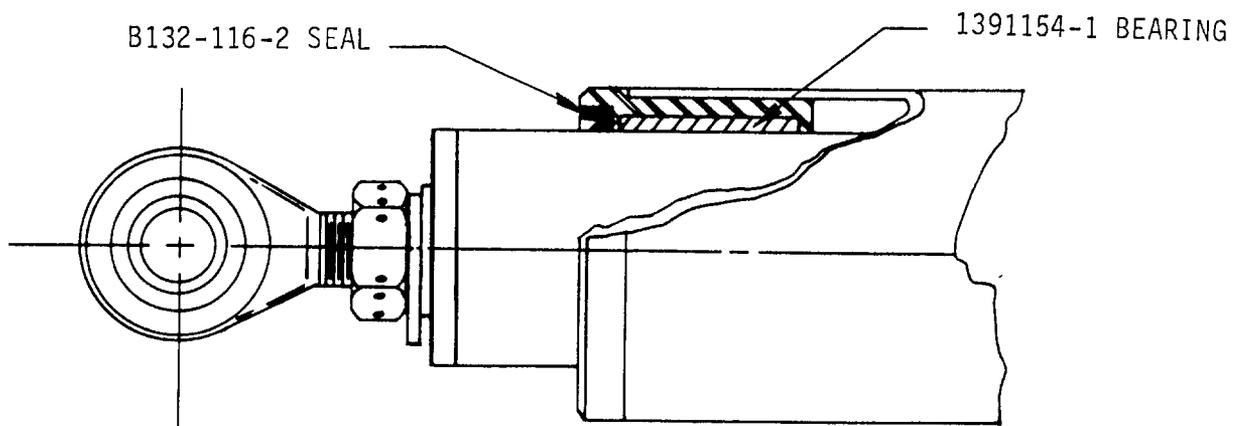
INBOARD ACTUATORS INCORPORATE TWO (2)
SLEEVE BEARINGS IN TANDEM (INSTALLATION
TYPICAL).

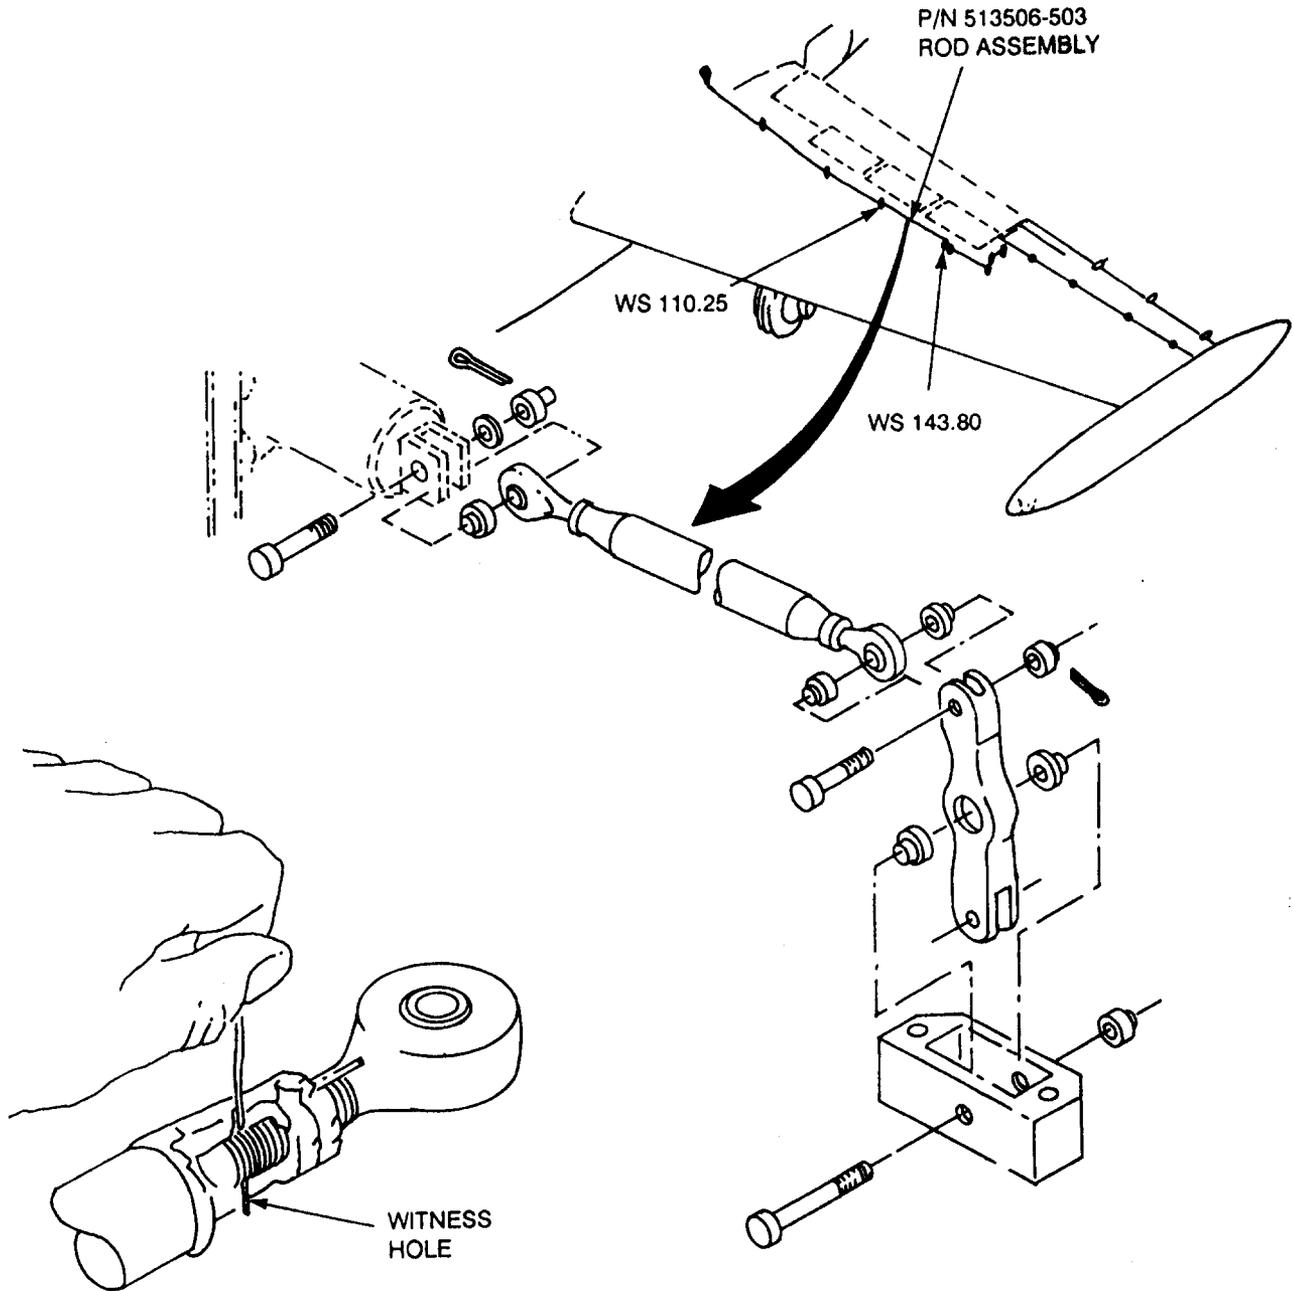
FIGURE 1

CAUTION:
IF SAFETY WIRE WILL PASS THROUGH
BOTH WITNESS HOLES, ROD END IS
EXTENDED PAST LIMITS.

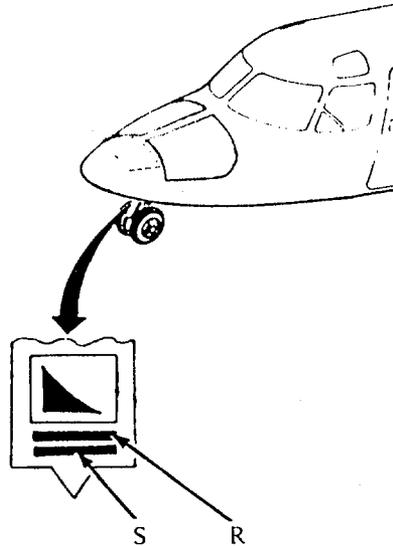
DETAIL R
P/N 113001-50

WARNING
SCISSOR ASSEMBLY MUST BE CONNECTED
AT ALL TIMES WHEN OPERATING AIRCRAFT
