A Quarterly Publication Regarding the Maintenance and Operation of Westwind Aircraft

March 30, 2005 Volume 3, Issue 3

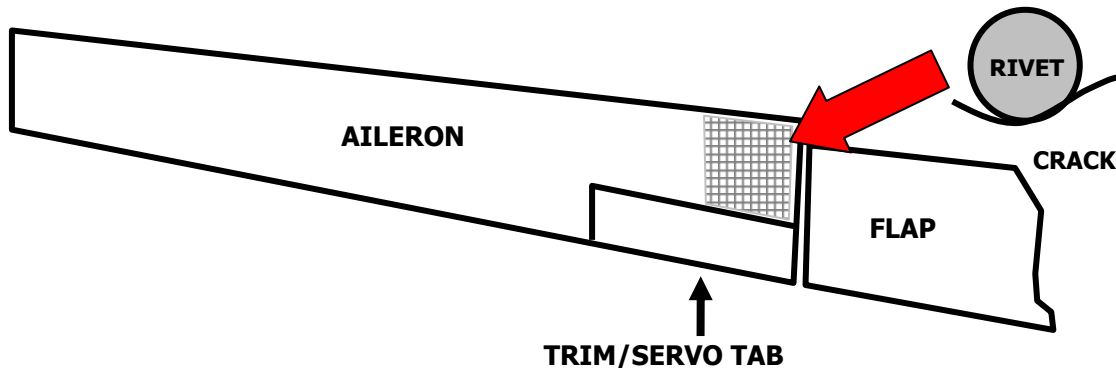
About six months ago, the shop foreman of Trimec Aviation, Doug Newman, showed me an area of concern with the aileron upper aluminum outer skins cracking at numerous rivet holes. The problem seems to be in an area between the inboard edge and the second rib from the inboard edge on both ailerons (see graphic).

As of this writing, Trimec has three ailerons in the hangar that have numerous cracks at these locations. Pay close attention to these areas on both ailerons during future inspections, since this just happens to be a very important piece of the flying puzzle we call airplanes.
