A Quarterly Publication Regarding the Maintenance and Operation of Westwind Aircraft

March 30, 2006 Volume 4, Issue 3

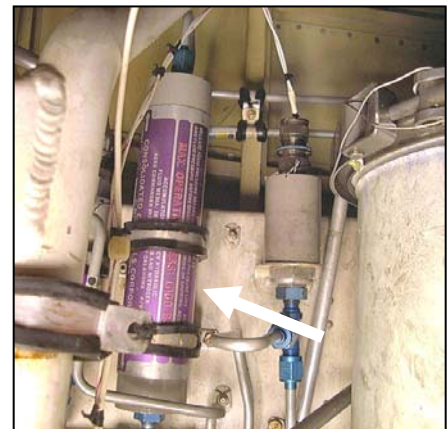
Emergency Brake System Accumulator

What causes the emergency pump to short cycle? Well, several things may cause the 1,000 psi to drop faster than it should: leaks (internal or external), thermal relief valve malfunctioning, pressure switch

malfunctioning, or an improperly-serviced emergency brake system accumulator. The latter is the most common cause that I have seen.

If the accumulator is under serviced, it will not have enough pressure on the separator piston to push all of the hydraulic fluid out throughout its entire action, causing the hydraulic pump to short cycle as pressure in the system bleeds down to 800 psi.

If a little bit of something is good, then more would obviously be better! Right? Wrong! At least in this case it is wrong. If the accumulator is over serviced, then there will not be enough space for the correct amount of hydraulic fluid to be stored within the accumulator, since more space is taken up on the nitrogen side of the separator piston. Not enough hydraulic fluid being stored in the accumulator correlates to the emergency pump short cycling as well.

The procedure for “Hydraulic Emergency System Accumulator Charging” is found in section 12-10-03 of the Aircraft Maintenance Manual (AMM). It calls out to charge the accumulator between 170 to 190 psi depending on the outside air temperature.

Outside Air Temperature	Charging Pressure
-20°F to 30°F	170 ± 5 psi
31°F to 80°F	180 ± 5 psi
81°F to 130°F	190 ± 5 psi

This accumulator is very small, and servicing it correctly is extremely critical. Make sure you pump the brakes down all the way (watching the direct reading gauge in the cockpit) while maintaining at least 500 psi of nitrogen in the accumulator. This allows the separator piston to bottom out completely, giving you the calibrated critical area inside the accumulator prior to the final charging pressure.
