A Quarterly Publication Regarding the Maintenance and Operation of Westwind Aircraft

June 30, 2005 Volume 3, Issue 4

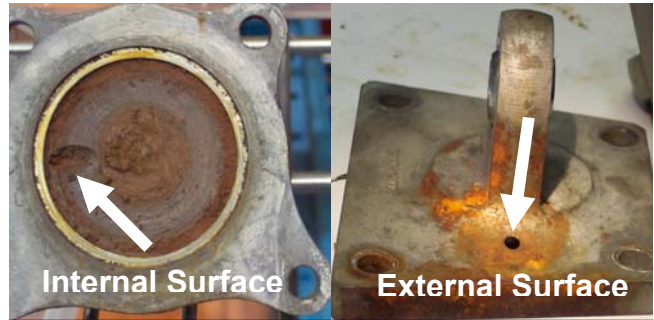
The drain holes can appear unobstructed during a cursory visual inspection (see graphic). However, the drains are becoming blocked at the internal surface of the actuator (see graphic), and only by inserting something non-marring like a coffee stir stick and moving it around will you be able to determine if water and/or corrosion are present. The grease and/or material gathered by the probe will appear orange or have moisture on it if the drain has become plugged. If water is present, the unit must be replaced.

Note plugged drain hole at internal surface; external surface appears to be open.

A publications change request will be submitted to clarify the inspection process. The inspection is currently at 400 hours, and we may drop it to 200 hours or six months while we continue to work at eliminating the possibility of water ingestion.

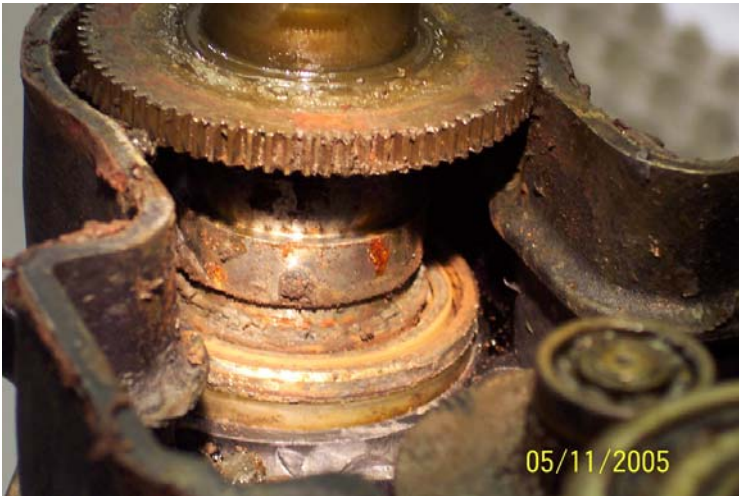
Another area of concern has been the actuator’s weak performance while in service. Failed primary motors and corrosion continue to be expensive nuisances. Actuators with substantially fewer landings than the required 2,500-landing overhaul interval show signs of water retention and resultant corrosion when sent to Ontic for repair of the failed motors. A Maintenance and Operations Letter (MOL) is forthcoming regarding inspecting the actuator drains. See the article on page 3 for more detailed information.

Close-up of one trim actuator's corroded internal parts

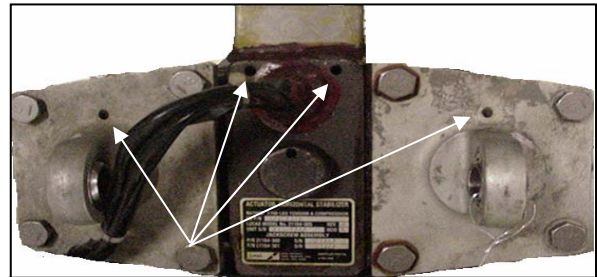
Maintenance Manual (MM) Chapter 5, section 5-20-06, page 201, lists certain inspection requirements for the Horizontal Stabilizer Trim Actuator at 400-hour intervals. One of the inspection items is to ensure that the drain holes located at the bottom of the actuator (as installed) are free of grease and foreign matter.

Drain holes to be checked on the actuator base exterior

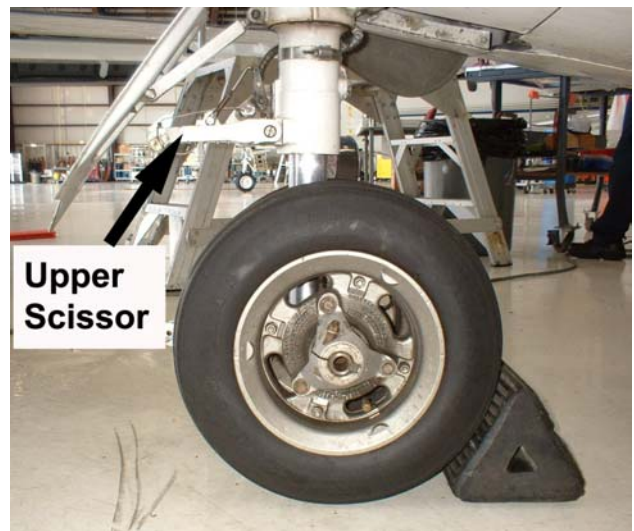
Air crews and ground personnel are reminded to monitor the service height of a Westwind's nose landing gear. With the crew and passengers out of the aircraft and the nose strut properly serviced, the upper scissor should be just above the nose wheels (see photo).

Although the scissors are disconnected for towing, a low strut will allow the upper scissor to become trapped between the nose tires. If the aircraft is handled in this condition, its steering limits can be exceeded, resulting in damage to the nose gear components and airframe structure. If you suspect the plane was moved while you were away, look for scuff marks on the inside of the tires

and rims and on the scissor, which may suggest the aircraft was improperly handled.
