A Quarterly Publication Regarding the Maintenance and Operation of Westwind Aircraft

June 30, 2006 Volume 4, Issue 4

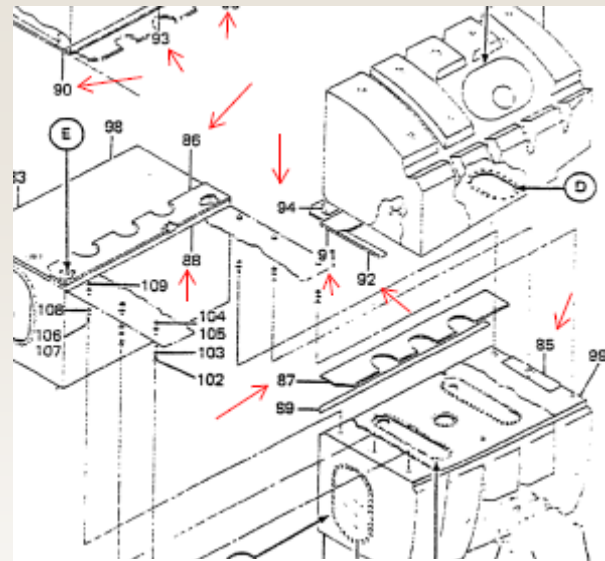
Storage Installation
Figure 2
(Sheet 1)

An operator recently had difficulty getting an order completed for the fuel cell foam blocks called out in the Illustrated Parts Catalog (IPC) and highlighted on the right. I am happy to report that an engineering order that applies to the 1121, 1123, 1124, and 1124A aircraft provides for the use of alternative material, as the original parts called out in the IPC are no longer available. The material called out in the EO is RUBATEX R103S, which is cut to fit the installation requirement.

An additional option is to use FR6705 LAST-A-FOAM, a 5 lb./cu ft. material made by General Plastics. (A special thanks to Mark Pidgeon for helping us out on this one.)
