**A Quarterly Publication Regarding the Maintenance and Operation of Westwind Aircraft**

**September 30, 2004 Volume 3, Issue 1**

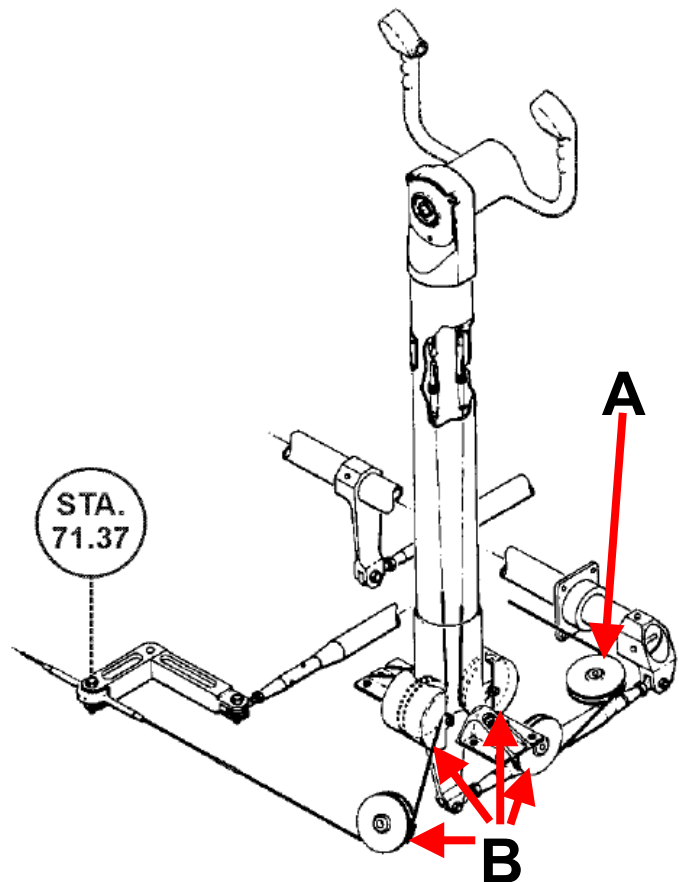
#### Aileron Cross-Over Cable Maintenance Tip

Recently, while working with Trimec Aviation, I noticed they had found three aileron crossover cables that were worn with broken cable strands in them. No big deal, except that it just so happened to be during the last three 800-hour "C" Inspections that they accomplished. Even though bad things seem to come in threes, I still sensed that there seemed to be a trend starting here. I chatted with the one of the lead technicians, Jay Stewart, about this in much more detail.

Areas of importance to look at are on the rear crossover cable at the rear outboard pulleys (see detail "A"). While moving the ailerons through their full travel, look for shiny spots on the cable where it contacts the pulley assembly. A shiny spot may indicate wear, and it will need to be looked at through a magnifying lens. If wear on the cable strands is more than 40 to 50%, it will need to be replaced. What Trimec has been finding in this area is at least 50% wear with some broken strands as well.

Now for the weird part – upon replacing the rear cross-over cable, Trimec has been finding broken cable strands under the other pulleys in that system. The ones that I looked at had absolutely no wear at all, but a closer inspection revealed broken strands. Chapter 27 of the Westwind Maintenance Manual states that any broken strand at a pulley necessitates

If you have to replace the rear cable, it is always a good idea to remove the forward cross-over cable as well for a detailed inspection. It takes only a few more minutes to remove it, once you have the aft one out; so it makes good sense to take the time to look at something that, more than likely, hasn't been thoroughly looked at in many years. As a matter of fact, every forward cable that Trimec has pulled out recently due to the rear one not passing inspection has broken strands in the pulley areas as well (see detail "B"). Those areas cannot be seen until the cable has been removed.
