A Quarterly Publication Regarding the Maintenance and Operation of Westwind Aircraft

December 19, 2003 Volume 2, Issue 1

(ATA 30): Reminder of Upgraded Engine HP Bleed Manifold Assembly

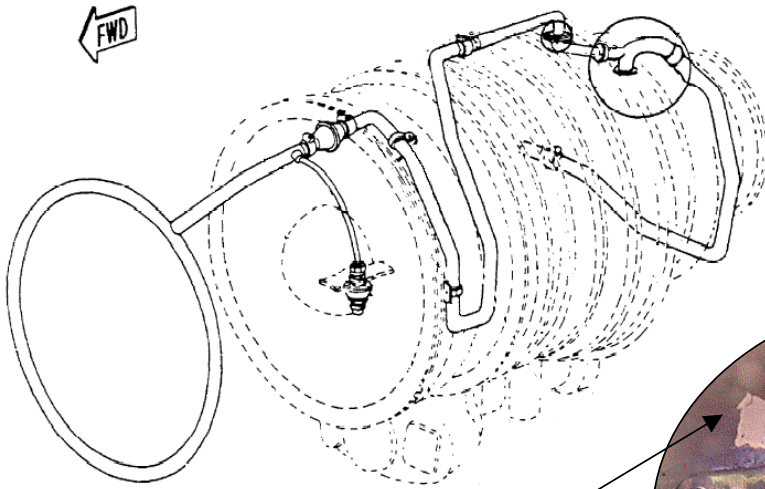
Recently, a Westwind operator discovered damage to the aluminum bypass duct of a 731-3 engine. Upon further investigation, the cause was determined to be a failed HP bleed manifold assembly, P/N F10A5P20242-7, with the subsequent hot bleed air damaging the fan bypass ducts that cannot be repaired. The failure occurred near the 12:00 plenum mount boss.

Discoloration here is evidence of a failed manifold duct.

We would like to remind operators of the availability of the F10A5P20242-9 bleed manifold assembly and that the Maintenance Manual, Chapter 5-20-07 maintenance practices call out a 200-hour inspection interval of the engine, nacelle, and pylon. Step 1.E. provides specific instructions to inspect the low- and high-pressure bleed ducts for leaks, cracks, fit, and general condition. Additionally, it has a note instructing the operator to inspect the manifold assembly during an engine Major Periodic Inspection or whenever the after body is removed. The bypass duct should also be inspected for any discoloration of the shroud. The flight crew will notice a rise in Interstage Turbine Temperature (ITT) if a manifold assembly has failed.

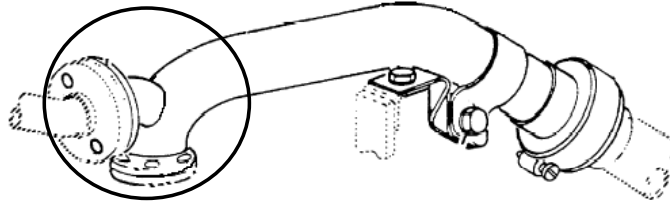
F10A5P20242-9
Manifold Duct

A two-piece saddle is welded on the -7 duct to create the -9 manifold duct.

Israel Aircraft Industries (IAI) issued Service Information Letter (SIL) 1124-30-080, dated May 29, 1990, informing operators of the availability of a new bleed manifold assembly, P/N F10A5P20242-9. The -9 is made from an F10A5P20242-7 bleed manifold assembly with reinforcement saddles welded in the area where the engine anti-ice line attaches (see illustration on next page). Refer to the 1124 Illustrated Parts Catalog, Chapter 30-20-00 for the upgraded -9 tube assembly.
