**A Quarterly Publication Regarding the Maintenance and Operation of Westwind Aircraft**

**December 30, 2004 Volume 3, Issue 2**

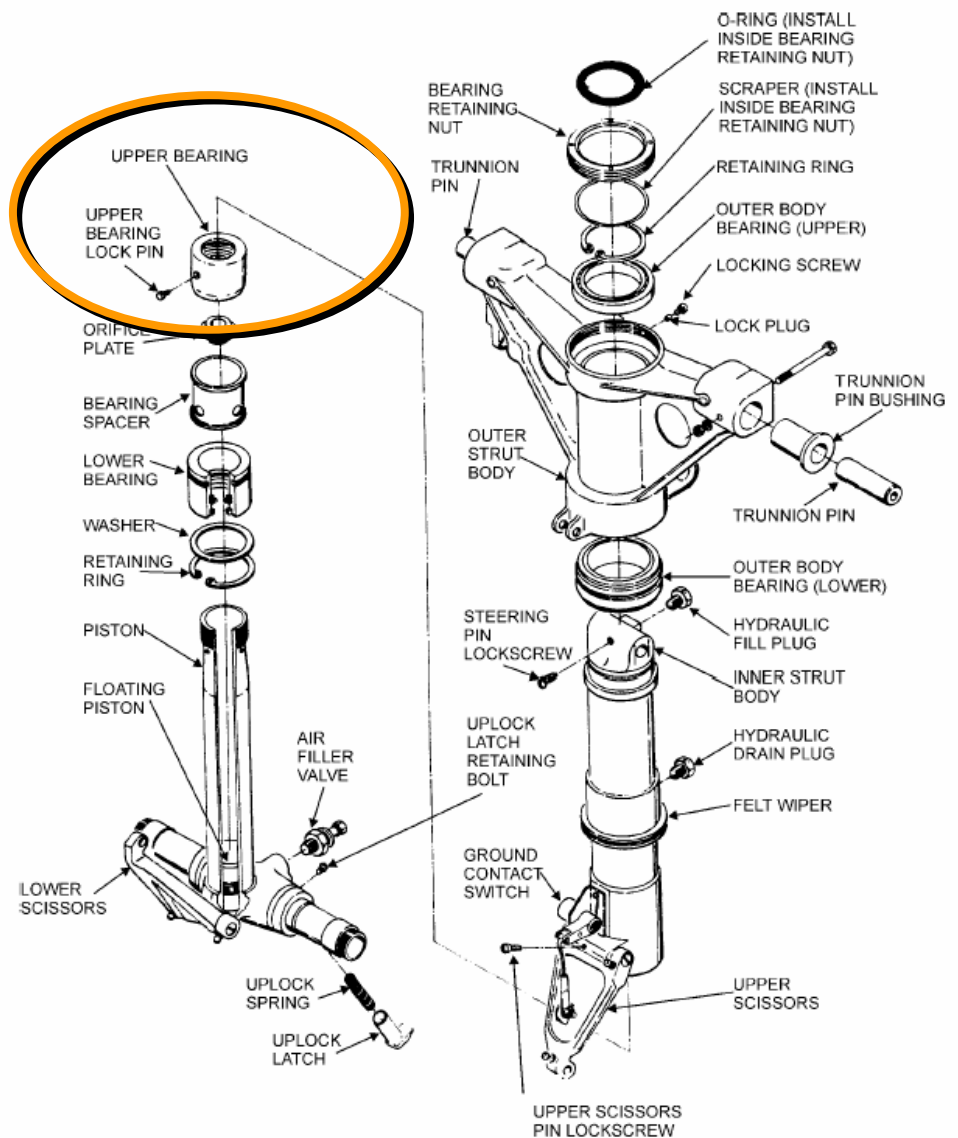
Pay careful attention to the "UPPER BEARING LOCK PIN" (see graphic) when re-assembling the nose strut. The lock pin's purpose is to secure the "UPPER BEARING" to the lower strut "PISTON," and without the lock pin installed, the upper bearing can unscrew itself from the lower strut piston during taxiing and towing operations.

If the upper bearing unscrews even a little bit, it will result in the strut lengthening, thus not allowing the nose landing gear to retract completely into the uplock assembly, failing to extinguish the red light in the gear handle.

This scenario has happened twice that I know of, and on both occasions, the lock pin was missing from the upper bearing. Luckily, the upper bearing did not completely unscrew itself from the lower strut piston, which could have resulted in a much bigger problem than a red light in the gear handle.
