WESTWIND SERVICE CENTER NEWSLETTER

January, 1987

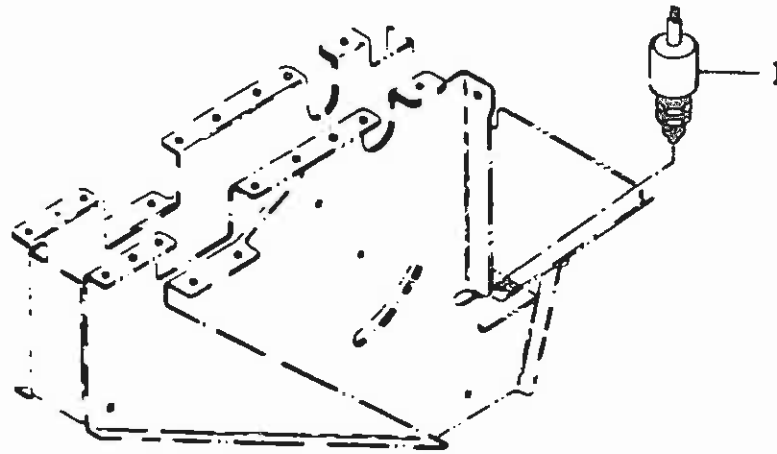
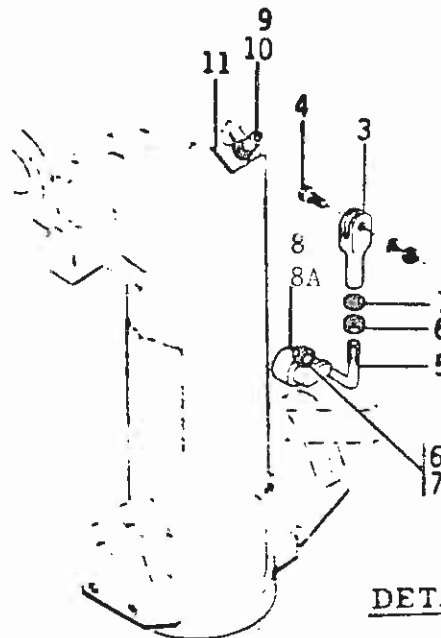
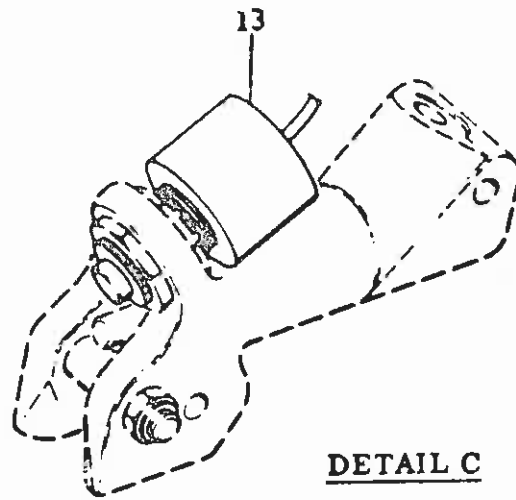
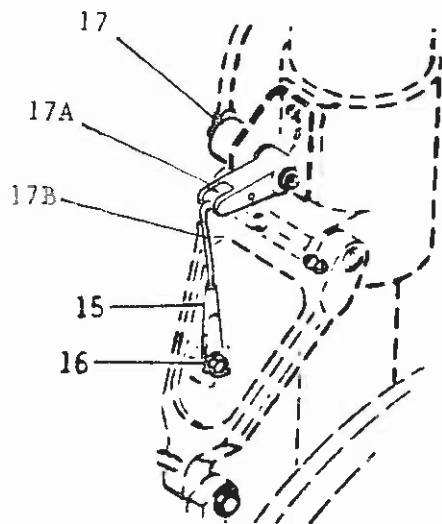
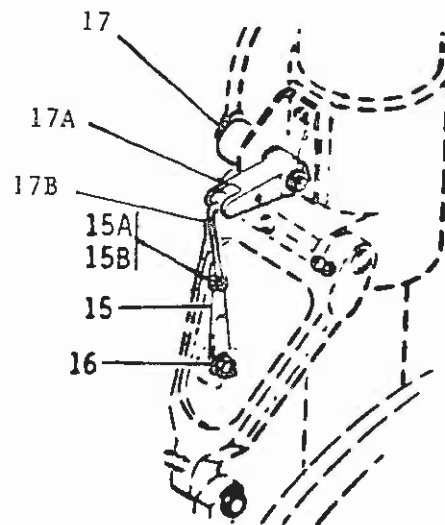
Figure 1. Position and Warning Instl (Page 3 of 4)

Special attention should be made to the 1124 IPC when ordering either the nose gear or the main gear **ground contact switches** and/or the adjustment bolts. On the nose, the bolt that is attached to the 6AP3 arm assembly is used (included with the replacement 444EN1-12 switch). On the main gear, this bolt is not used and should be discarded. Bolt part number 253507-1 is the proper bolt and will not be included with the 444EN1-12. This bolt must be ordered separately. Note also, that the 6AP3 arm assembly can be purchased individually. The corrected IPC pages are attached.
