**A Quarterly Publication Regarding the Maintenance and Operation of Westwind Aircraft**

**March 30, 2007 Volume 5, Issue 3**

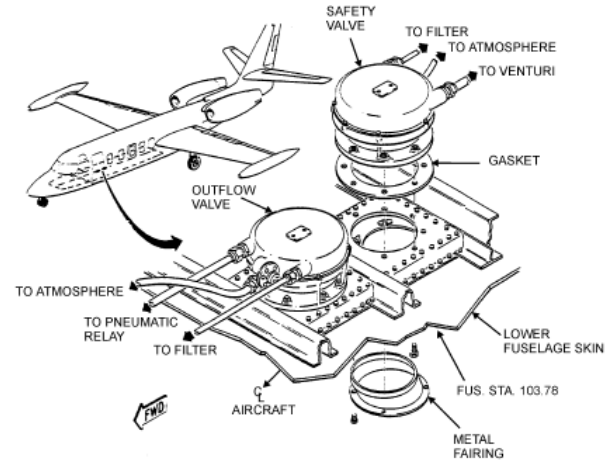
**Outflow and Safety Valves**

Keep the outflow valve **CLEAN**. Use mild soap or isopropyl alcohol to wipe the knife-edge seal. Spray a little LPS-1 into the vent hole and on the valve shaft.

One last thing—Do **not** replace the controller! In over 25 years of maintaining Westwinds, we have replaced controllers approximately 5 times. It is as trouble free as you can get. Look for vacuum leaks, Ty-Wraps or rags in the outflow valves, dirty ejector screens, weak dump solenoids, etc.

Before trying to pressurize the aircraft, check the following items first:

1. Normal system – outflow valve opens during/after engine start (could be either valve)
2. After starting, close doors and DV window. GROUND PRESS switch engaged—outflow valve closes  $\frac{3}{4}$  of the way, safety valve starts to open, outflow valve closes almost fully.
3. Trip LH ground switch to flight—safety valve closes fully, outflow valve opens and meters (put controller below S/L and max rate).

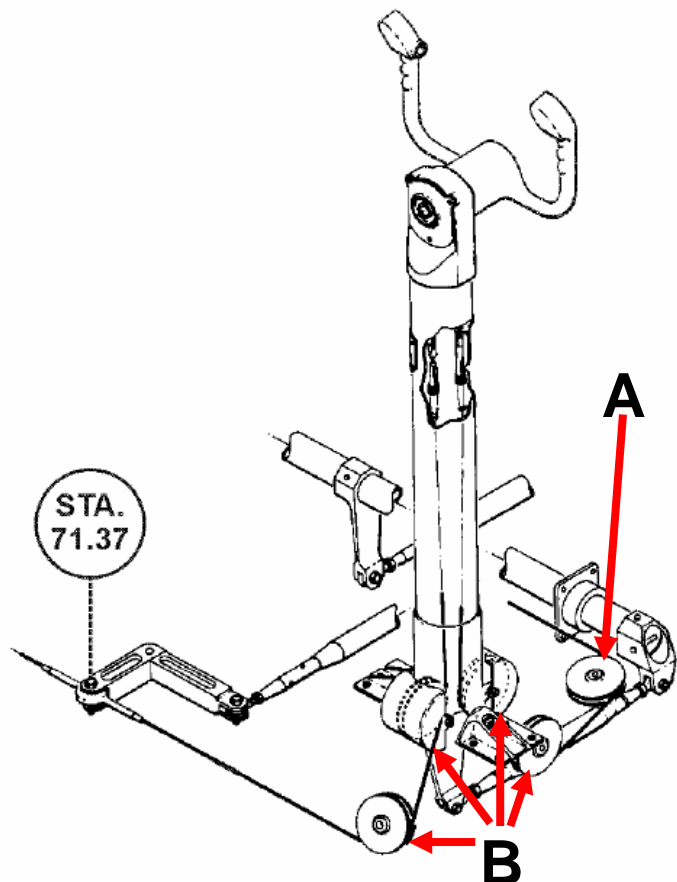
Areas of importance to look at are on the rear crossover cable at the rear outboard pulleys (see detail "A"). While moving the ailerons through their full travel, look for shiny spots on the cable where it contacts the pulley assembly. A shiny spot may indicate wear, and it will need to be looked at through a magnifying lens. If wear on the cable strands is more than 40 to 50%, it will need to be replaced. What Trimec has been finding in this area is at least 50% wear with some broken strands as well.

Now for the weird part – upon replacing the rear cross-over cable, Trimec has been finding broken cable strands under the other pulleys in that system. The ones that I looked at had absolutely no wear at all, but a closer inspection revealed broken strands. Chapter 27 of the Westwind Maintenance Manual states that any broken strand at a pulley necessitates replacement of that cable as well.

always a good idea to remove the forward cross-over cable as well for a detailed inspection. It takes only a few more minutes to remove it, once you have the aft one out; so it makes good sense to take the time to look at something that, more than likely, hasn't been thoroughly looked at in many years. As a matter of fact, every forward cable that Trimec has pulled out recently due to the rear one not passing inspection has broken strands in the pulley areas as well (see detail "B"). Those areas cannot be seen until the cable has been removed.
