**A Quarterly Publication Regarding the Maintenance and Operation of Westwind Aircraft**

**September 29, 2006 Volume 5, Issue 1**

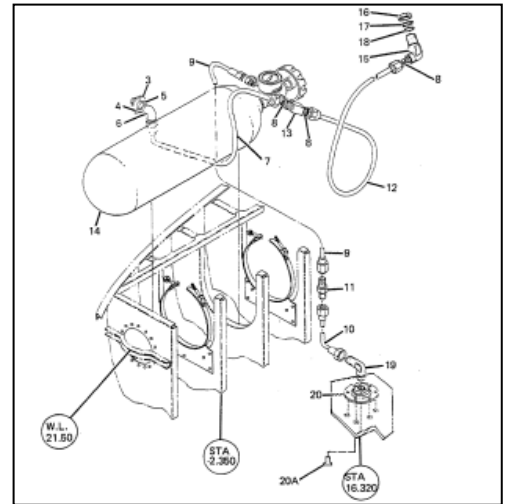
**WW 1124, 1124A Oxygen System – Main System O2 Bottle Installation**

A call came into my desk recently concerning the Main Oxygen System O2 Bottle installation. The P/N of the bottle does not match those listed in the Illustrated Parts Catalog (IPC).

The bottles listed are classified as 3HT Cylinders and carry the requirement to be Hydrostatic Tested at 3-year intervals per CFR Title 49, Part 173.34. The bottle in discussion was reported as a 3AA bottle that has different requirements. I was unable to substantiate the installation through Supplemental Type Certificate (STC) or some other approved method, but will be pursuing it further, as the 3AA cylinders do have advantages over the 3HT cylinders.

Cylinder Specifications/Identification: Metal-stamped into the neck of each steel cylinder is an ICC/DOT number (3HT or 3AA) along with the month and year of manufacture.

- The 3HT lightweight cylinder has a service pressure of 1,850 psi, a useful life of 24 years, and a required hydrostatic test every three years.
- The 3AA standard weight cylinder has a service pressure of 1,800 psi, an unlimited service life, and a required hydrostatic test every five years.
