1124 AND 1124A WESTWIND SERVICE BULLETIN INDEX

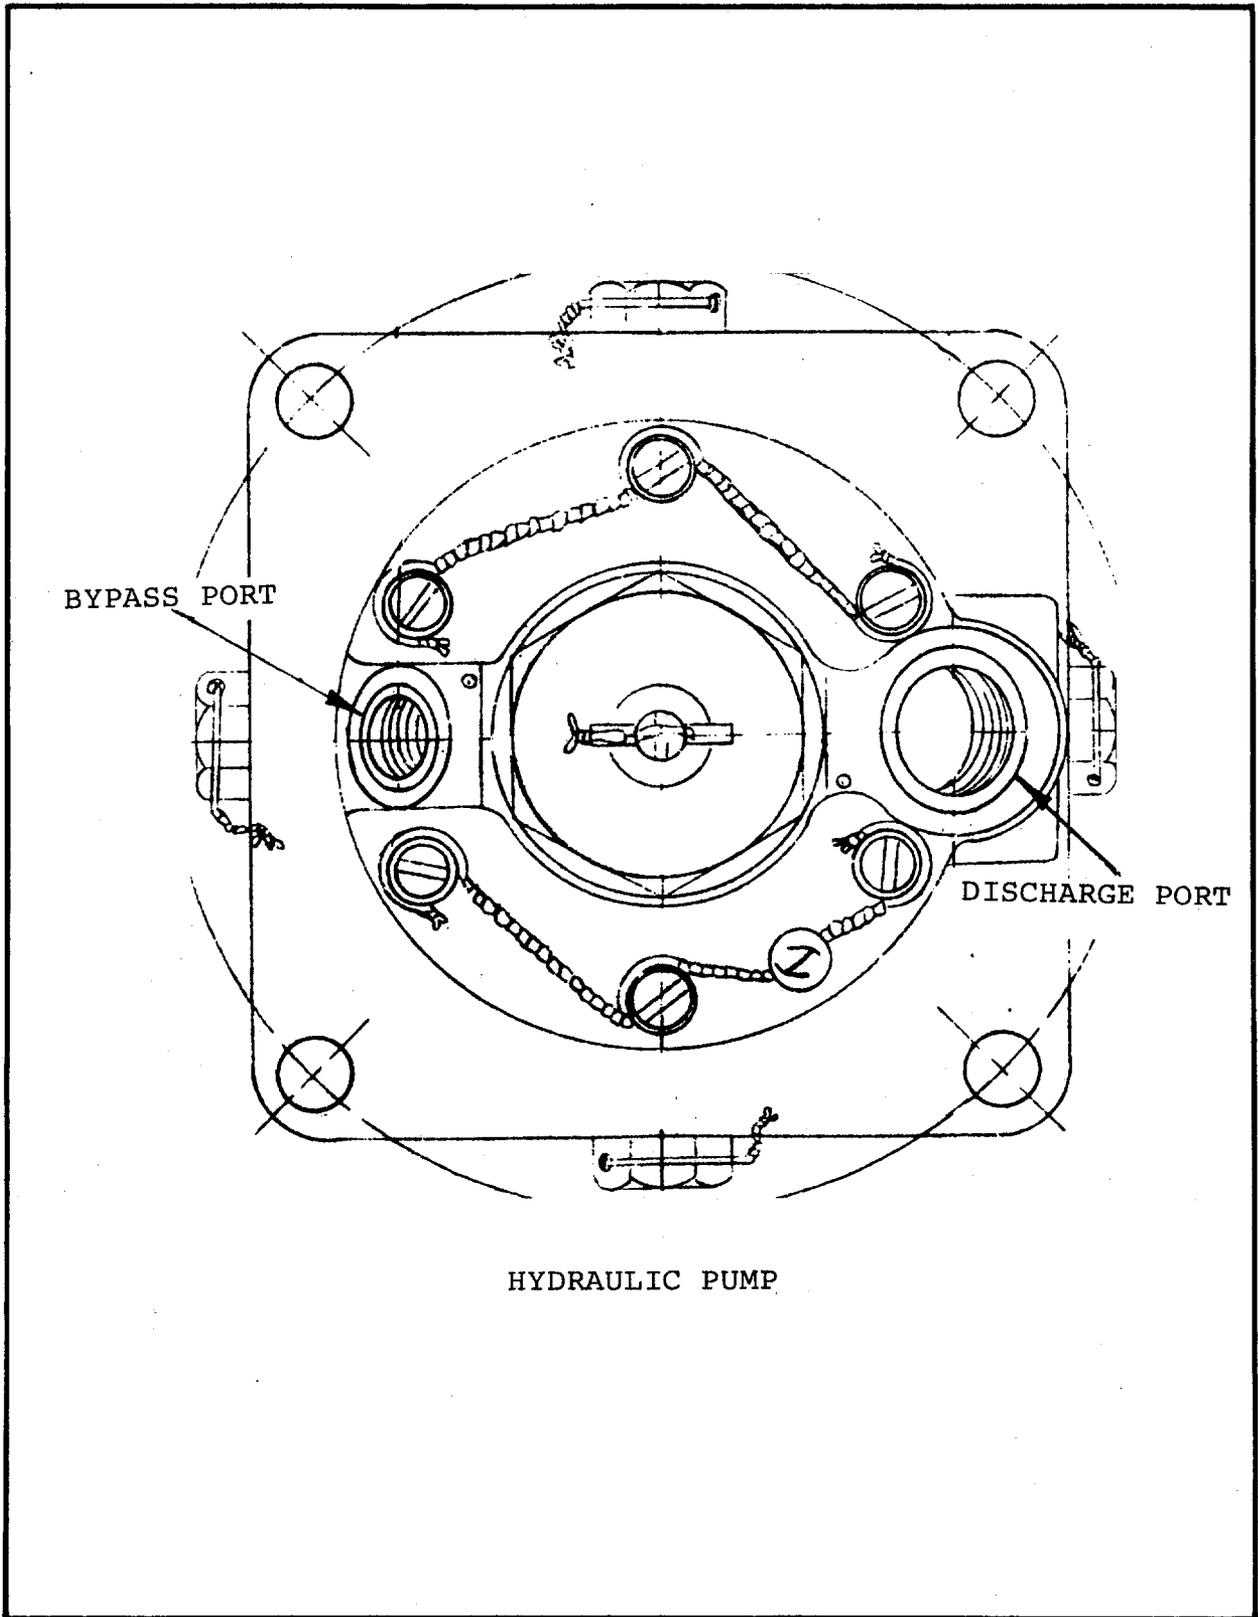
FIGURE 1

SUBJECT: ENGINE DRIVEN HYDRAULIC PUMP BYPASS PORT PLUG REPLACEMENT.

1. Release main system hydraulic pressure per 1124 Maintenance Manual, Chapter 12-10-03.
2. Release hydraulic reservoir air pressure.
3. Open engine cowl.
4. Remove the aluminum bypass port plug from the pressure regulating body of the engine driven hydraulic pump. (SEE FIG. 1)
5. Install new o'ring P/N NAS1612-4 on plug and install steel plug P/N AN814-4JL. Tighten to 40-65 inch-pounds torque and lock wire.
6. Repeat other side.
7. Run up engines and perform check of main hydraulic power system and inspect for leaks, per Maintenance Manual, Chapter 29-10-00.
8. Close engine cowls.

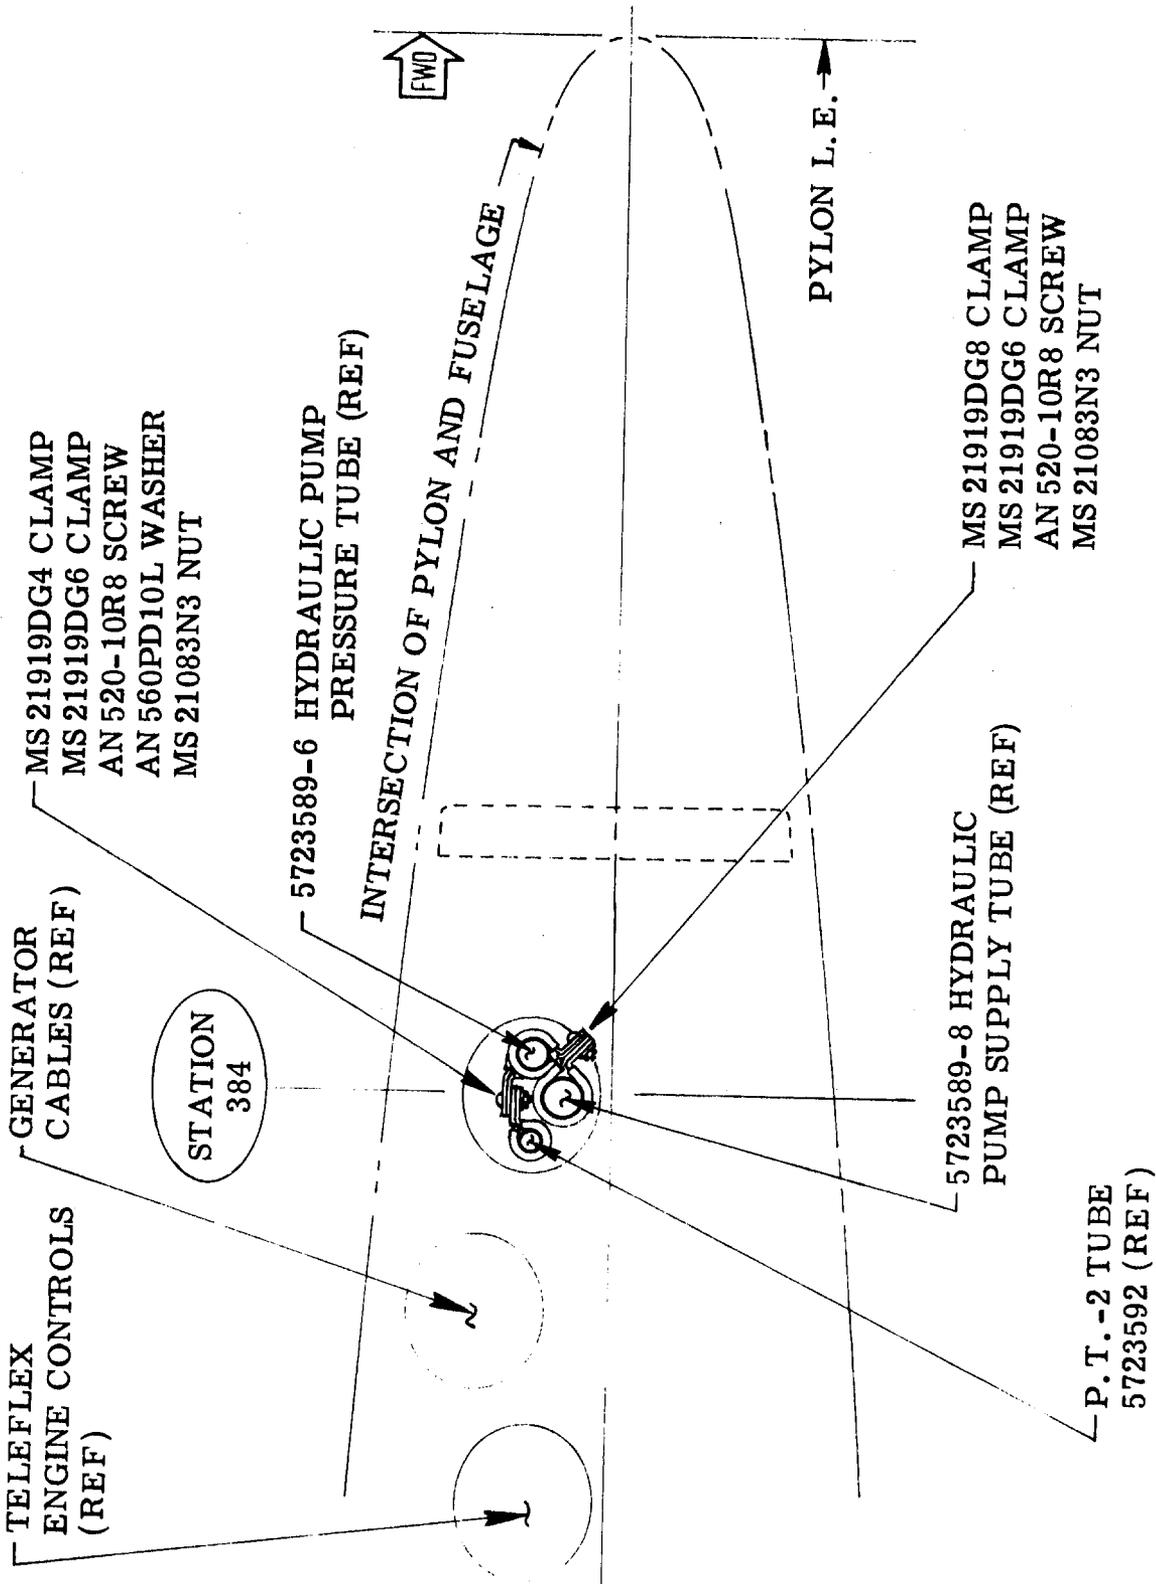
FIGURE 1

INSTALLATION OF TUBING CLAMPS

1. Gain access to entrance of P. T. -2 Tube, 5723589-8 hydraulic pump supply tube and 5723589-6 hydraulic pump pressure tube into airframe from the L. H. engine pylon, located at Station 385, slightly aft and above the forward baggage compartment door opening. Remove air conditioning ducting as necessary.

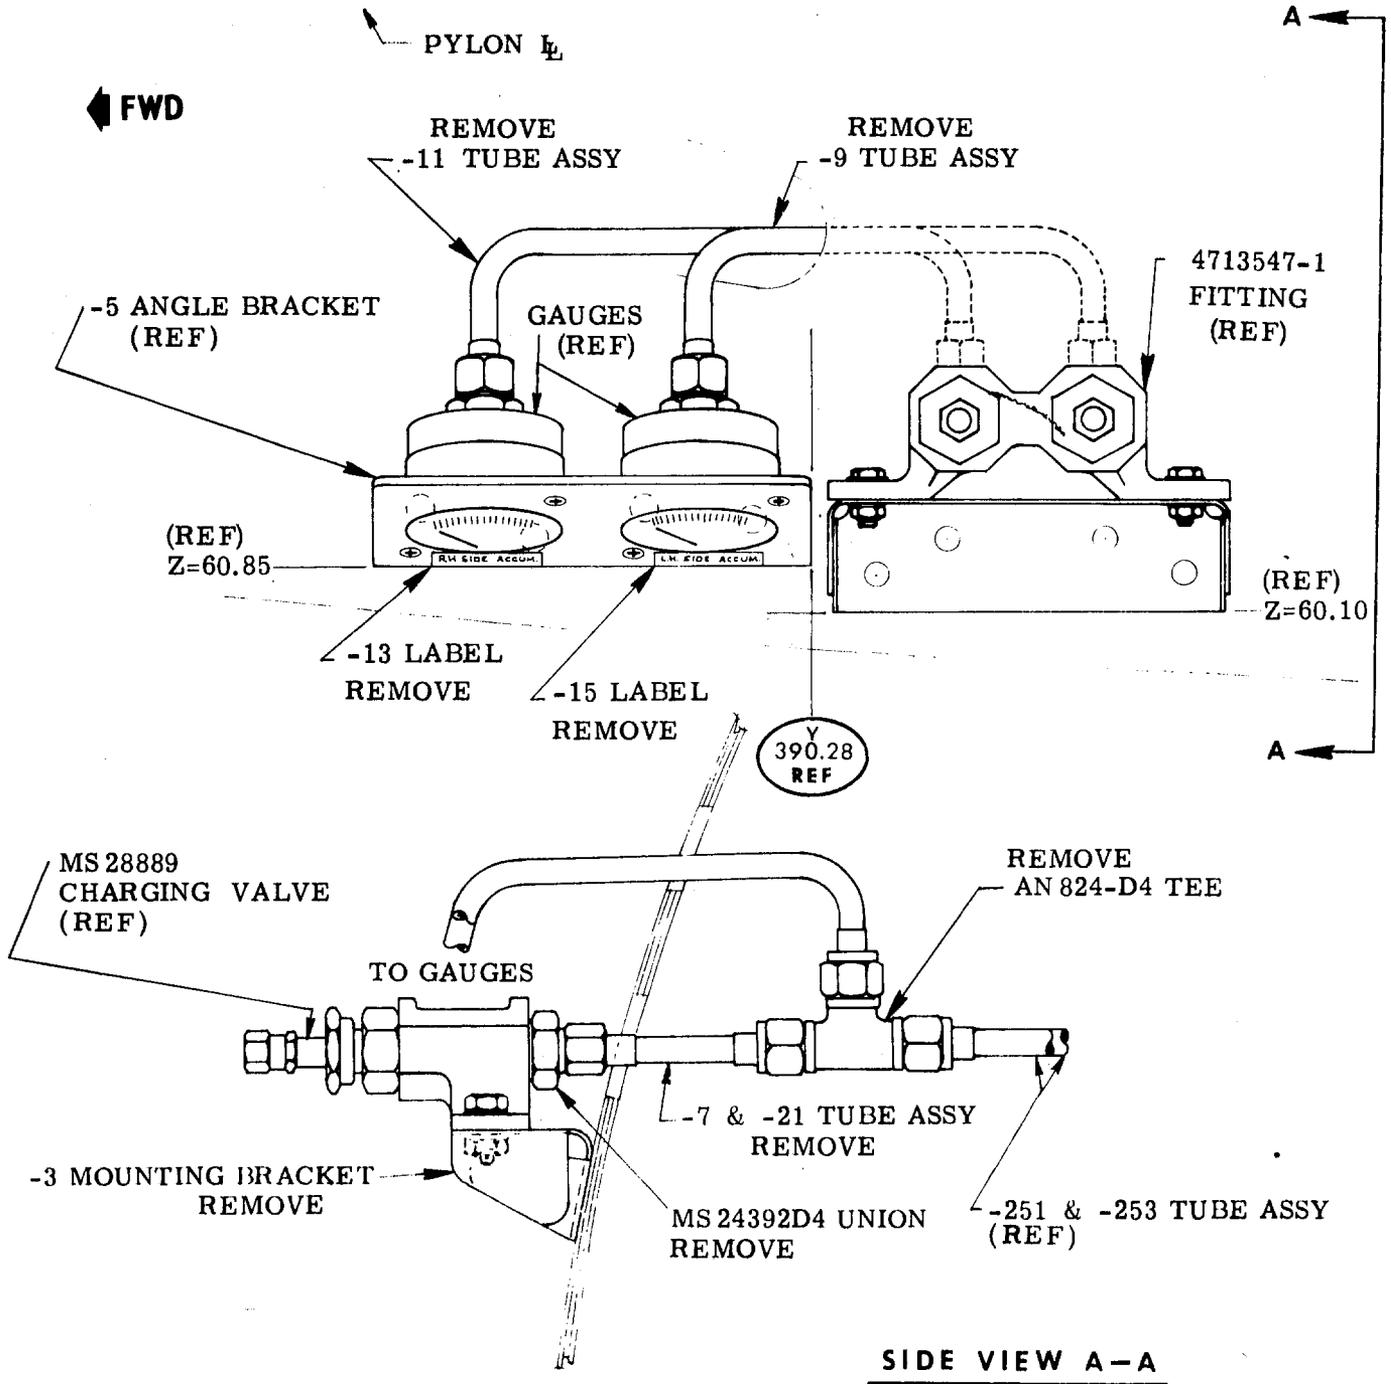
FIGURE 2

PRESENT CONFIGURATION OF NITROGEN GAUGES AND CHARGING VALVES

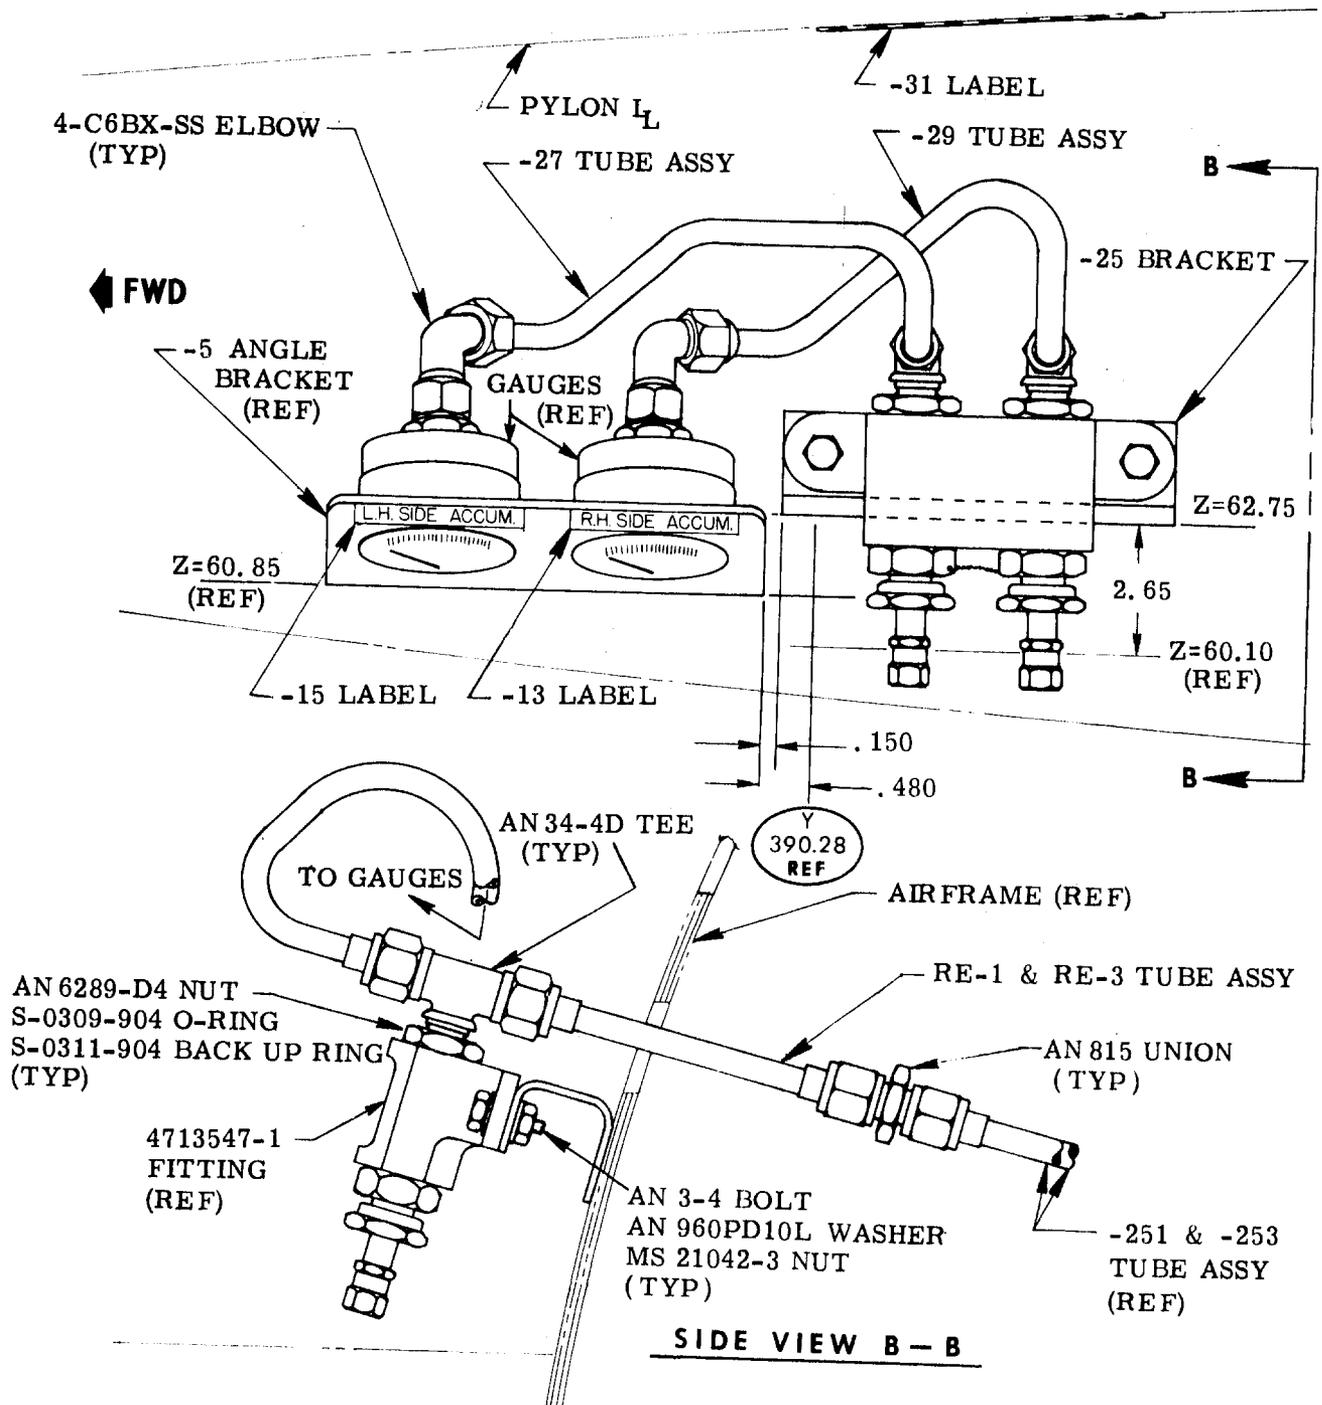
RELOCATION OF NITROGEN GAUGES AND CHARGING VALVES
 FIGURE 3

13. Install 4-C6BX-SS elbow on each -503 gauge. Mount gauges to -5 bracket with existing fasteners. Connect L. H. gauges with -27 and -29 tube assemblies to respective L. H. and R. H. AN34-4D tees.
14. Clean surface of -5 bracket with solvent and apply -13 and -15 labels above R. H. and L. H. gauges. Clean surface and apply -31 label to inside pylon skin where easily seen.
15. Charge nitrogen accumulator systems per -31 label instructions and leak check all connections.
16. Replace pylon access hole cover.

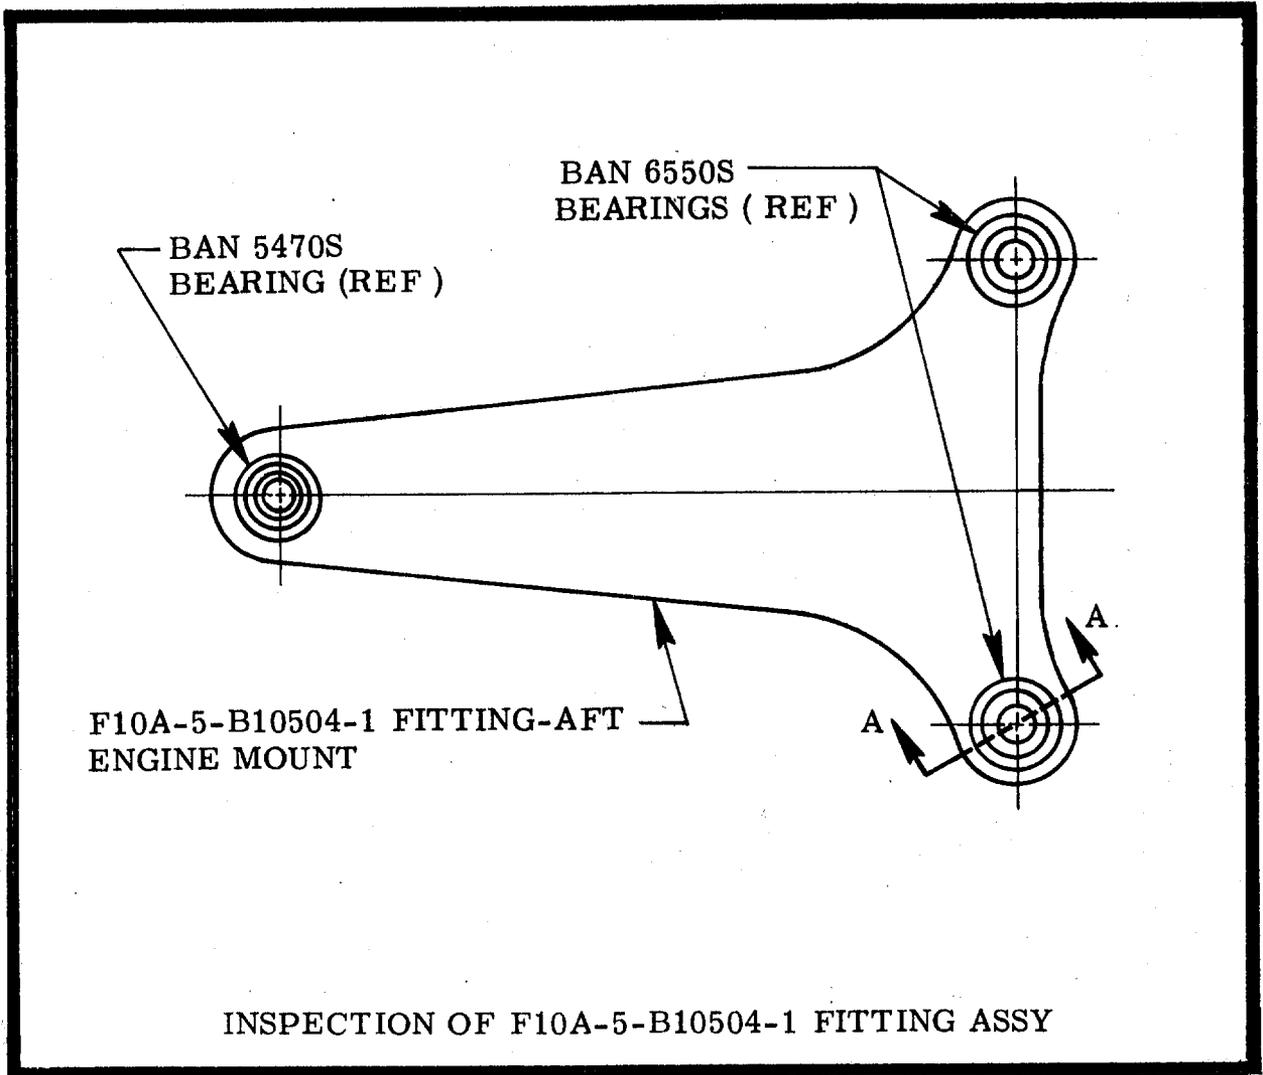
FIGURE 1

PURPOSE: TO INSPECT FOR AND REPLACE AFT ENGINE MOUNT FITTING ASSEMBLIES WHICH HAVE BEARINGS WHICH MAY BE LOOSE DUE TO INSUFFICIENT CHAMFER OR SWAGING.

INSPECTION OF F10A-5-B10504-1 FITTING ASSY

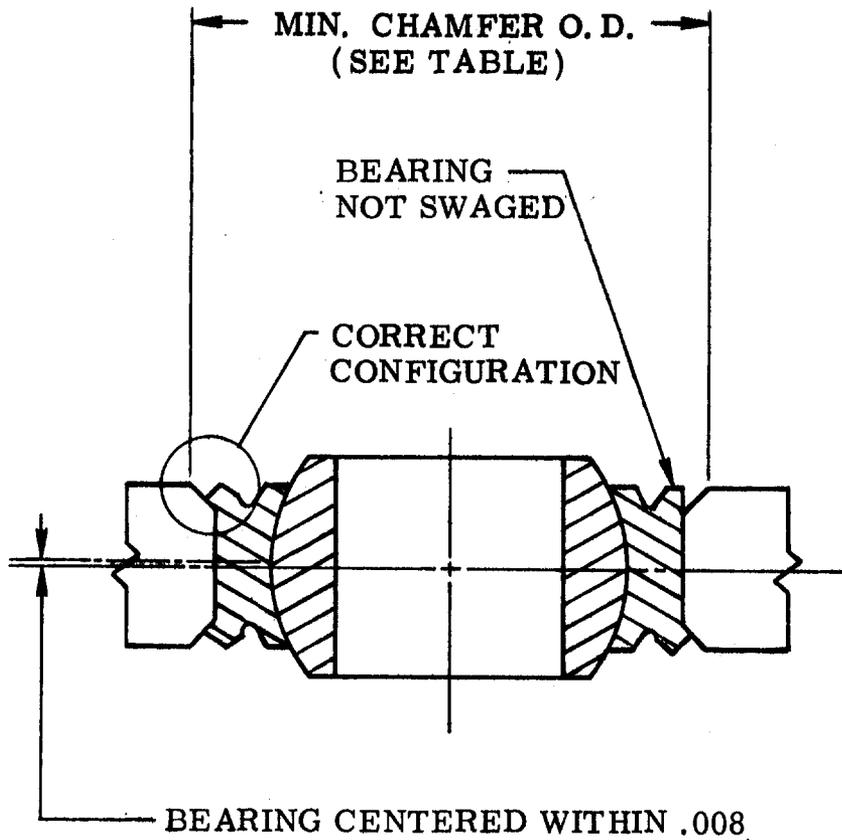
FIGURE 2

Inadequate chamfer may be determined by measuring the O. D. of chamfer on fitting. (SEE FIGURE 2) The diameter should be no less than:

If diameter measures less than above minimum, the fitting assembly should be replaced.

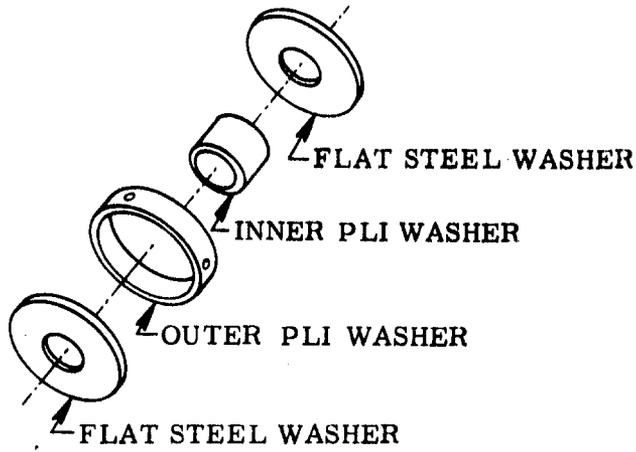
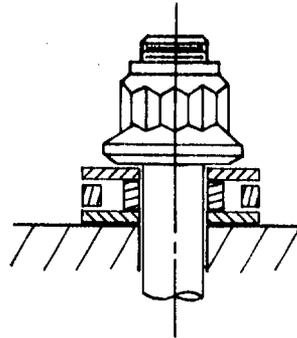
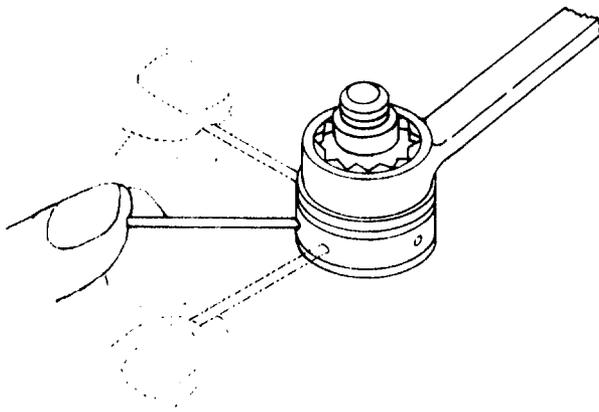
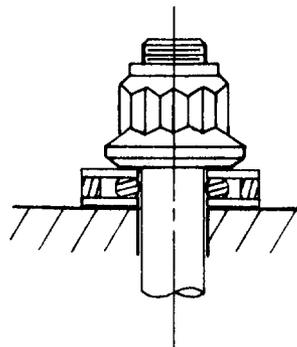
FIGURE 1

INSTALLATION OF PRE-LOAD INDICATING WASHERS ON FORWARD ENGINE MOUNT ATTACHMENT BOLTS

- A. Perform complete replacement and torquing procedure at one fastener location before proceeding to another location.
 - B. Remove and dispose of existing nut and pre-load indicating washer set. USED PLI WASHERS MUST BE DESTROYED TO PREVENT RE-USE.

DO NOT OVERTIGHTEN. IF NUT IS TIGHTENED MORE THAN 1/8 TURN BEYOND POINT WHEN OUTER PLI WASHER BECOMES IMMOVABLE, THE ENTIRE BOLT, NUT, AND PLI WASHER ASSEMBLY MUST BE REPLACED.

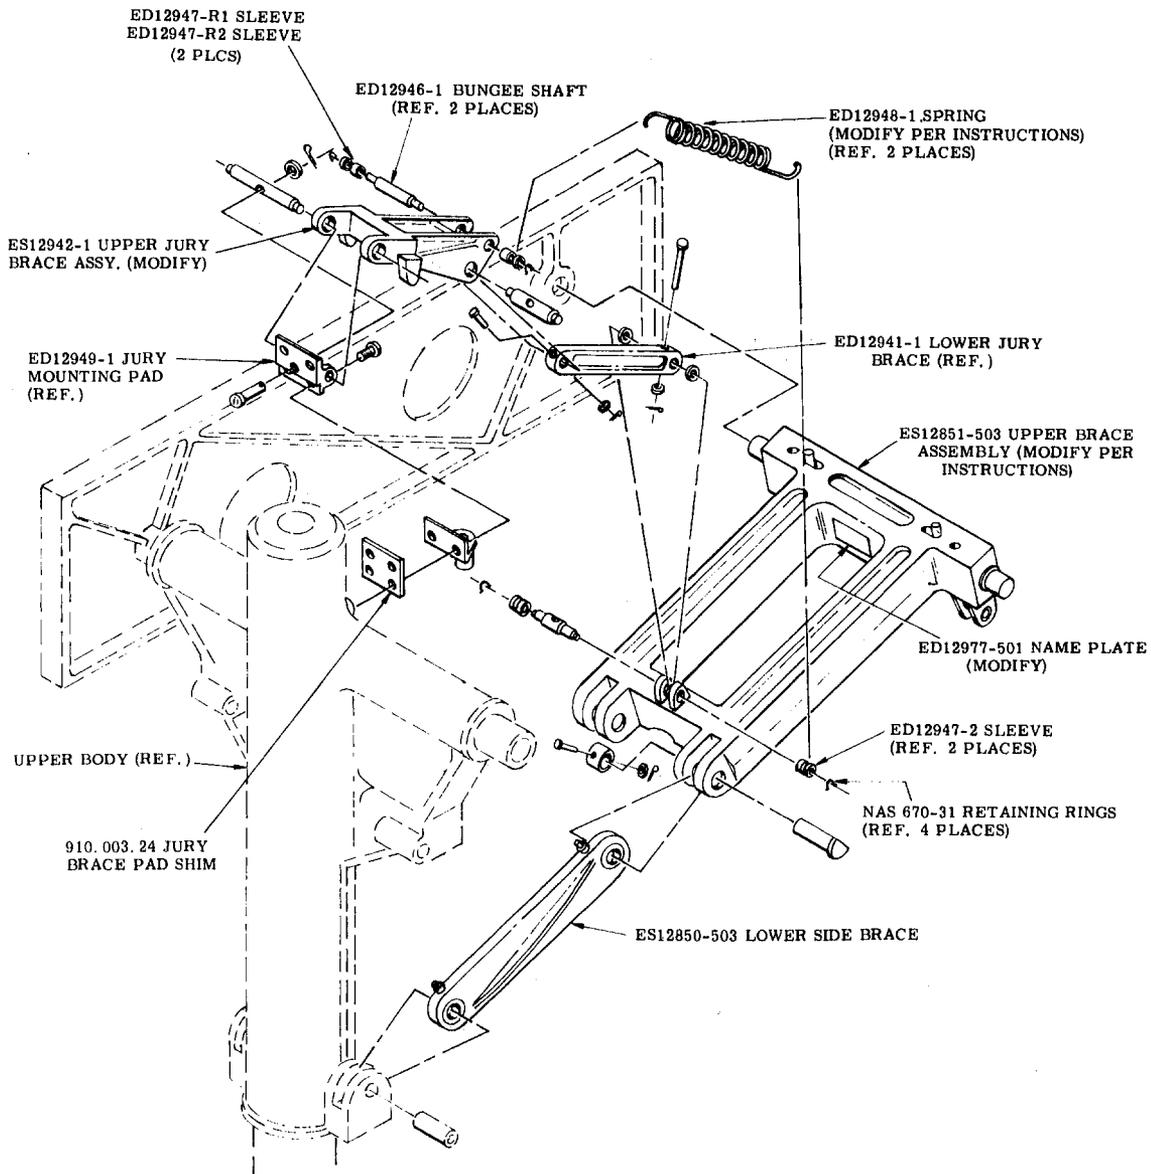
FIGURE 1

SIDE AND JURY BRACE ASSEMBLY
EA1681-503 MODIFICATION TO EA1681-505

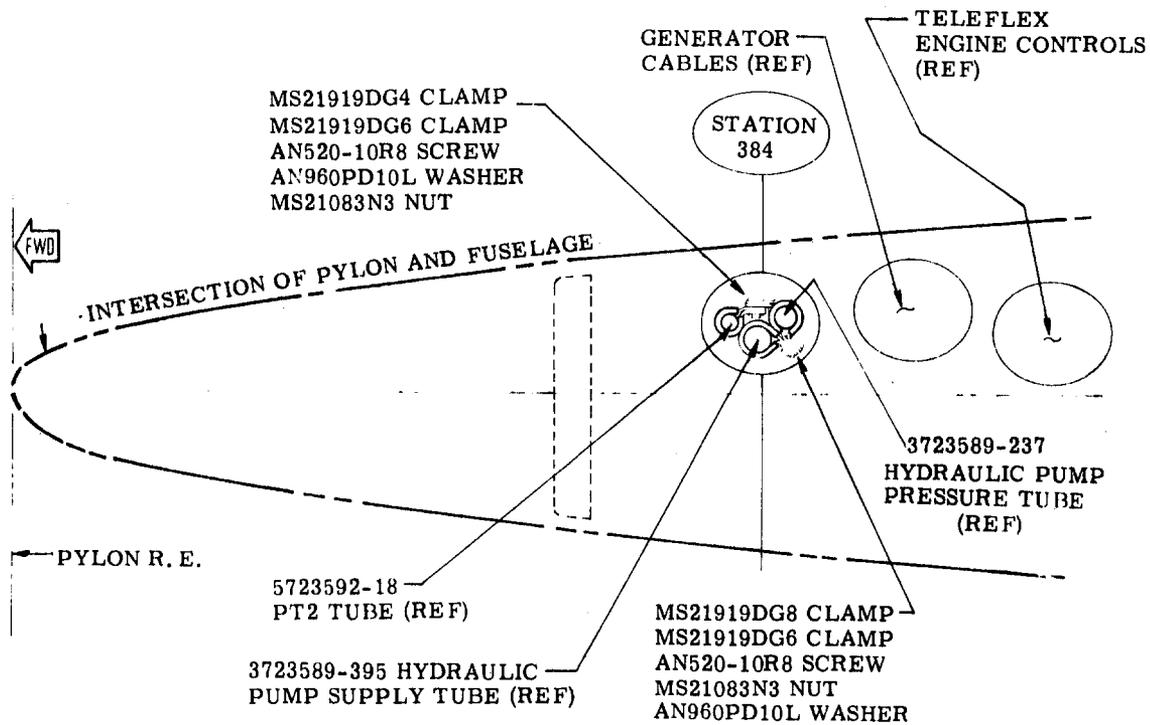
VIEW - INSIDE AIRFRAME TOWARD R. H. ENGINE PYLON
INSTALLATION OF TUBING CLAMPS
FIGURE 1

1. Remove aft panel of fwd baggage compartment and remove air conditioning ducting as necessary to gain access to tubing entering aft fuselage from engine pylon at Station 385.

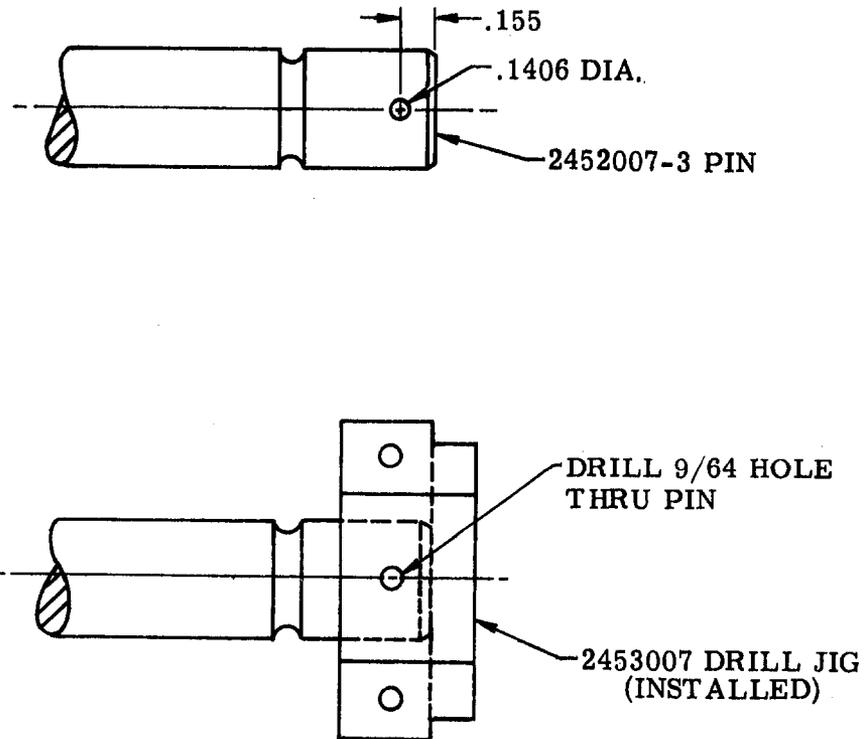
FIGURE 2

DRILL JIG INSTALLATION

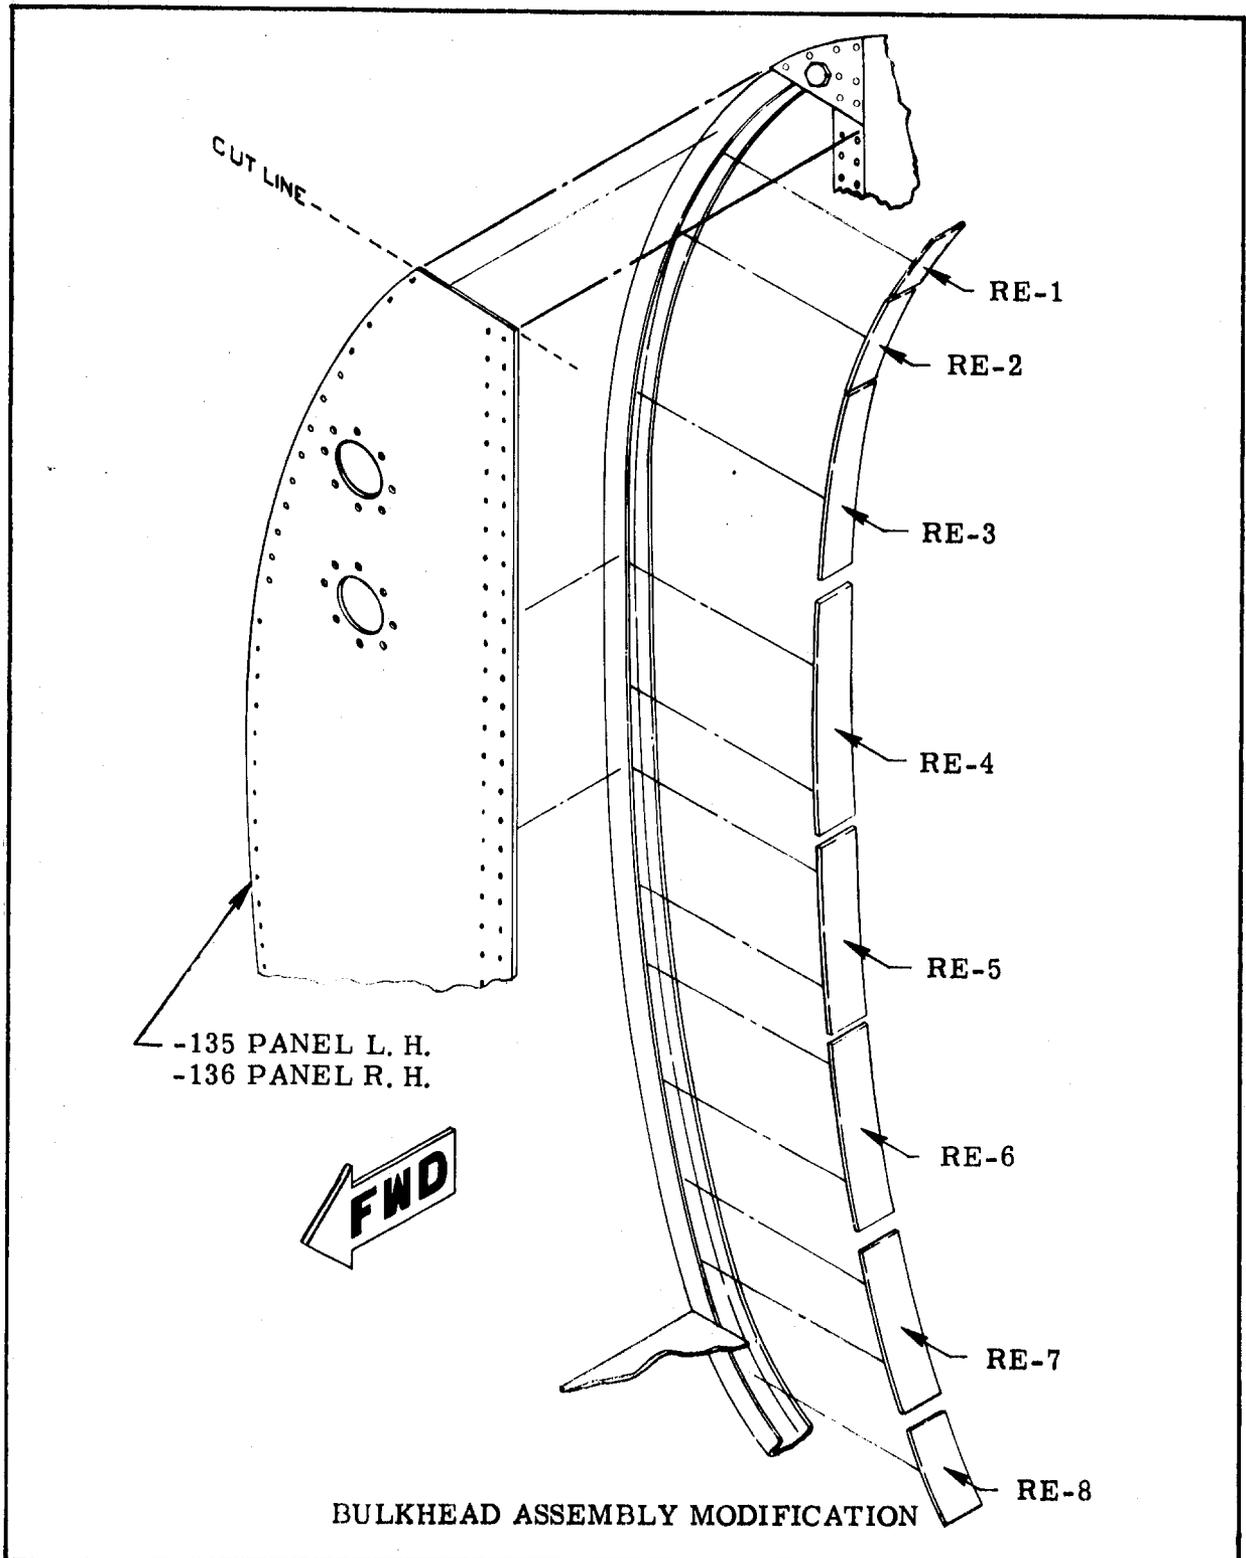
FIGURE 2

PURPOSE: TO PREVENT CRACKING OF THE "U-CHANNEL" IN THE AFT PRESSURE BULKHEAD

1. Remove interior so as to have free access to the entire area of the Aft Pressure Bulkhead Assembly.
2. Remove wiring, plugs, ducting, fittings, etc., as necessary to facilitate removal of insulation and sound proofing covering the R. H. and L. H. panels. (SEE FIGURE 1)
3. Mark "cut line" on upper portion of R. H. and L. H. panels. Drill out rivets below "cut line" securing panels to the airframe and pull panels loose. (SEE FIGURE 2)

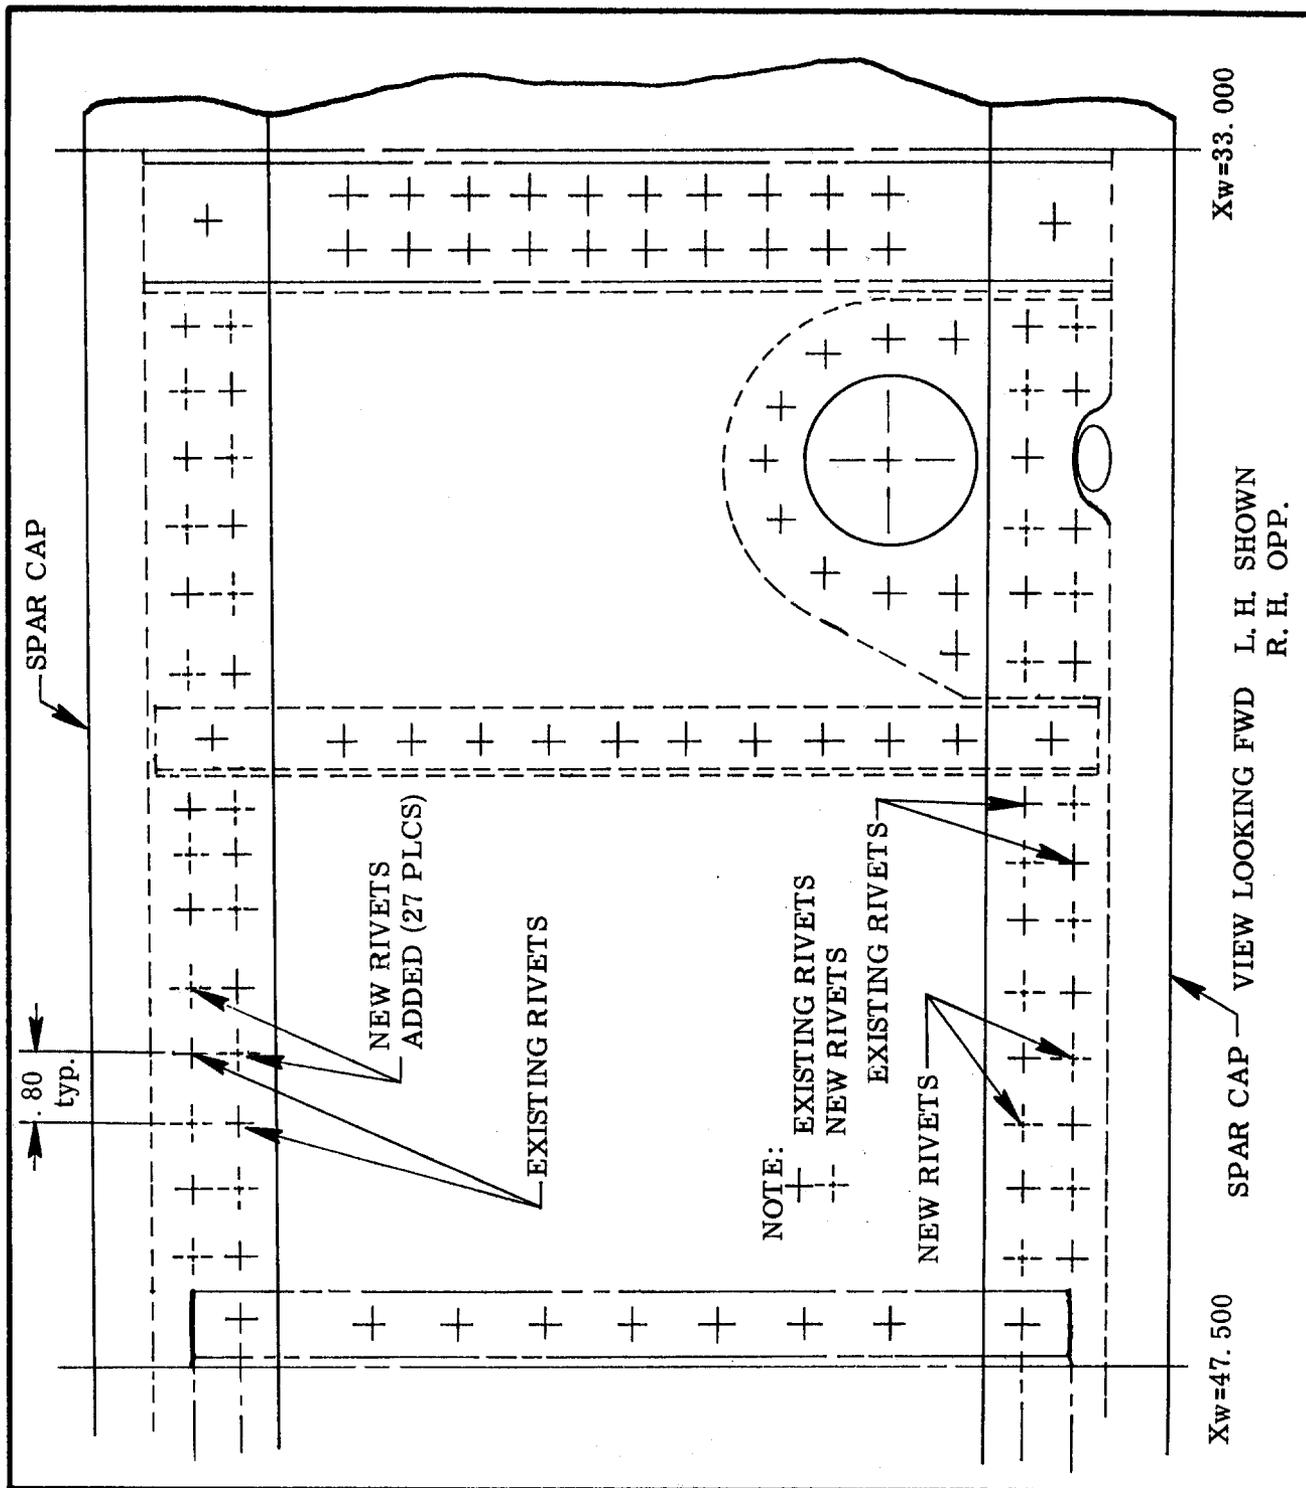
FIGURE 1.

RIVET INSTALLATION-25%(FRONT) SPAR

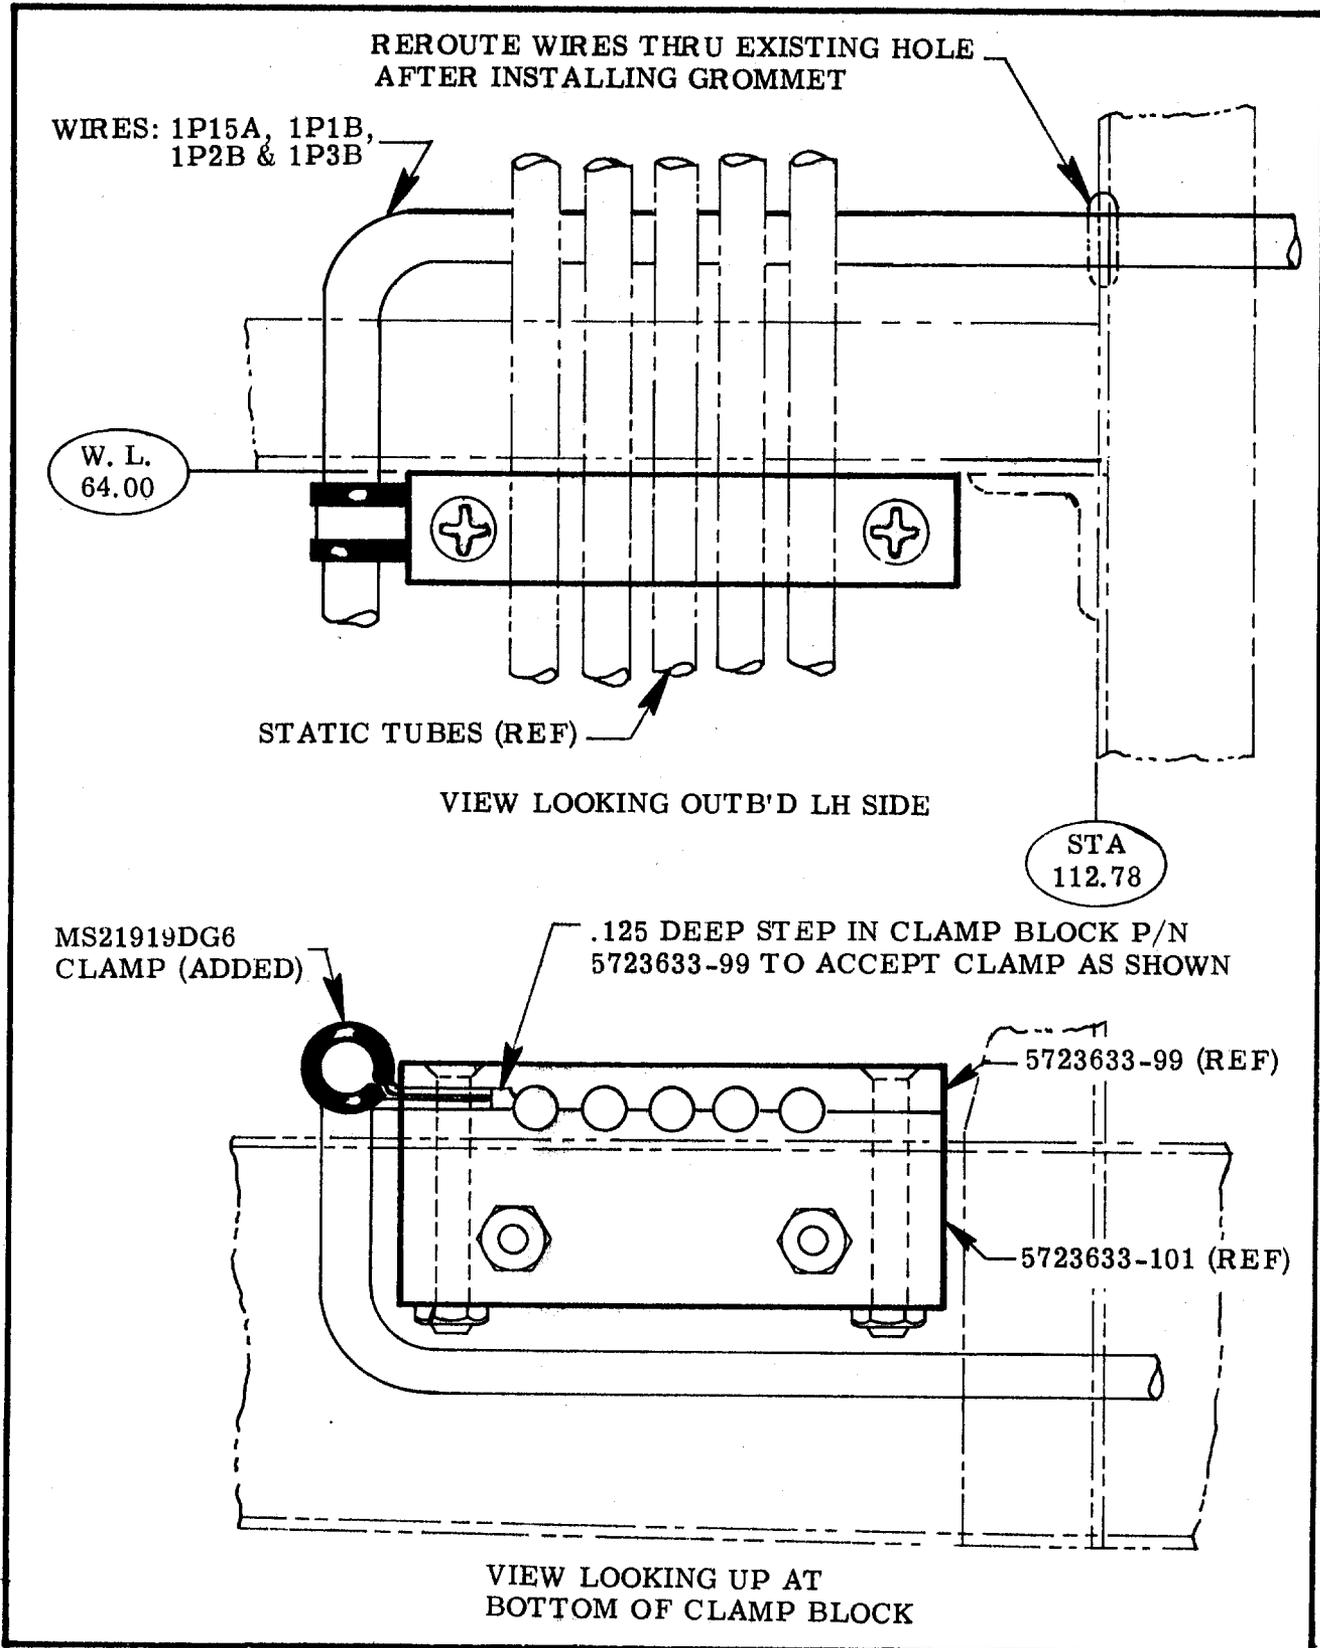
FIGURE 1

1. Remove upper hot liquid container in galley aft of Fus. Sta. 112, LH side.
2. Inspect electrical wire bundles located behind upper corner of container for evidence of chafing marks or damaged insulation.
3. If chafing is evident or damaged insulation is discovered, proceed to Part II of these Instructions. If chafing is not discovered, the aircraft may be continued in service at Operators discretion, provided the upper container is removed, loose electrical wiring is secured and a Placard is installed prohibiting the installation and use of the container until the proper routing and protection of electrical wiring is accomplished in accordance with Part II of these Instructions.

3. Reroute wires and install MS21919DG6 support clamp per Figure 1, and reconnect wires to terminal board "AC".
4. Replace or repair any wiring damaged by chafing, as determined by inspection per Part I of these Instructions.

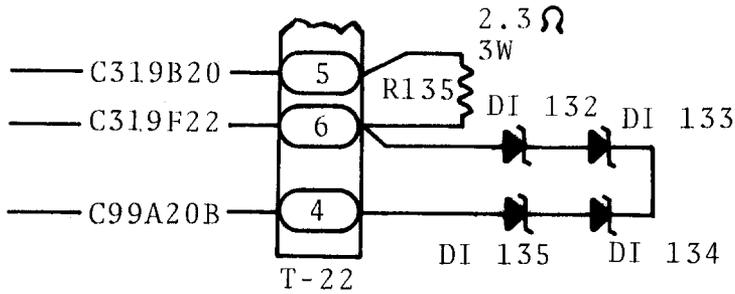
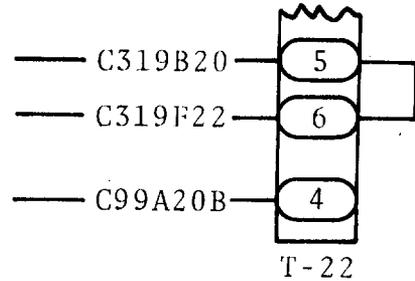
FIGURE 1

To avoid possible overheating of subject resistors or diodes due to inverter overvoltage protection circuit failure.

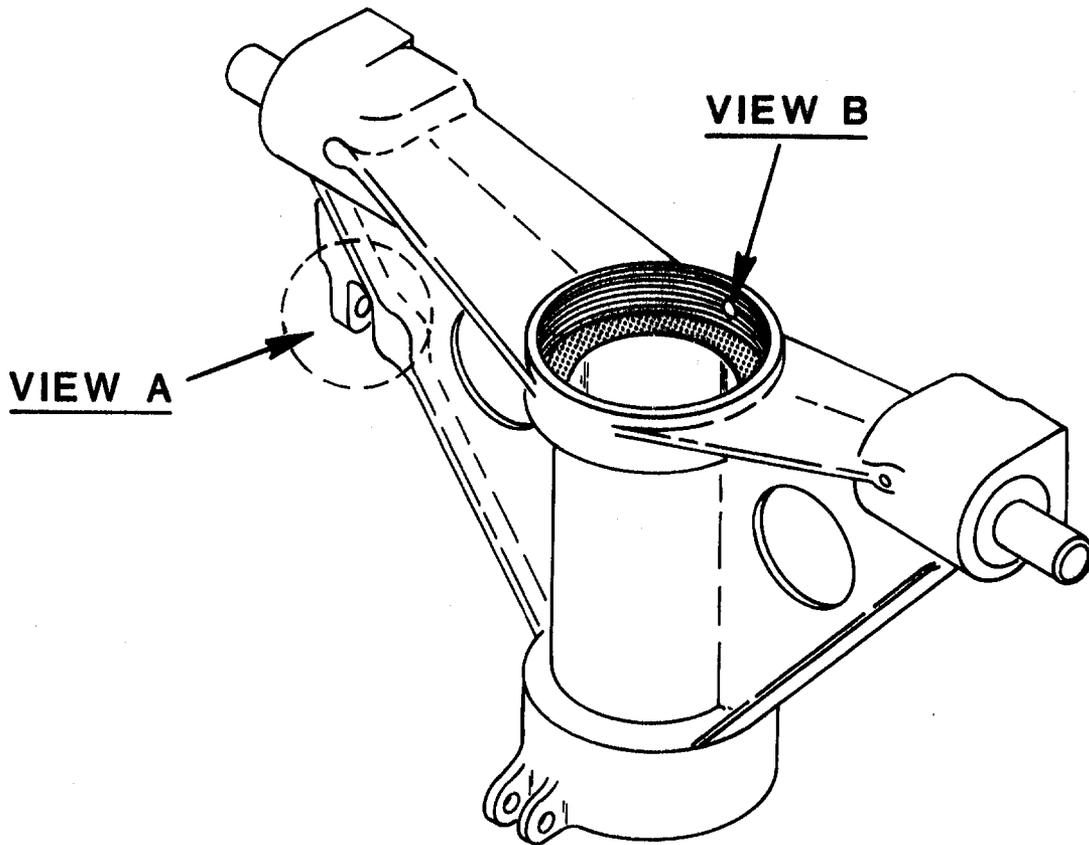
FIGURE 1 AREAS OF INSPECTION

This service bulletin details the inspection and method to detect cracks at three locations on the NLG outer strut-body.

- D. Clean outer strut-body and strip paint from areas to be inspected. See Figure 1.
- E. Inspect the following areas for cracks and/or corrosion using dye penetrant or fluorescent inspection method and a 10-power magnifying glass:
- Area A - Roots of lug where retraction cylinder attaches to outer strut-body.
 - Area B - The area where the upper bearing retaining nut threads meet the threaded hole for the retaining nut lock-screw.
 - Area C - The upper bearing bore shoulder area. This inspection is required on P/N ES12854-1 or struts manufactured from 7079-T6 aluminum alloy only.

The outer strut-body forging is disqualified for further flight if a crack is detected in any of the three areas unless it can be blended out in accordance with the rework limits of 2.F. of this service bulletin. Corrosion in excess of the limits of 2.F will also disqualify the outer strut-body for flight.

NLG OUTER STRUT BODY
P/N ES12854-1 or ES12854-501

VIEW A — INSPECTION AND REWORK (AREA A)

- F. Cracks or corrosion found in the aforementioned inspection may be blended out with a .157 inch diameter rotary file and then polished with 400 grit paper as long as they do not exceed the following limits:
- (1) Corrosion in the bearing bore shoulder may not exceed a depth of .039 inches.
 - (2) Cracks may not exceed .118 inches in length and .039 inches in depth.
 - (3) Treat all reworked areas with Alodine 1201.
- G. Rework of Areas A and B must be accomplished to remove cracks and may also be accomplished to relieve stress that could cause cracking in the future. Reference Figure 2. (Rework will not be necessary if it has already been accomplished. Refer to NOTES in paragraph 1.C. of this bulletin).
