1124 AND 1124A WESTWIND SERVICE BULLETIN INDEX

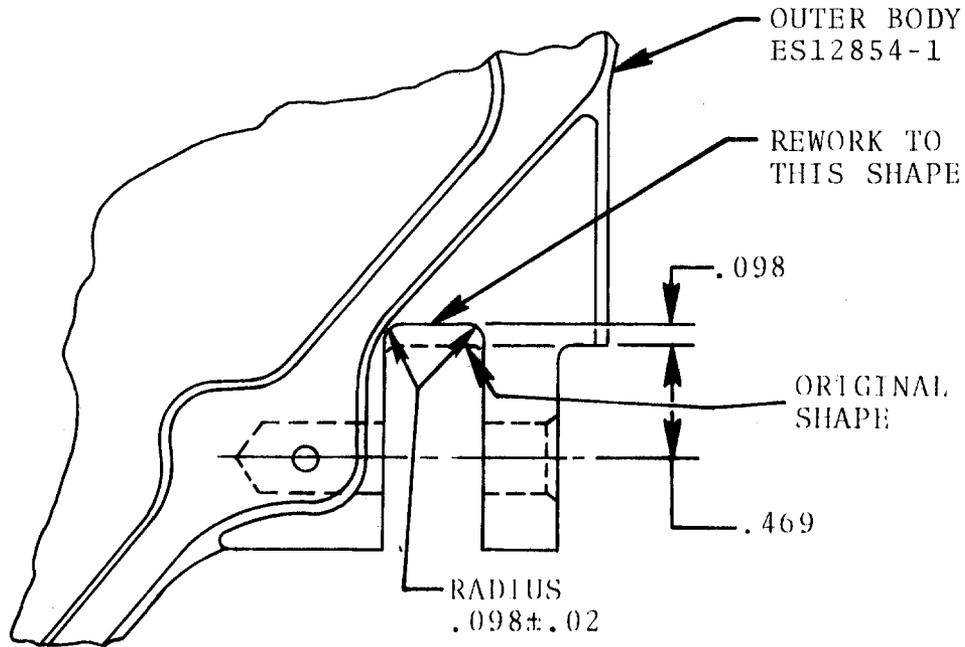
VIEW A RETRACT CYLINDER
LUG AREA REWORK

Rework of Area A to relieve stress is not required on some replacement struts, i.e. P/N ES12854-501. Careful inspection of P/N ES12854-501 struts will be necessary to determine if rework has already been accomplished. See Figure 2 for dimensions. Reworked struts should be marked with an "A" in the area of the strut part number (strut part number should be located on the aft side of the barrel portion of the strut body). Struts which have been reworked but not marked or struts that are reworked in accordance with this service bulletin should be marked with "A" in the area of the strut part number.

- b. Reinspect cut area for cracks before polishing.
 - c. Polish cut area with 400 grit paper.
 - d. Treat bare metal with Alodine 1201.
- (2) Accomplish rework of Area B as follows:
 - a. Drill and ream lock screw hole, through outer strut body, to a diameter of .211 + .008 inch
- .000

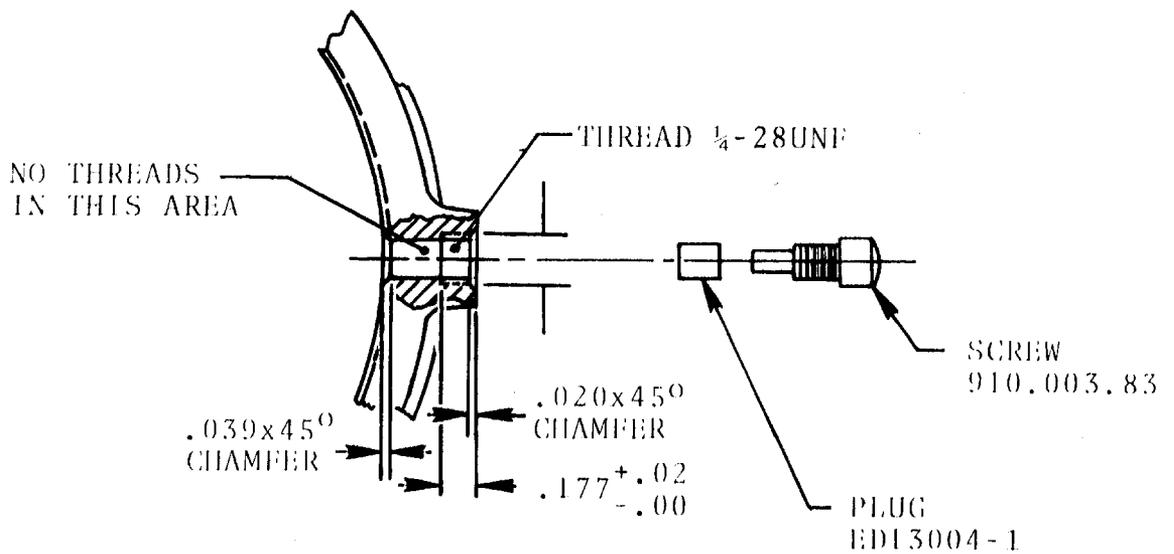
VIEW B LOCK SCREW HOLE
REWORK

Rework of Area B to relieve stress is not required on some replacement struts P/N ES12854-501. Reworked struts will not have the upper bearing retaining nut lock-screw hole threaded all the way through.

- d. Carefully clean any burrs from hole and threads, especially at hole/thread intersection.
 - e. Reinspect area for cracks.
 - f. Polish hole and chamfered areas.

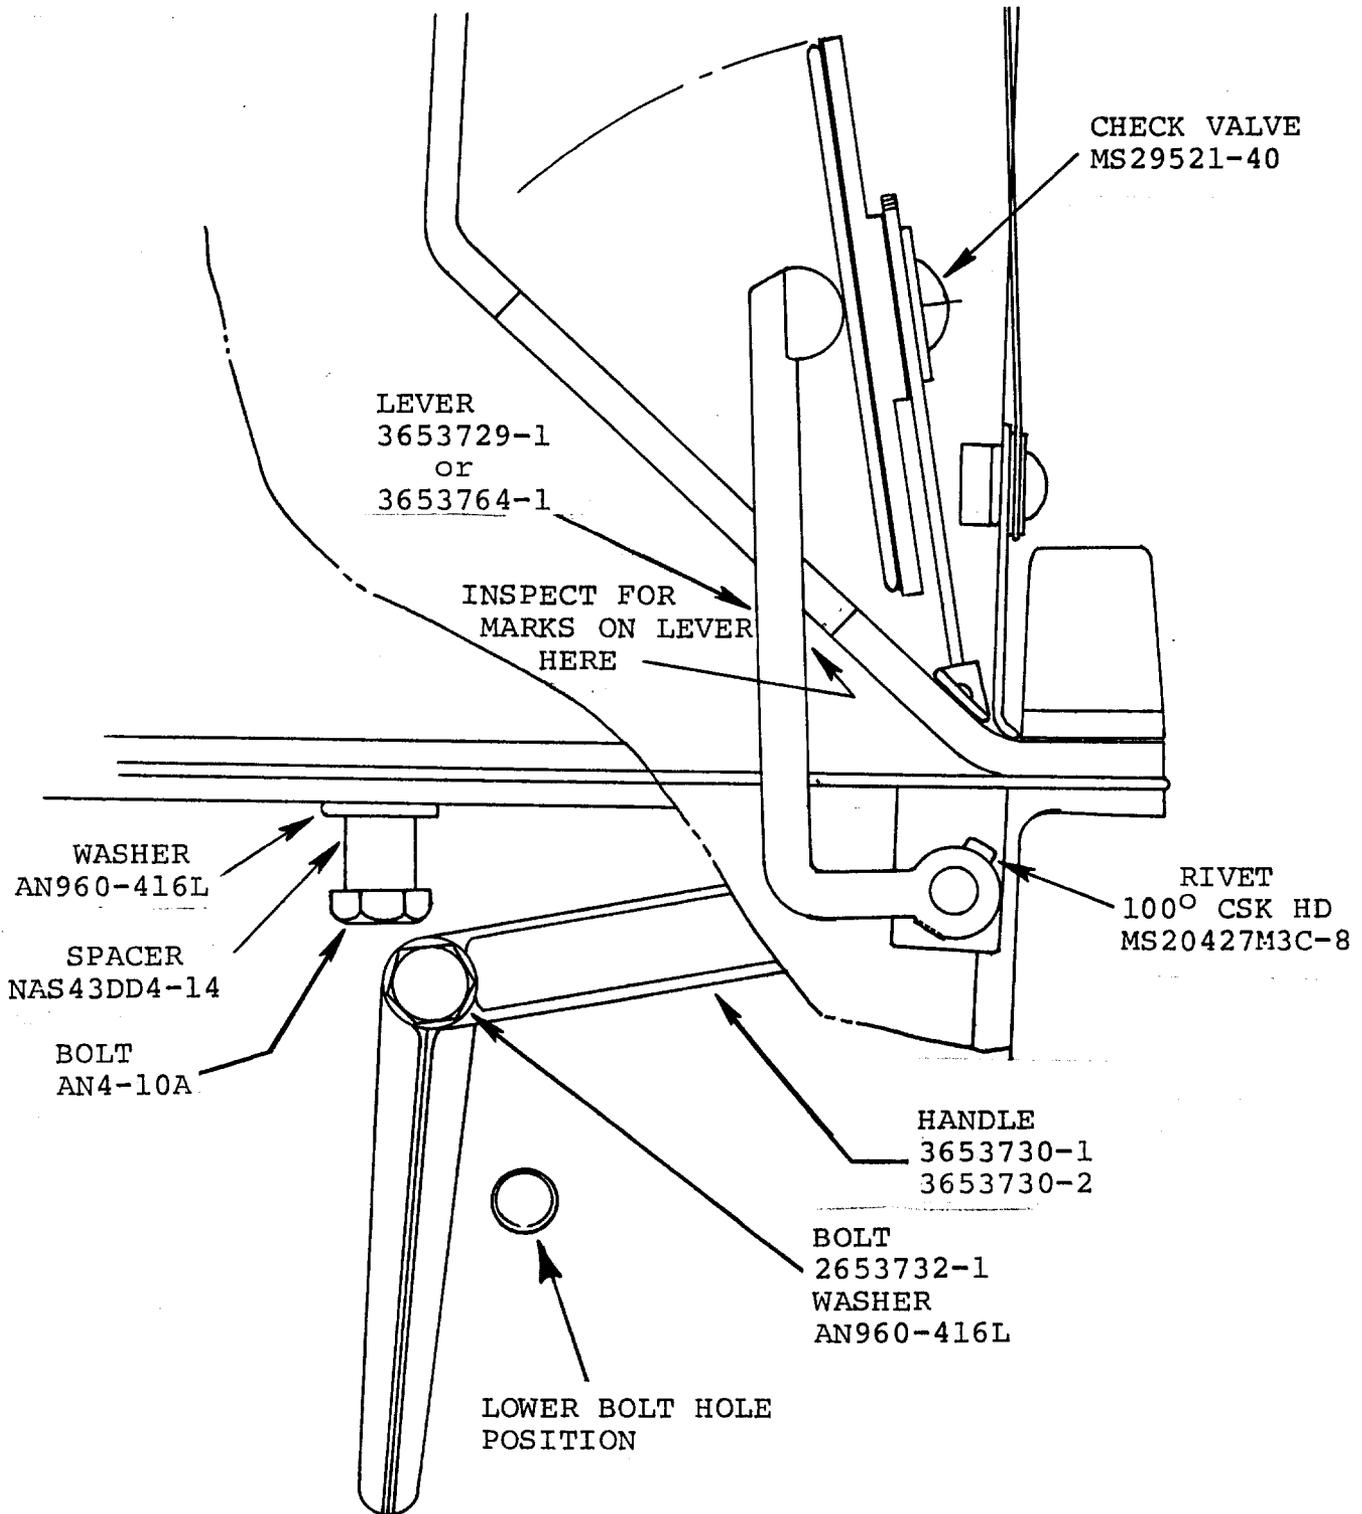
FIGURE 1
FUEL SUMP CHECK VALVE INSPECTION

To inspect for damage to the flapper-type check valve lever which may occur by exerting force on the lever handle in the up or open position, beyond the sump case upper securing bolt hole. This overtravel may cause the flapper valve hold-open lever to contact the edge of the upper sump fuel passage port. A manual lever stop is to be incorporated to prevent overtravel.

Should any marks be noted on the P/N 3653729-1 or P/N 3653764-1 lever, the lower sump casing assembly is to be removed. A dye check is to be performed on the lever for crack indication. Suspect levers are to be replaced.

Instruction is provided for a dye penetrant inspection and replacement of the check valve lever should it be required.

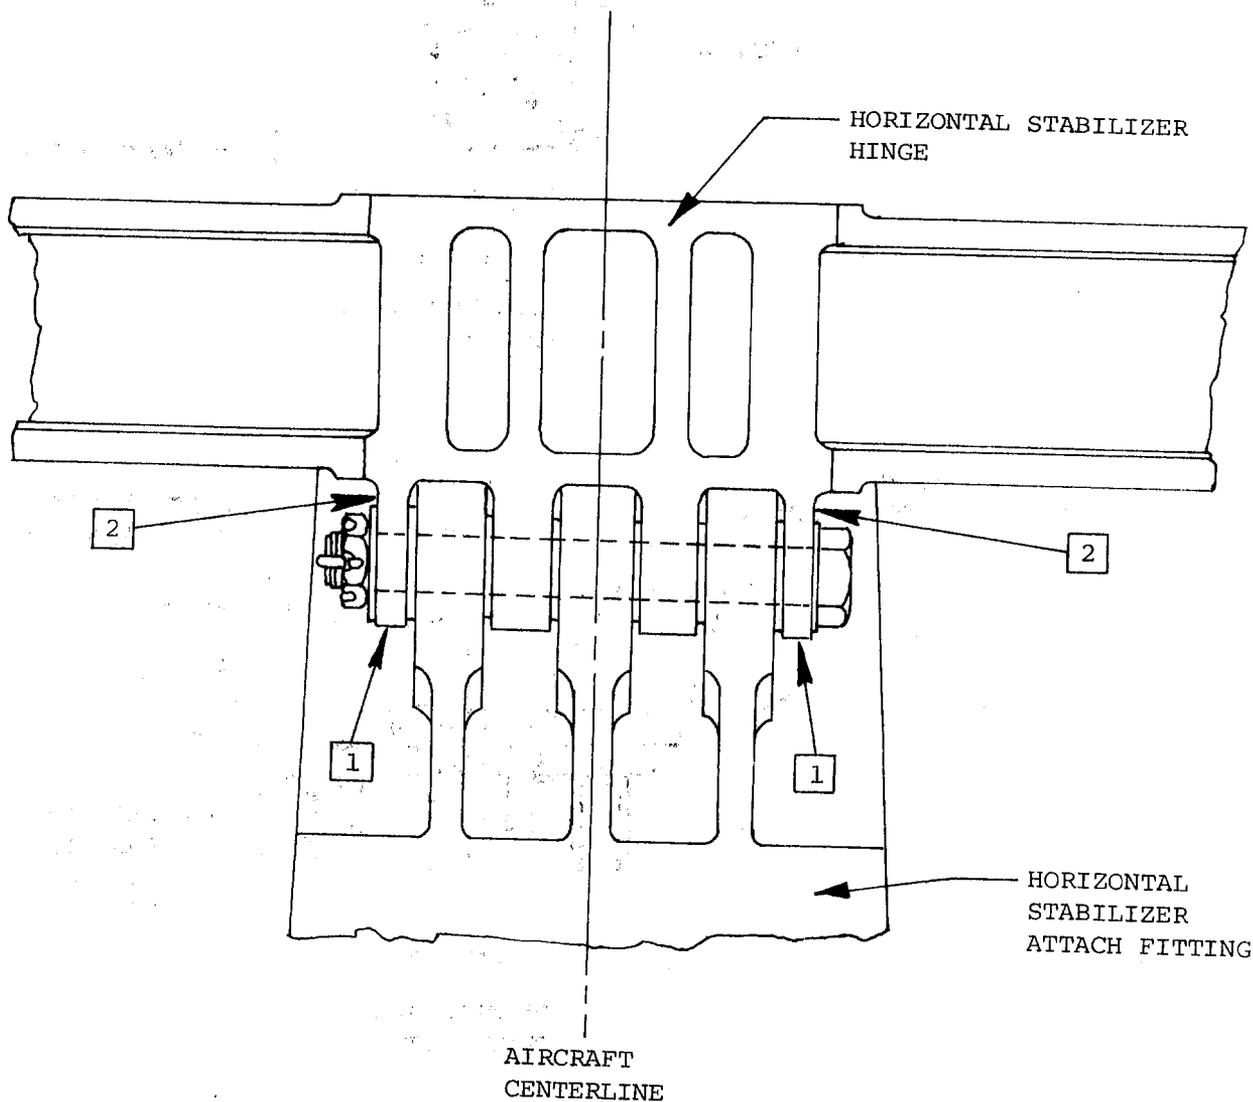
FIGURE 12

INSTALLATION OF
LOWER FITTING

- (1.3) Install NAS6604-14X bolt with AN960C416L washer in center hole - do not tighten.
- (1.4) Loosen outboard bolts in upper attach fitting. Insert GAP "C" filler. Install MS90353-5-4 blind fasteners as shown in Figure 12, View E.

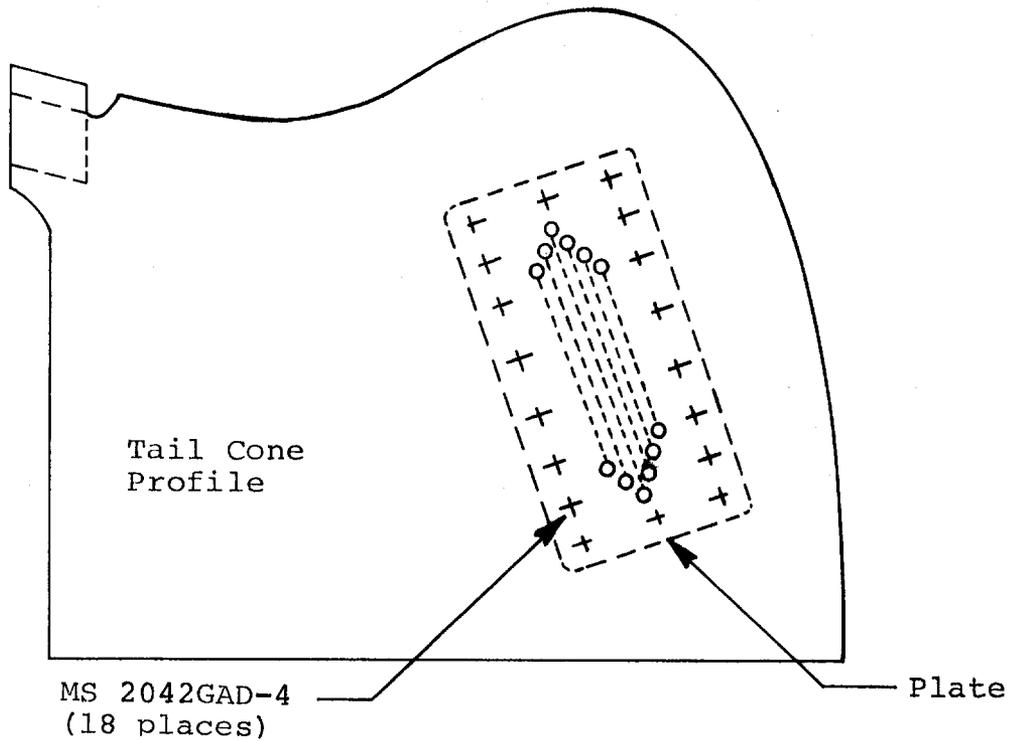
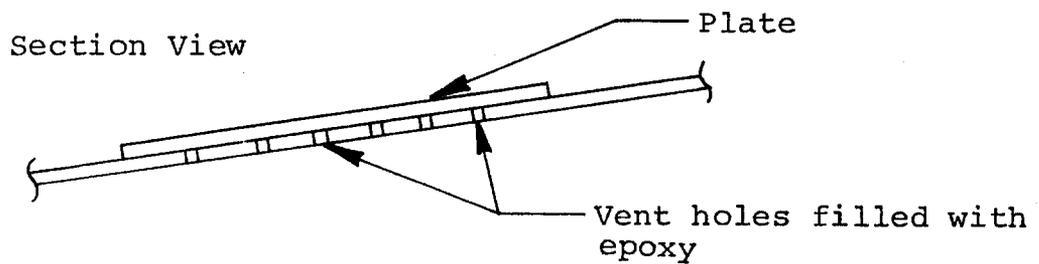
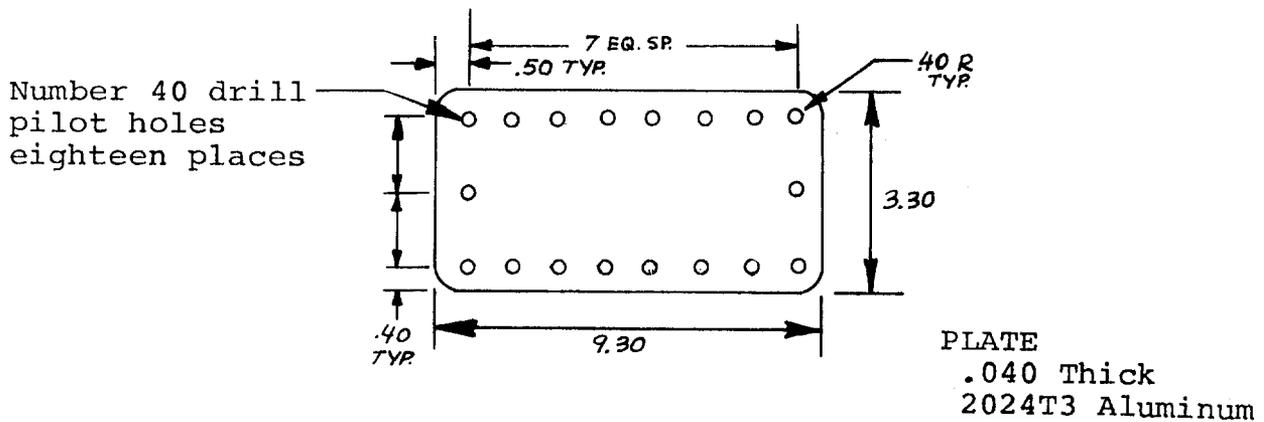
FIGURE 1

To reduce excessive airflow to electronic equipment.
To eliminate the collection of rain water and/or moisture in the tail cone area.

CLOSURE OF TAIL CONE VENT HOLES

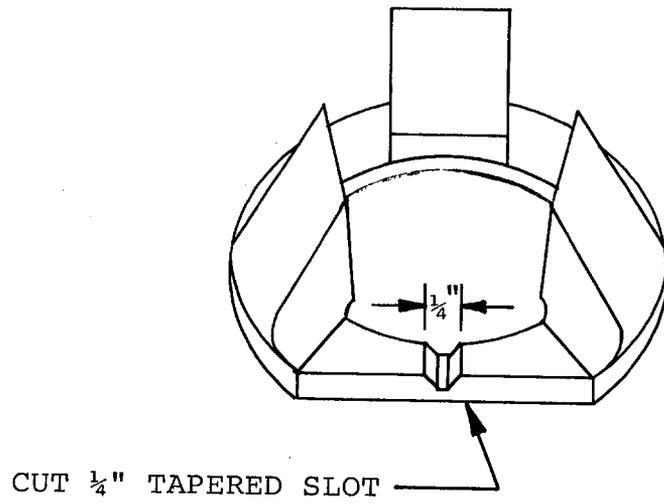
FIGURE 1

This service bulletin provides the means of draining moisture from the fuselage fuel probe base support and also ensures that sufficient clearance exists between the tubes and/or hoses routed along side the probes.

FUEL PROBE BASE SUPPORT

- (1) Defuel aircraft in accordance with Maintenance Manual, Chapter 12.
- (2) Remove electrical power from aircraft.
- (3) Remove external access side panels and access side covers from lower, fuselage tanks in accordance with Maintenance Manual, Chapter 28-10-00.
- (4) Remove external access side panels and access side covers from lower fuselage tanks in accordance with Maintenance Manual, Chapter 28-10-00.
- (5) Remove or loosen clamps securing probe to tubes.
- (6) Raise probe sufficiently to gain access to the base support.

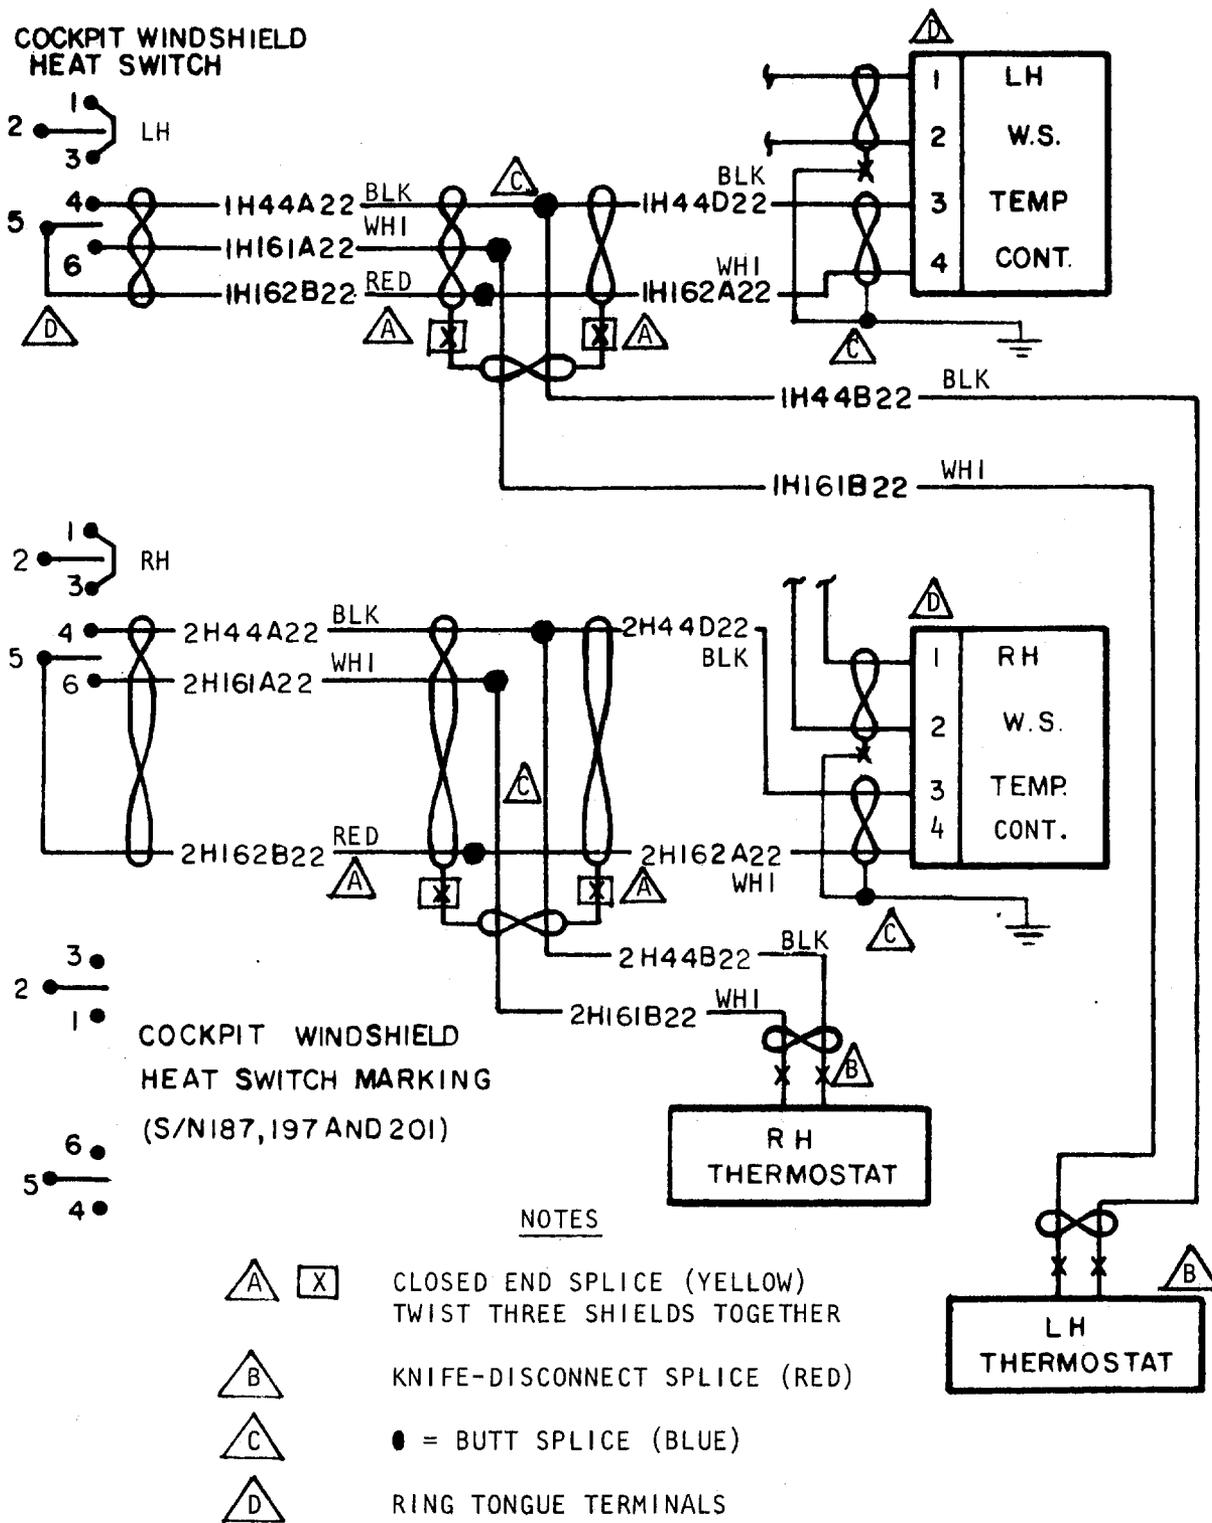
FIGURE 1 SHIELDED WIRING CONNECTIONS

PART I Induced voltages have been determined to be the cause of unwanted cycling of the windshield heat contactors, P/N 833044-1. This bulletin describes the steps necessary to remove unshielded wires and replace them with shielded wires that are properly grounded at each termination point.

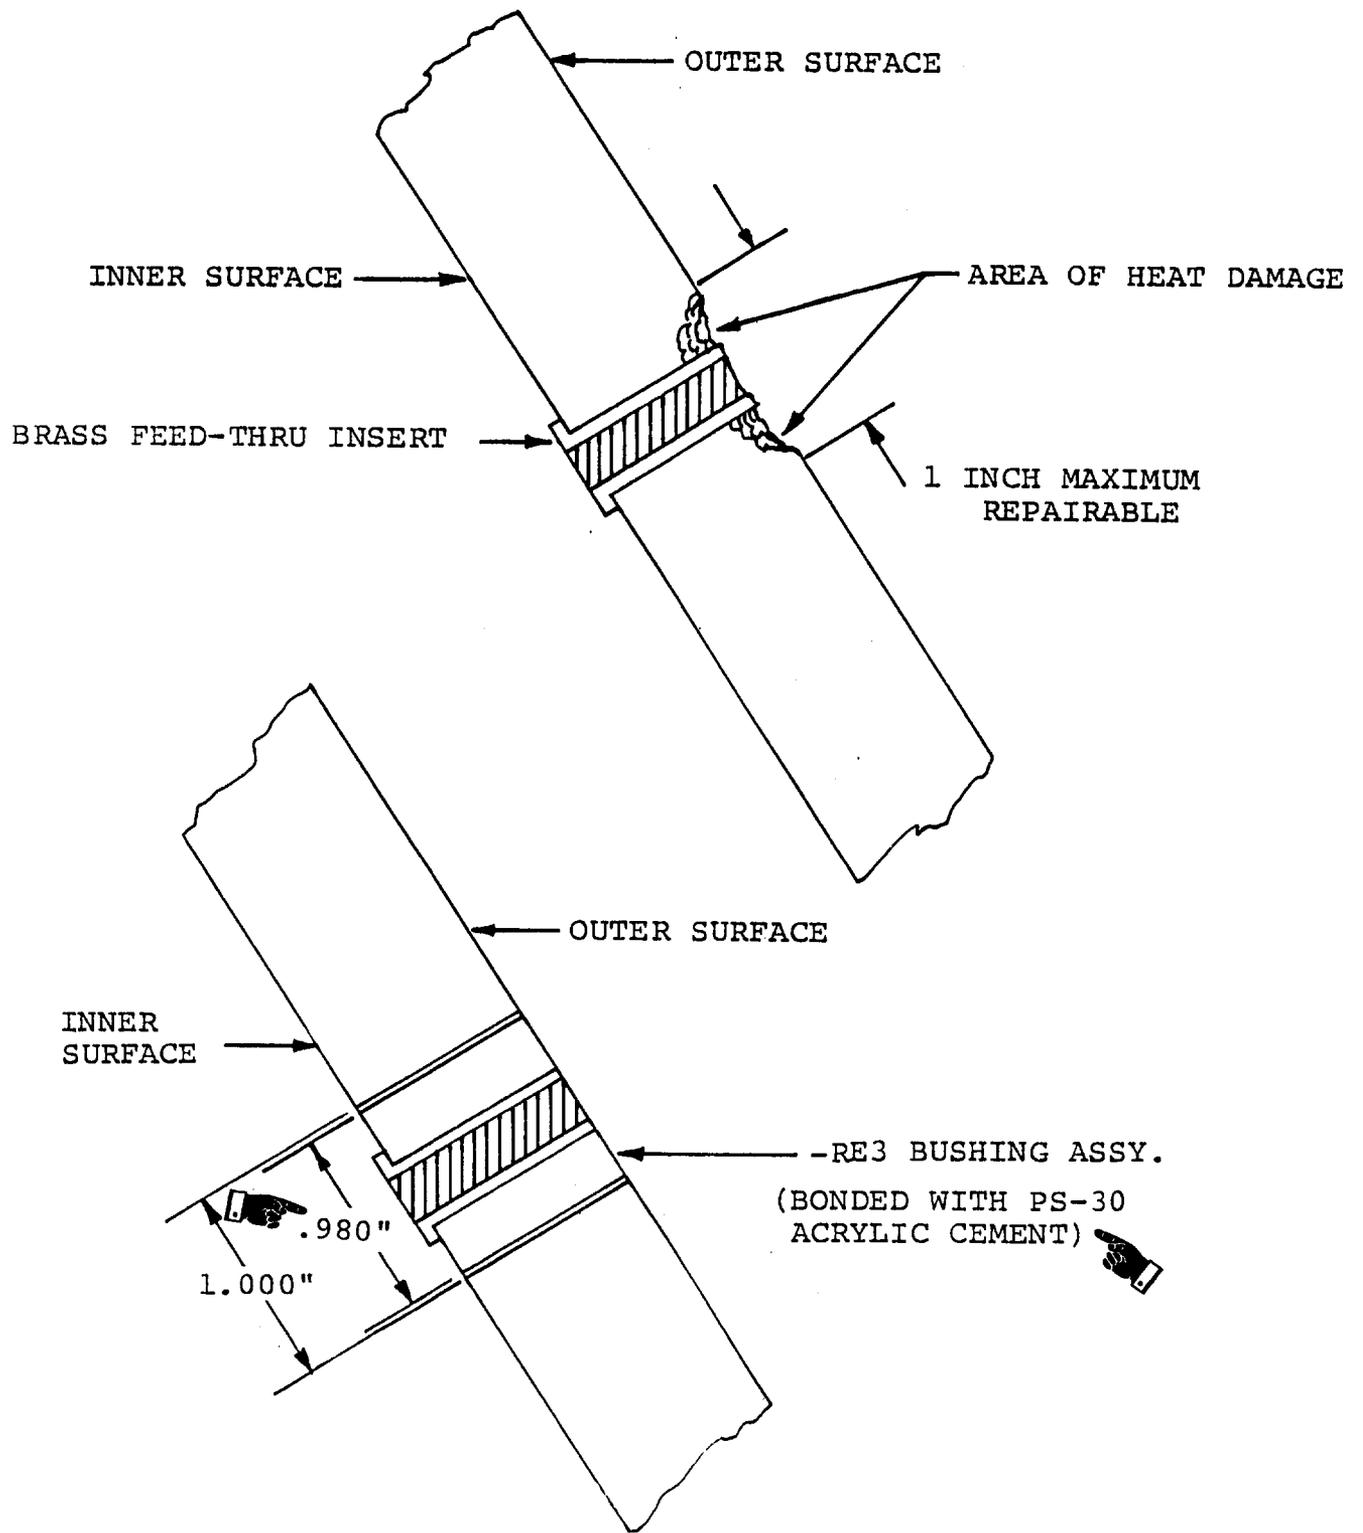
FIGURE 1

To provide typical repair method and materials required to repair inner windshield at the windshield heat terminal feed-through locations. This repair is applicable to any of the six terminal locations.

The windshield repair procedure provided may be used on windshield heat probe feed-through locations which have suffered localized heat damage due to arcing of the contact at that position.

Remove existing feed-through bushing, remove heat-damaged acrylic material, counterbore 1-inch hole through windshield at damage location and install P/N A01WW5343025-RE3, bushing assembly.

- A. Removal of damaged area and feed-through hole preparation (refer to Figure 1).
- (1) Remove electrical power from aircraft.
 - (2) Remove outer windshield panel to access damaged area per instructions in 56-10-01.
 - (3) Remove electrical terminal assembly from feed-through.
 - (4) Remove brass feed-through bushing.
 - (5) Outer surface of inner windshield may be crystallized adjacent to the brass bushing. This crystallization must be removed prior to enlarging the feed-through hole in preparation for installation of the -RE3 bushing assembly.

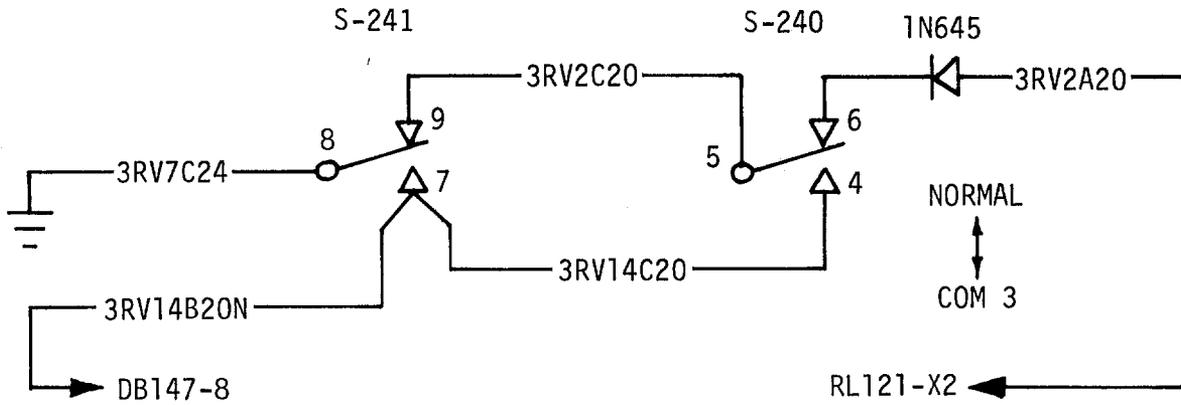
FIGURE 1B

COMM 3/NORMAL SWITCH CONFIGURATION AFTER MODIFICATION

- (1) Should S-56 contain a spare set of contacts (E.G. double pole, single throw switch), install a jumper wire from the extra normally open contact to existing wire 3RV116A20, which is an airframe ground.
 - (a) Should S-56 be a single pole switch, replace it with a DPDT type such as ALCO MST-205N, JBT type JMT-223, or equivalent.
- (2) Add new wire, marked 3RV14B20N from the extra switch common terminal to the PS-823() power supply connector DB-147 pin 8. Remove, cap, and store any existing wire in pin 8.
- (3) Check wiring, DB 147 pin 8 must be OPEN with COM 3 "OFF" and grounded with COM 3 "ON".

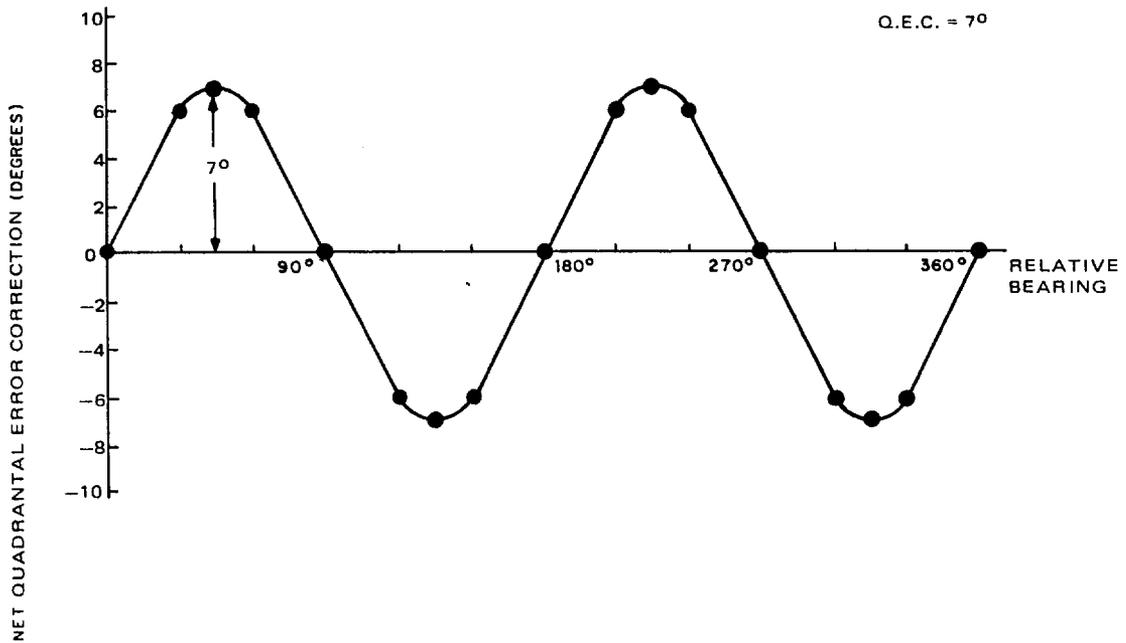
Sample Quadrantal Error Correction Curve
Figure 2-36

Referring to figure 2-36, the peak value of QEC is 7°. This is the required NET QEC of the ADF-60 system as installed in the aircraft.

For sample error correction curve, figure 2-36, an additional 7 degrees of QEC are required. For an initial strapping of 10 degrees, the total required QEC is 17 degrees. Jumper wire connecting 4-8, 12-20 would be removed and 4-16 should be strapped (from figure 2-38).

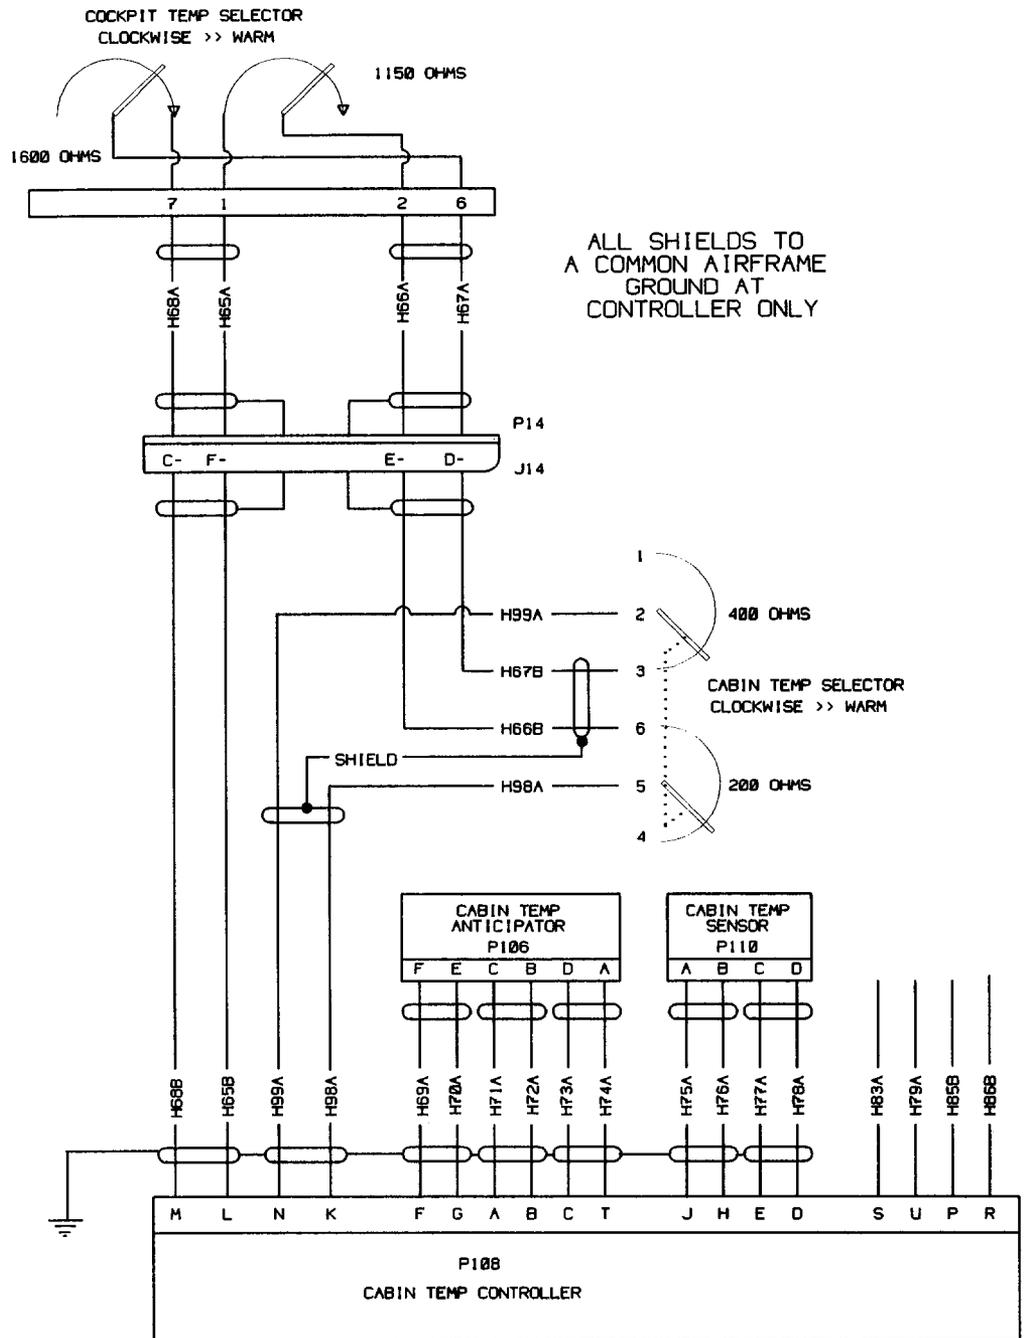
AC POWERED CABIN TEMPERATURE CONTROLLER
S/N's 152, 154, 174, 181, 185-237, 240-255, 257 & 258
FIGURE 1

PART A - Provides instructions to replace existing wiring from cabin temperature controller to the input sensors with shielded wire to improve noise immunity.

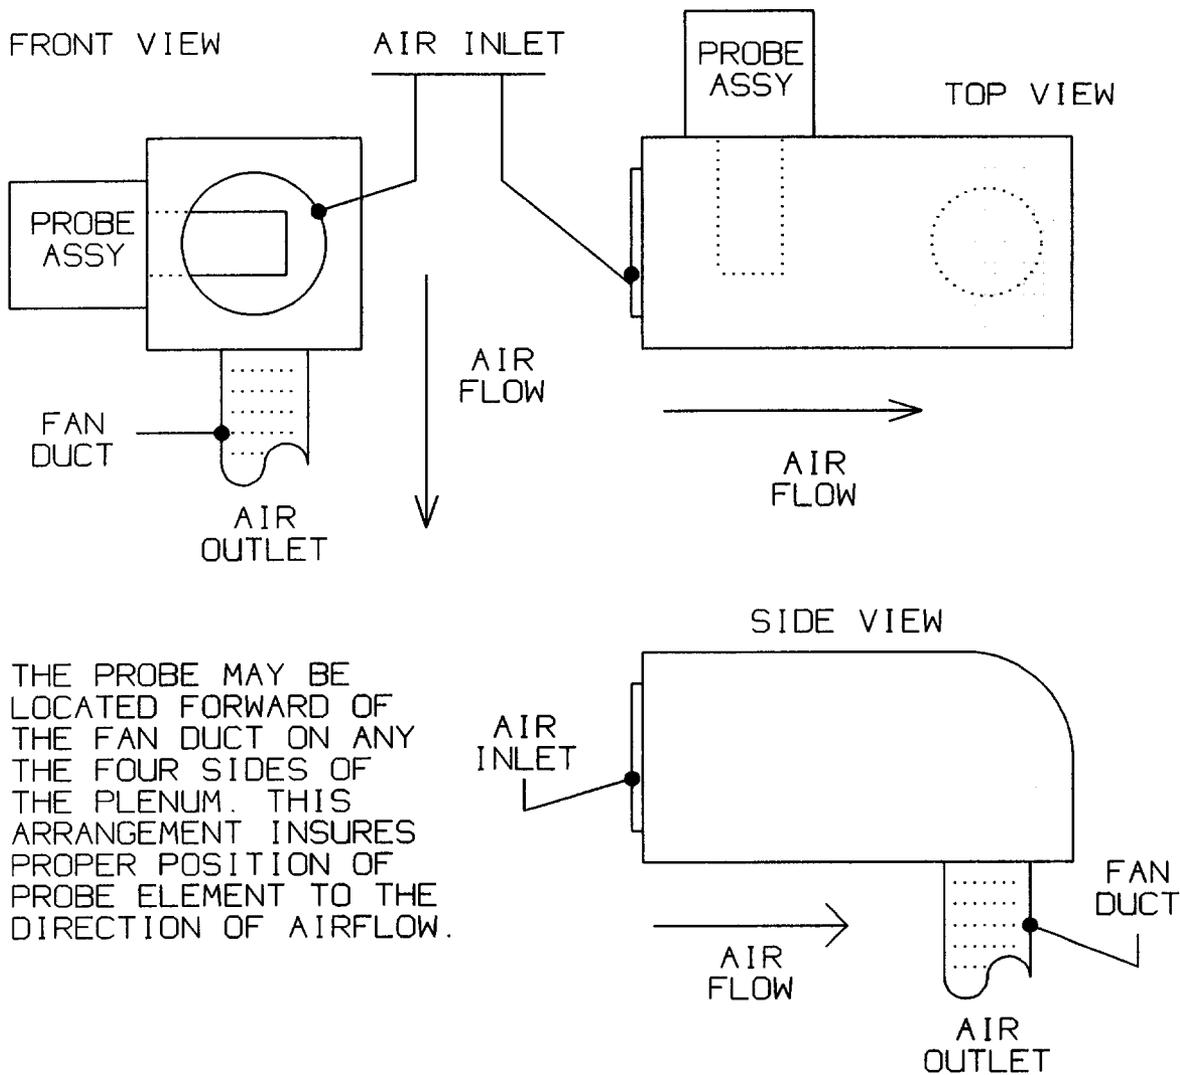
**SUGGESTED CABIN TEMPERATURE SENSOR,
PLENUM, & DUCT ARRANGEMENT
FIGURE 4**

- (b) Sensor mount area should be such that passenger's coats, briefcases and other personal items will not block cabin air inlet to sensor.
- (c) Avoid mounting sensor in an area where damage may occur to sensor, wiring, or fan duct.
- (d) Avoid mounting sensor too close to either cabin floor or ceiling.
- (e) Sensor must be mounted so that probe is at right angles to airflow. Refer to Figure 4.
- (f) The preferred location for the fan assembly is under the floor, left or right of center as desired, and aft of aft cabin bulkhead. This allows access to mount fan assembly through available access panels under lavatory or avionics equipment mounted on left side of aircraft. Where possible use fan mounts from original location. Plan for unrestricted routing of duct to sensor.

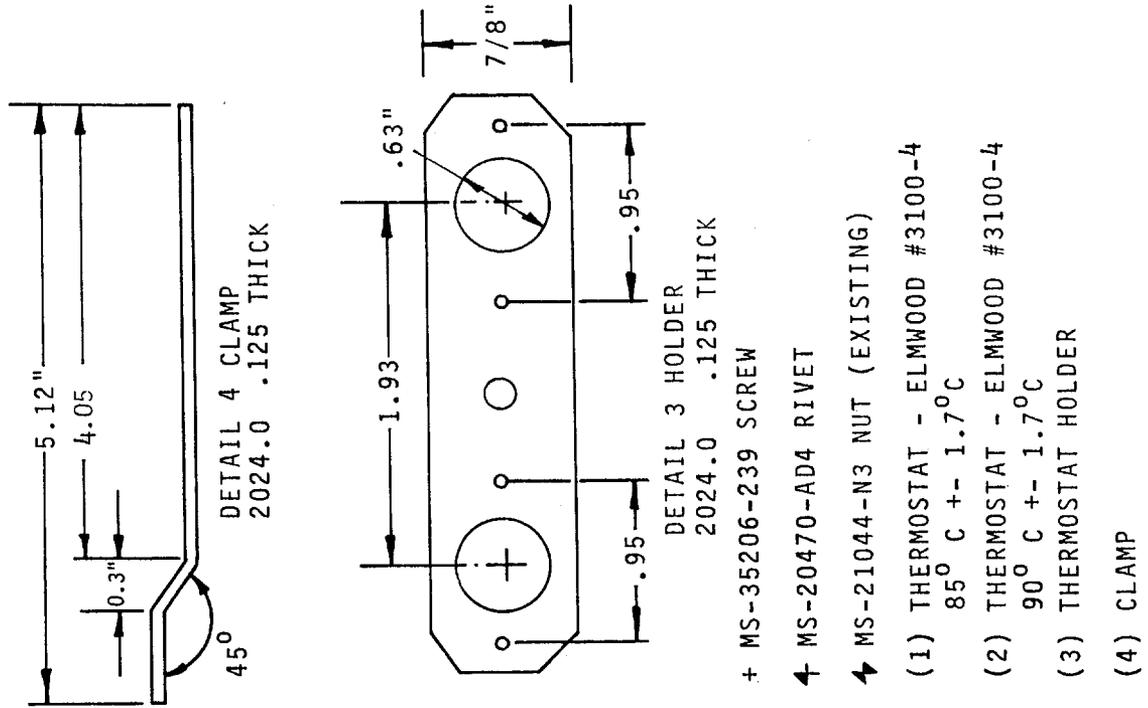
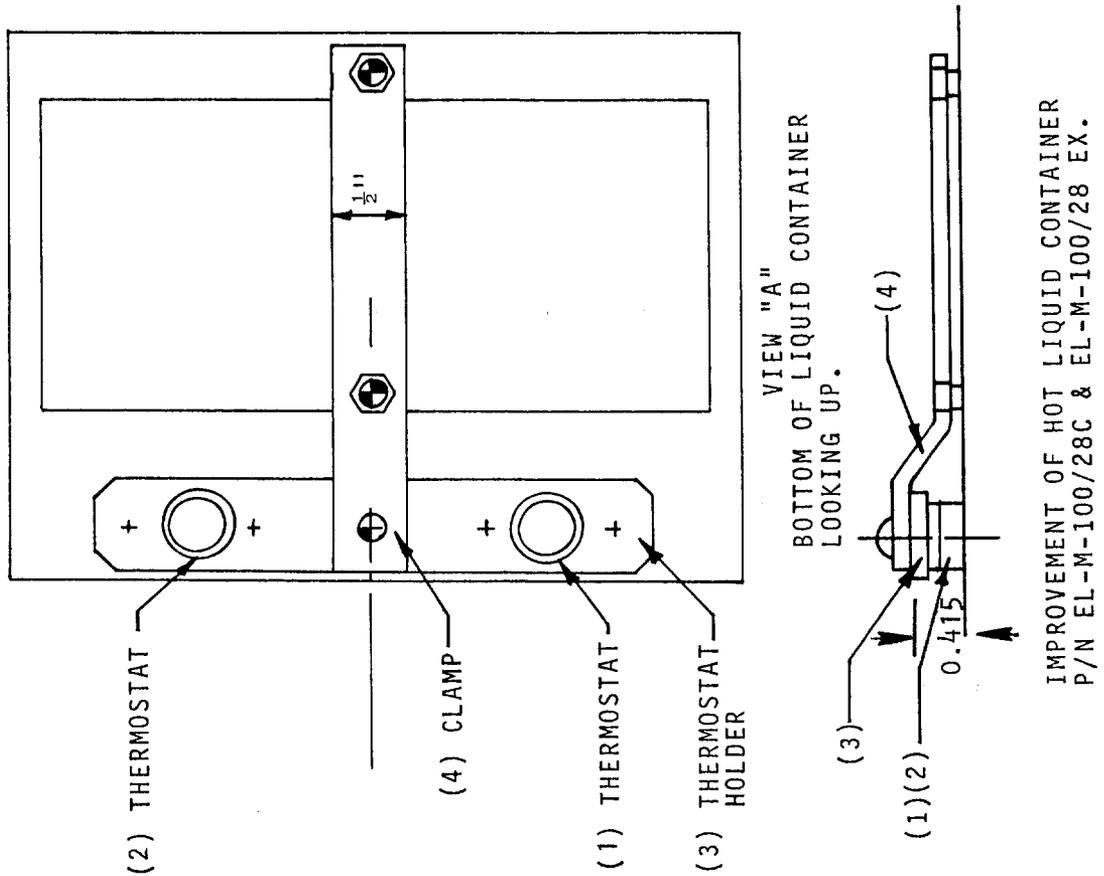
Figure 1

To provide repair/modification instructions for operators that utilize hot liquid containers.

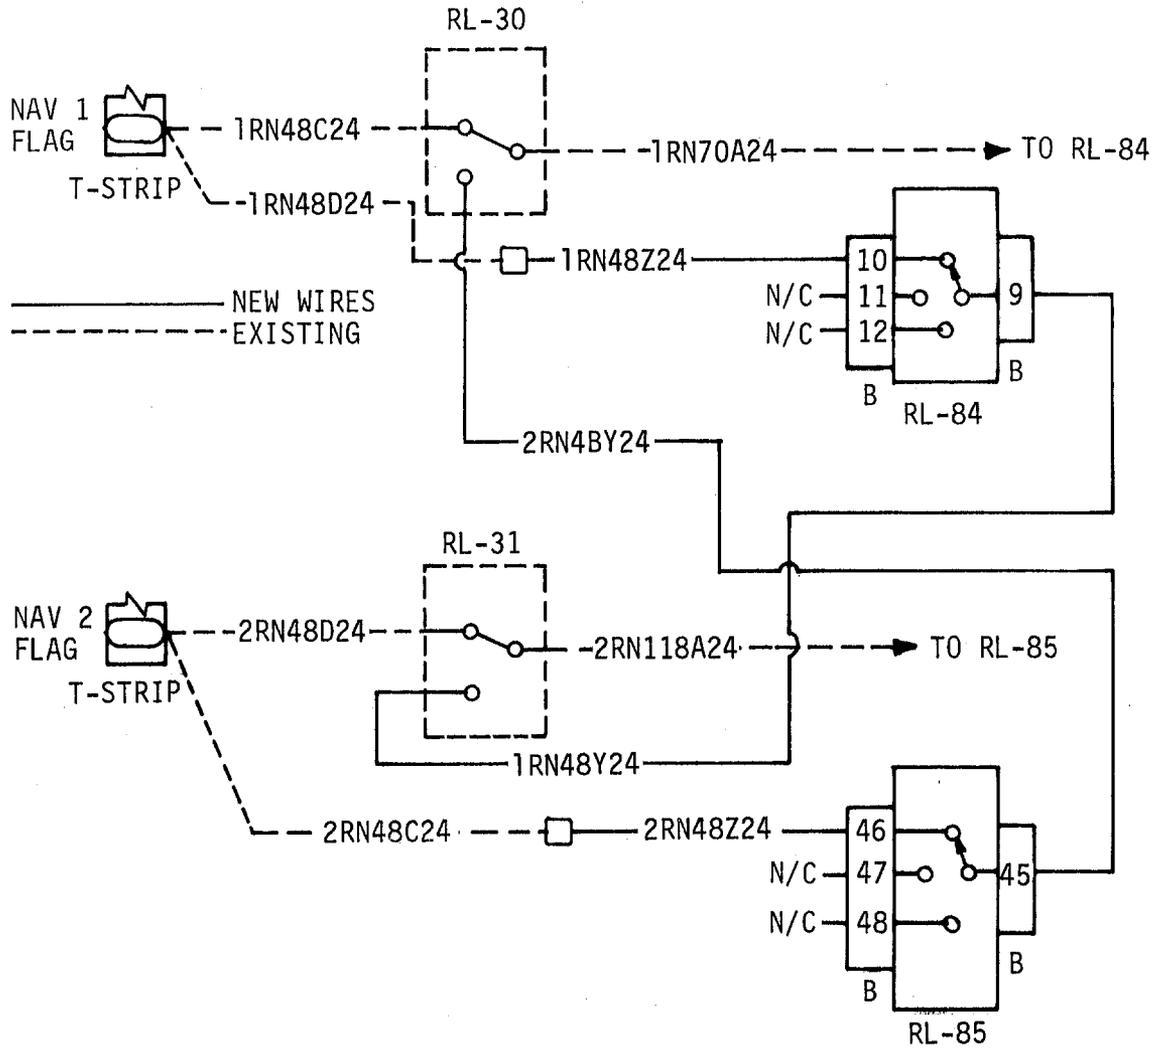
FIGURE 1

NAV FLAG SWITCHING

- C. Remove wire 1RN80A22 from RL84B-9 and the jumper wires from RL84B-10 and/or RL84B-11. Splice these wires together.
- (1) This will result in a pilot "RPT NAV 2" annunciation whenever "RPT NAV 2" is depressed, regardless of information displayed on the Pilot HSI. This prevents switching the HSI into a possible invalid operating condition.

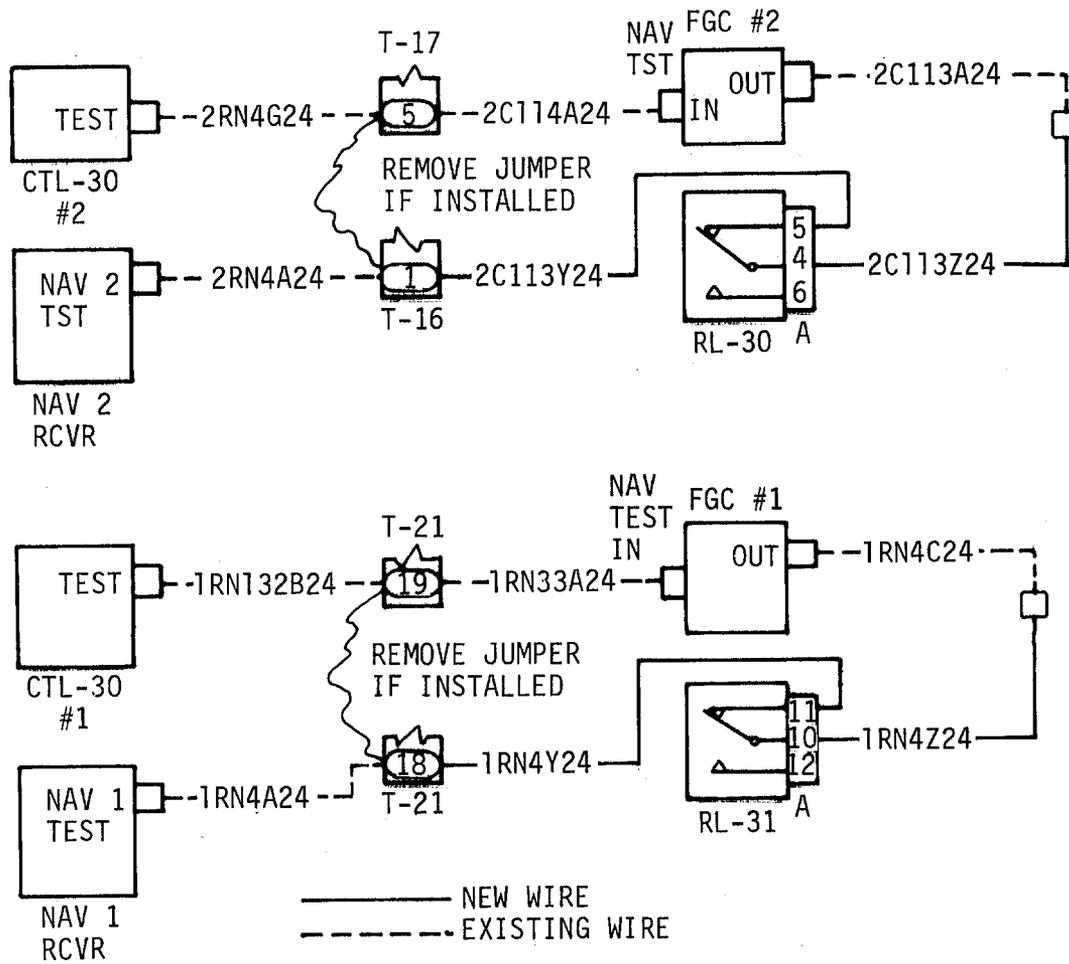
FIGURE 2

NAV TEST LOCK-OUT

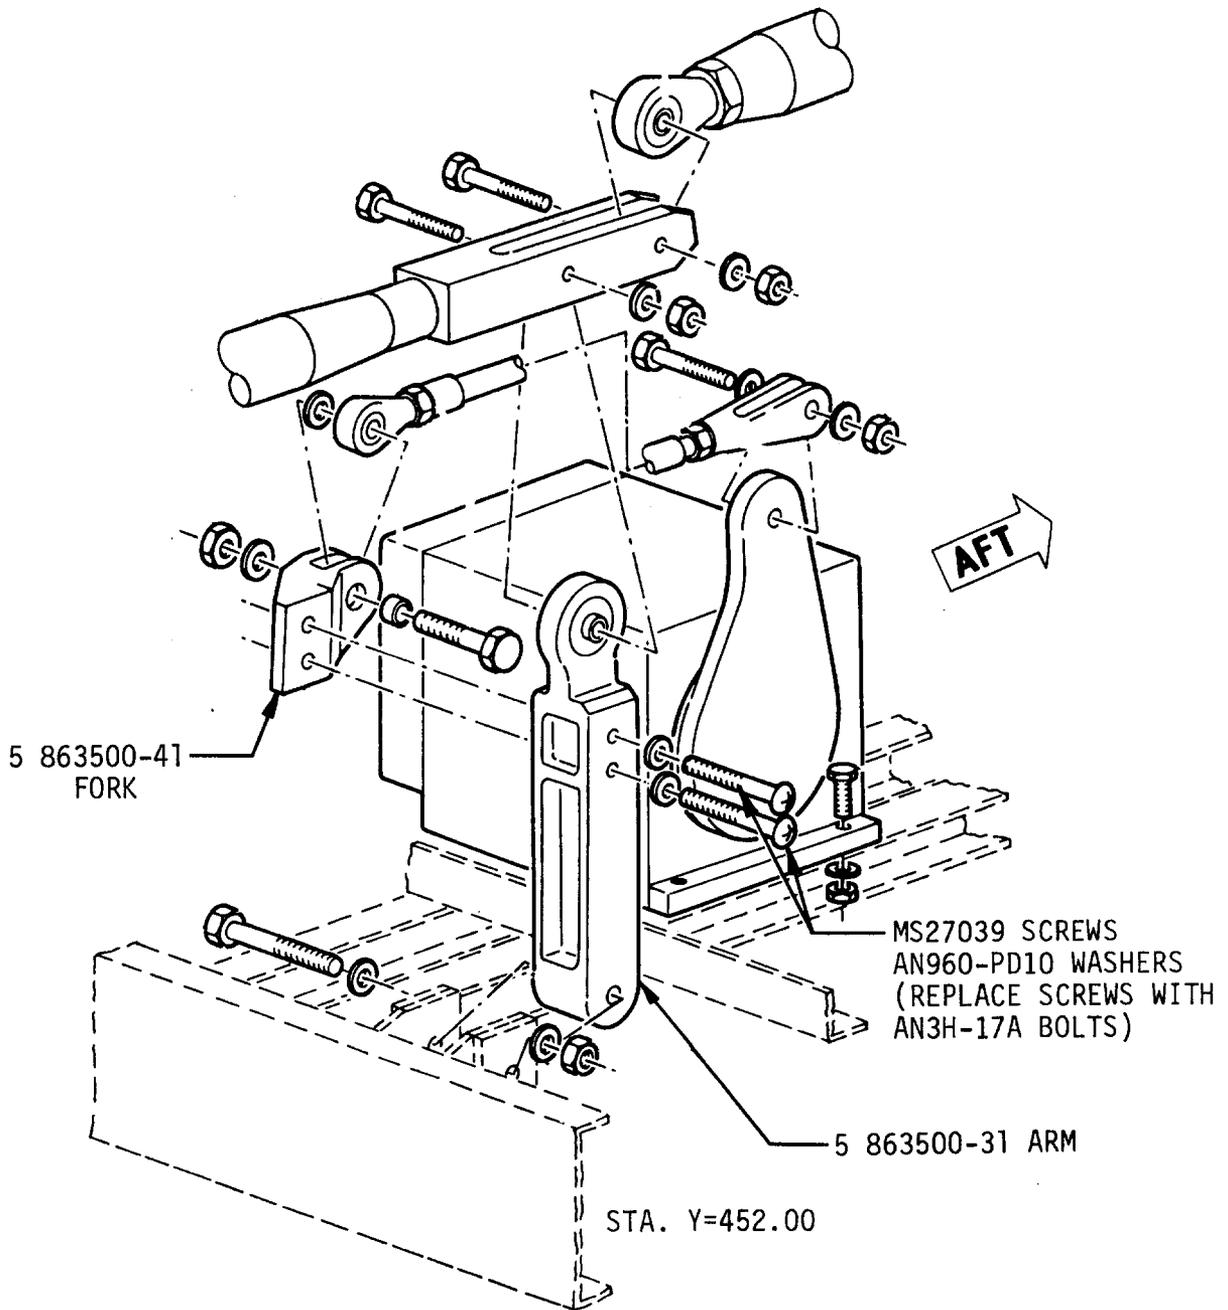
FIGURE 1

Replacement of existing select hardware to minimize the possibility of elevator and/or rudder control interference.
