1124 AND 1124A WESTWIND SERVICE BULLETIN INDEX

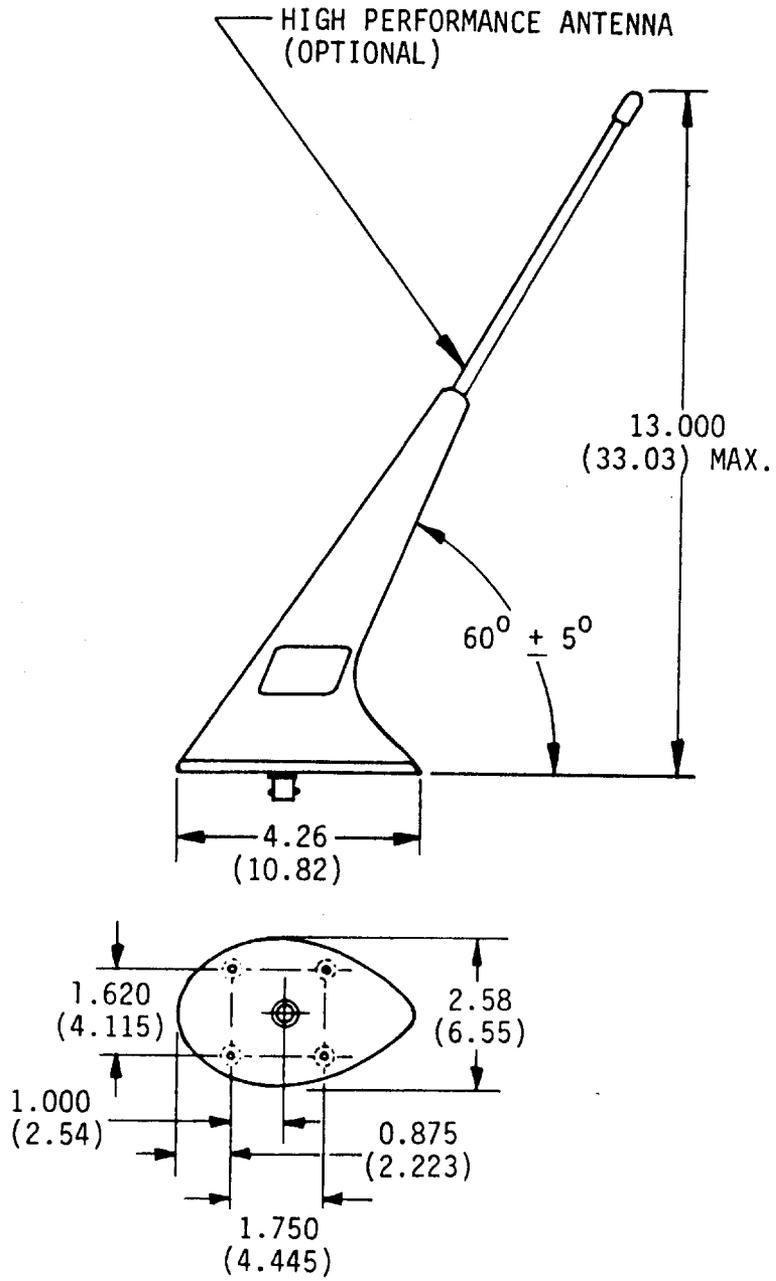
FIGURE 1

To correct aural hum caused by antenna whip action.

This service bulletin details replacements of DMQ-18-1A antenna with a DMQ-18-3 ELT antenna.

- H. Drill antenna mounting holes (4) and the antenna coax connector hole (1) to size per antenna mounting instructions. Prepare and finish all metal surfaces to receive new antenna.
- I. Install new antenna in position and secure all fasteners.
- J. Connect ELT coax connector to antenna.
- K. Clean, paint and pressure seal as required and replace interior after test of antenna.

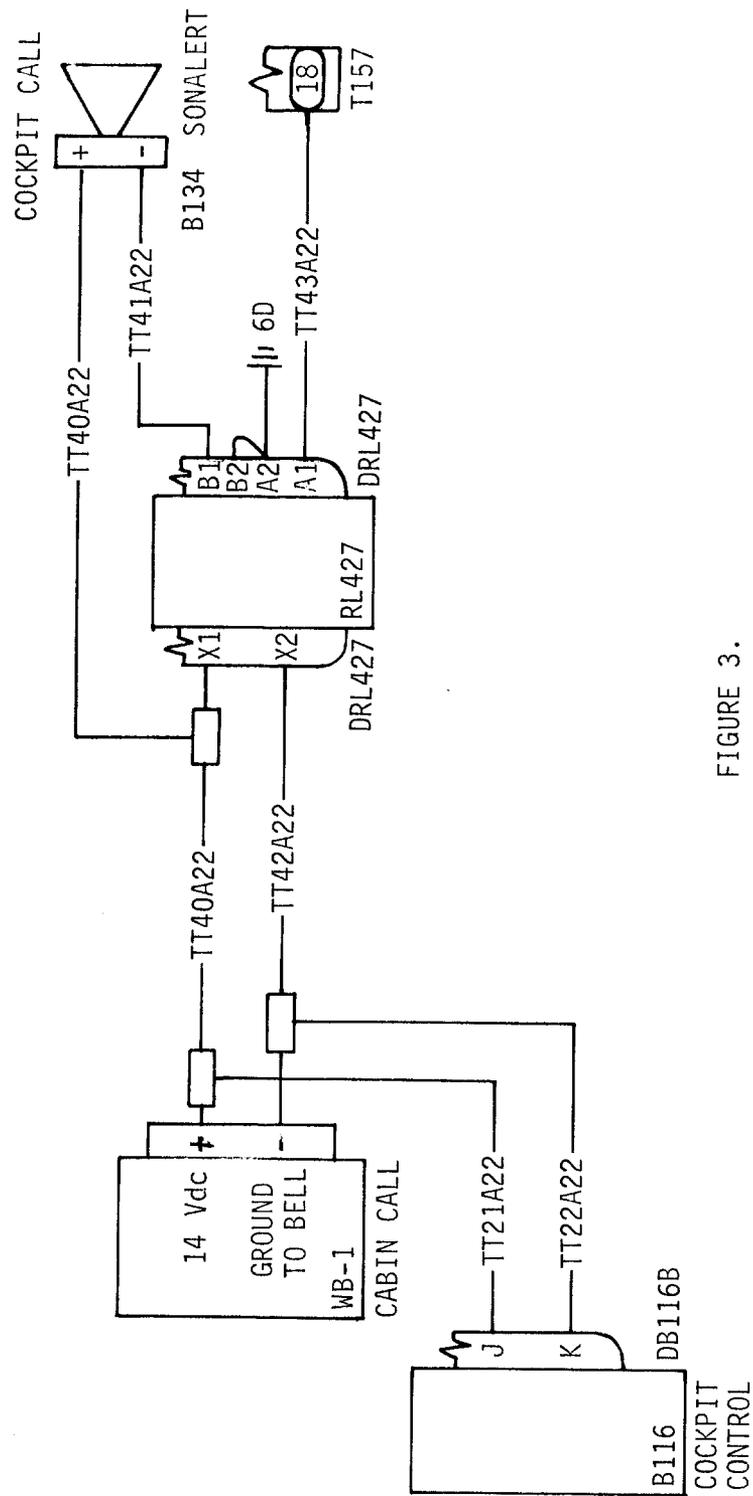
FIGURE 3.

PART D: To permit proper operation of intercom system by preventing ICS logic lockup through cockpit and cabin call annunciators and to replace the existing cabin call gong with a more reliable aural alert.

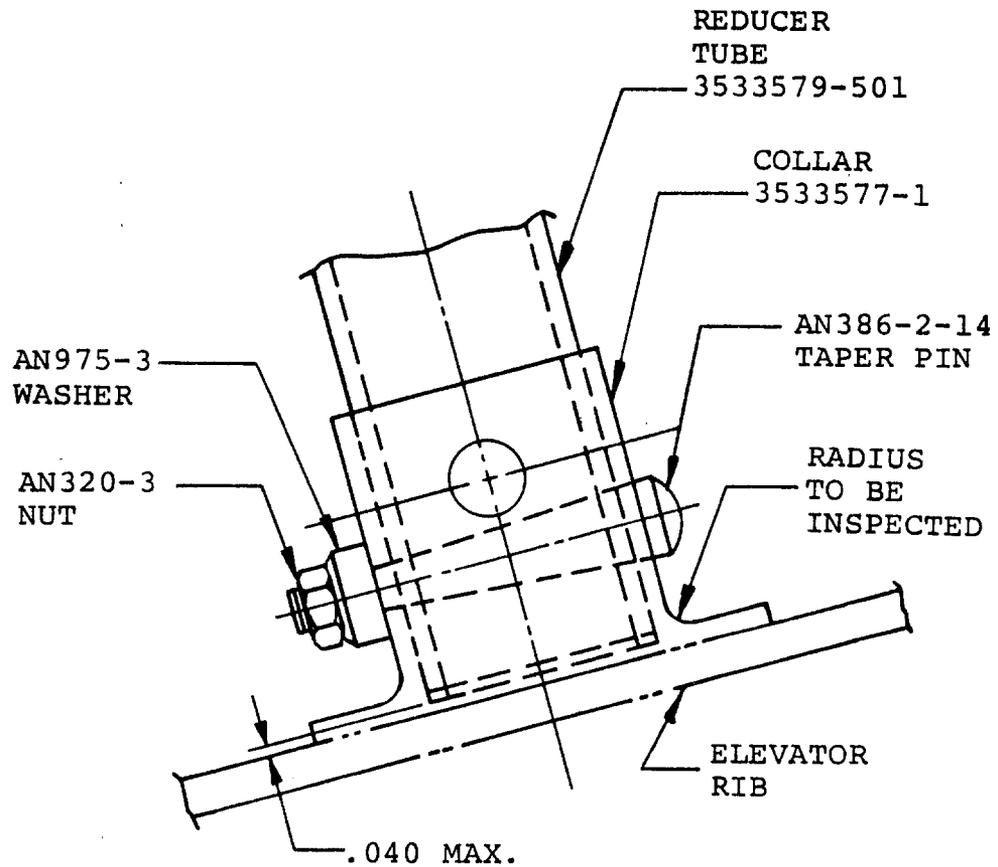
FIGURE 1

Misalignment of the collar flange attachments to the elevators, if not corrected, could induce cracks in the collars, leading to structural failure of the torque tube-elevator interface.

ELEVATOR TORQUE TUBE COLLAR

- C. Perform dye-penetrant inspection in radius of both collars (reference Figure 1).
- D. If no defects, proceed to step E. Defective collars must be replaced with a new reducer tube P/N 3533579-501 and collar P/N 3533577-1 as follows:

- I. Check the reducer tube in relation to collar flange. If the reducer tube is recessed in the collar by more than .040" (reference Figure 1), the collar and reducer tube must be replaced as per Part I, para. 2.D.

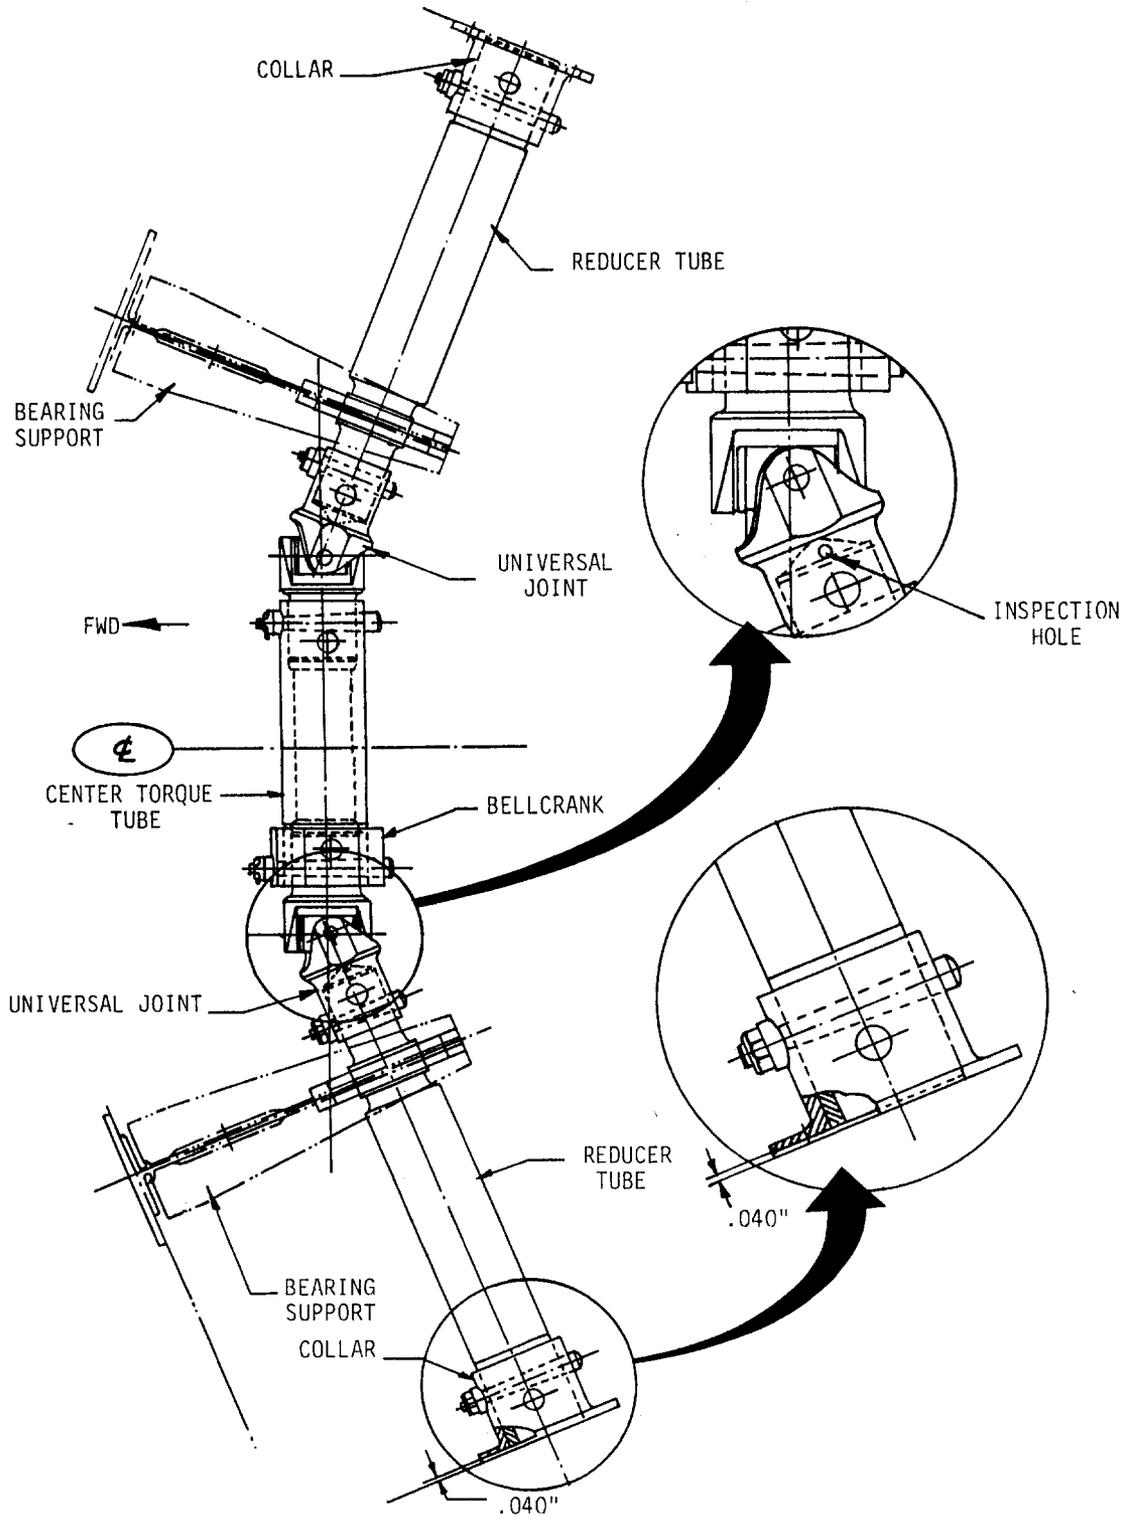
FIGURE 2

ELEVATOR TORQUE TUBE ASSEMBLY

NOTE: DURING INSTALLATION OF TAPER PINS, NARROW END SHALL NOT PROTRUDE BEYOND THE COLLAR BY MORE THAN .060"

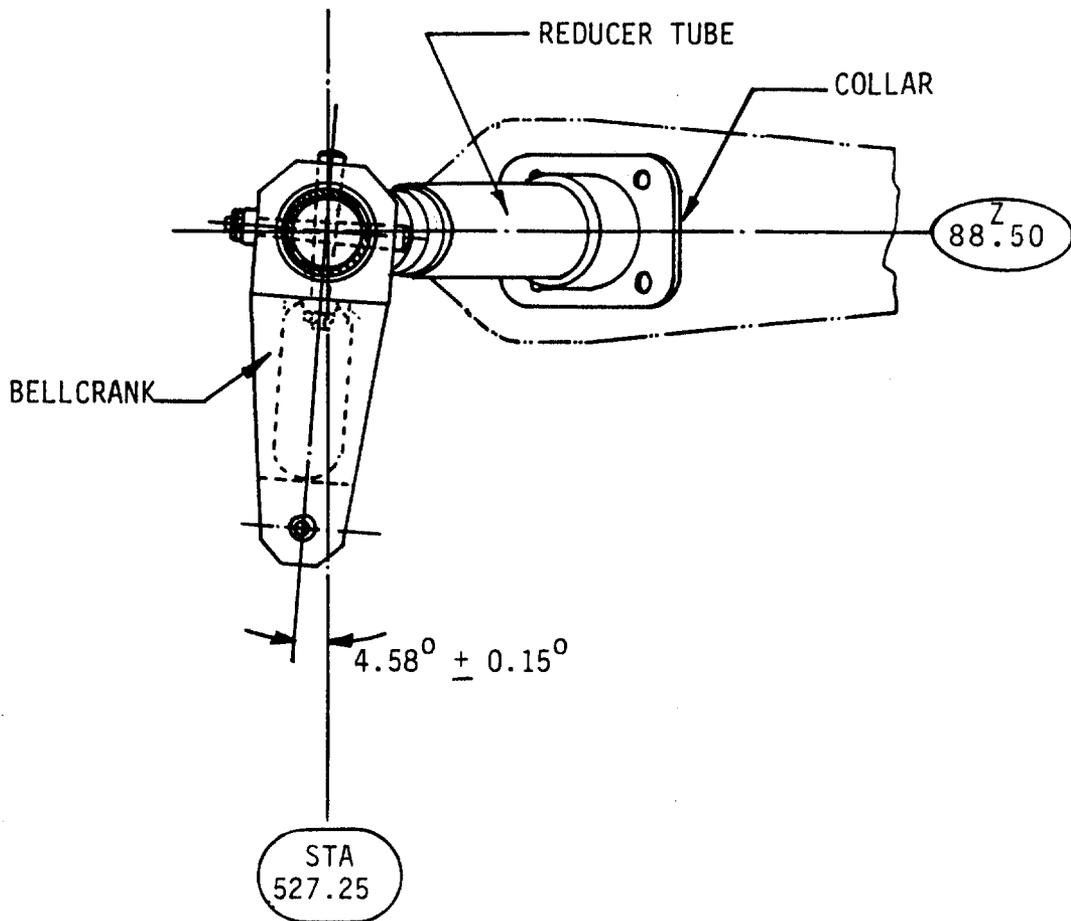
FIGURE 3

ALIGNMENT OF CENTER TORQUE TUBE BELLCRANK
TO ELEVATOR TORQUE TUBE COLLAR

CAUTION: VERIFY ELEVATOR CONTROL SYSTEM RIGGING IS CORRECT BEFORE DRILLING AND REAMING NEW PARTS.

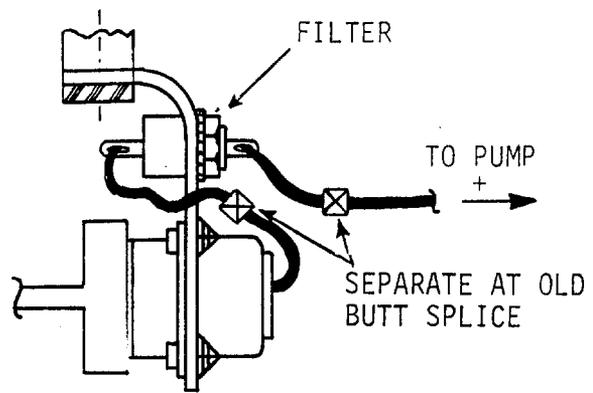
FIGURE 5

To eliminate possibility of EMI filter dormant failure that might lead boost pump to become inoperative.

FUEL BOOST PUMP EMI FILTER/BRACKET INSTALLATION

RECONNECT WIRES WITH
NEW BUTT SPLICE AND
DISCARD FILTER

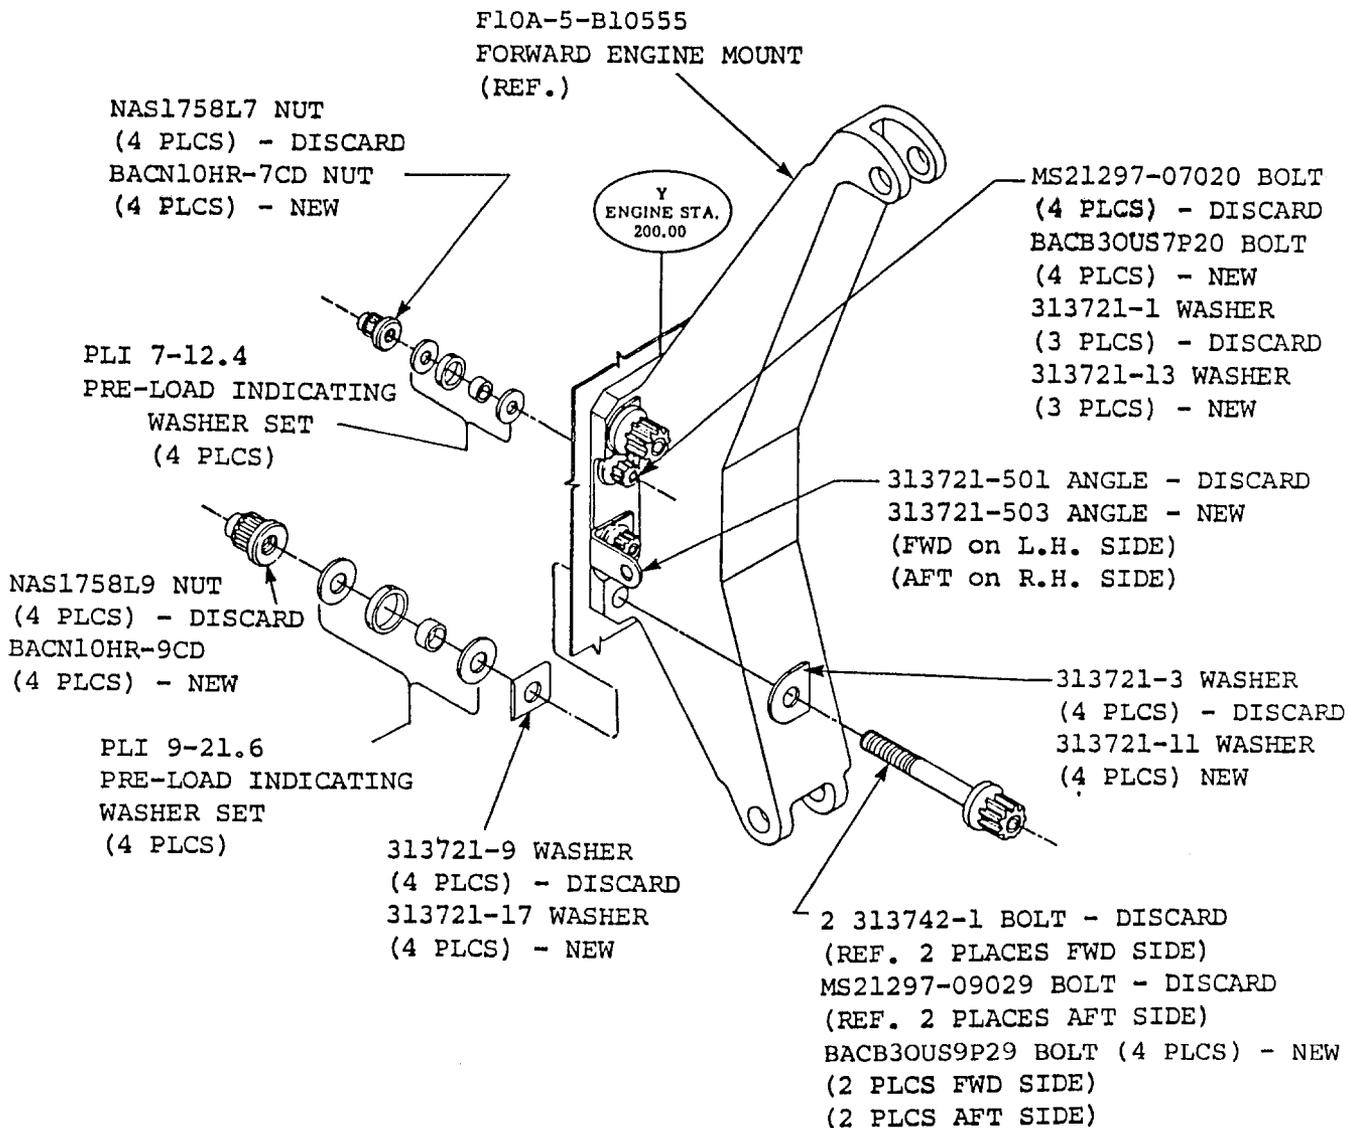
FIGURE 1

To prevent potential stress corrosion failure of the forward
engine mount mounting bolts and nuts made from H-11 steel.

INSTALLATION OF FORWARD ENGINE MOUNT
ATTACHMENT FASTENERS

PART II of this service bulletin provides instructions to
replace the engine mount attach fasteners.

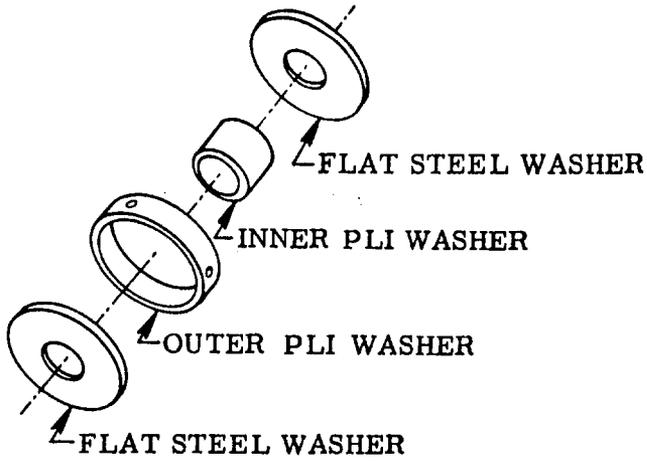
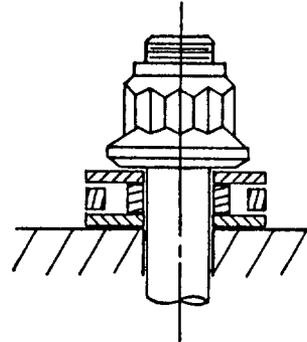
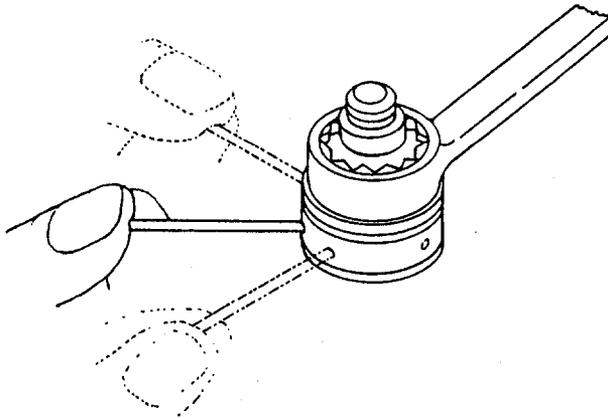
A. TYPICAL PLI WASHER ASSEMBLY

B. INITIAL POSITION OF PLI WASHERS

D. TESTING OUTER WASHER FOR MOVEMENT

Do not overtighten. If nut is tightened more than 1/8 turn beyond point where outer PLI washer becomes immovable, the entire bolt, nut and washer assembly must be replaced.

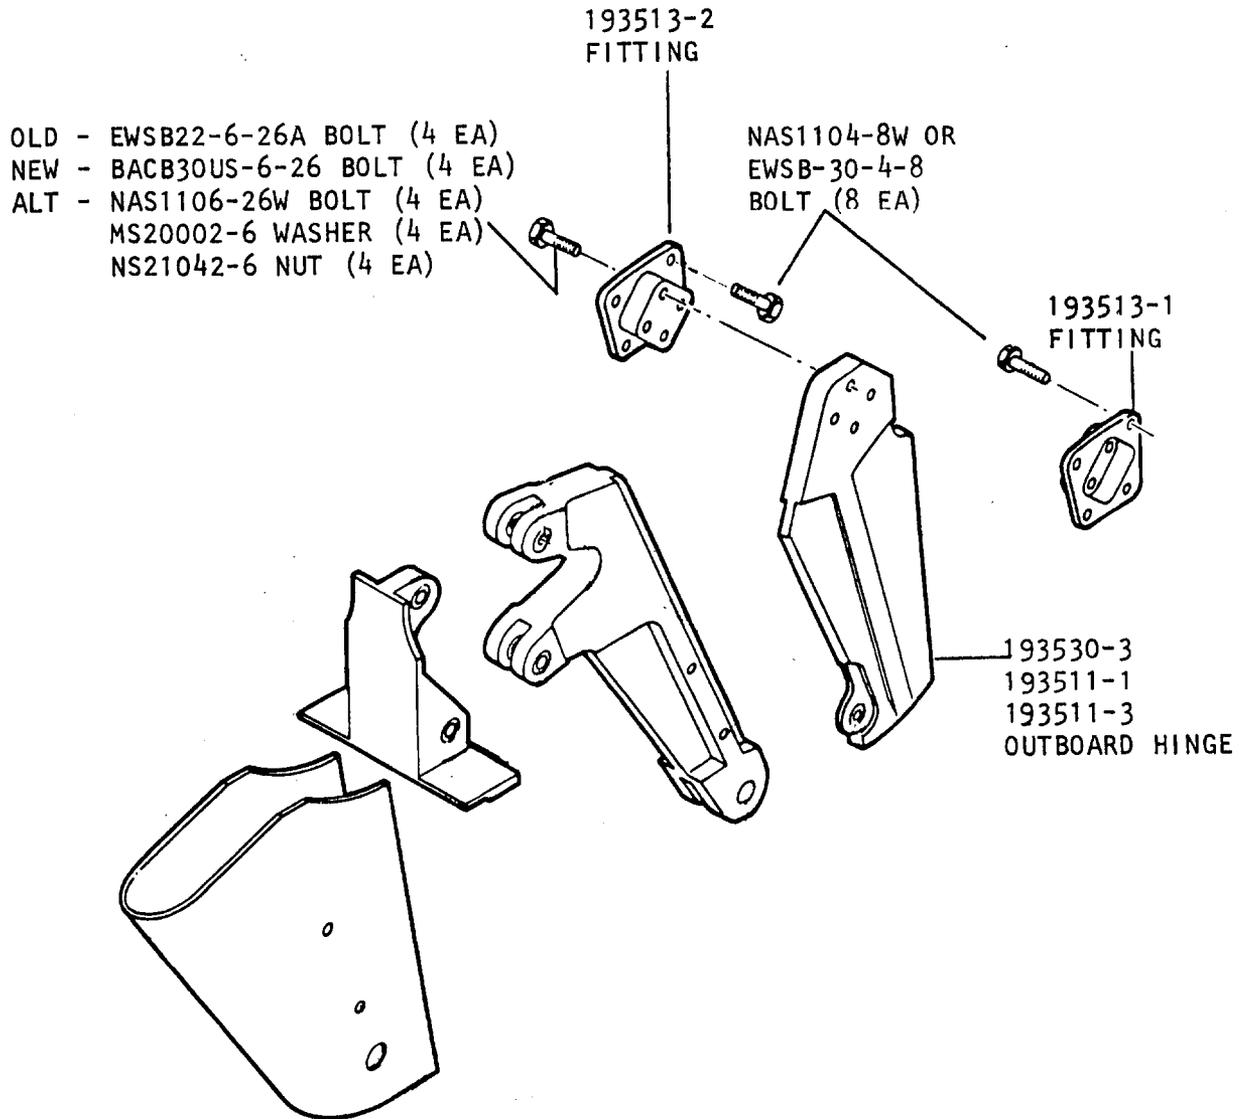
FIGURE 1

To prevent potential stress corrosion failure of the flap hinge to flap fasteners made from H-11 steel.

This service bulletin requires an inspection of the outboard wing flap hinge to wing flap attach bolts to determine if H-11 alloy steel bolts have been installed and provides instructions to replace these bolts, if necessary.

WING-TO-FLAP ATTACH FITTING

- I. Inspect markings on bolt heads of fasteners which assemble fittings P/N 193513-1 and -2 to flap hinge.
- J. If bolts are identified as NAS1106 type bolts, proceed to Step L.
- K. If bolts are identified as EWSB22 type bolts, replace bolts, one at a time, with new replacement bolts P/N BACB30US-6-26 or NAS1106-26W. Torque bolts to 120-150 in-lbs.
- L. Reinstall hinge assembly, with shims (if removed), torque 8 each EWSB-30-4-8 or NAS1104-8W bolts to 50-60 in-lbs.
- M. Reinstall leading edge support brackets using NAS1671-08L-6 or P164A-6 fasteners.
- N. Reinstall hinge covers and wheel well fairings.
- O. Install flaps on aircraft.

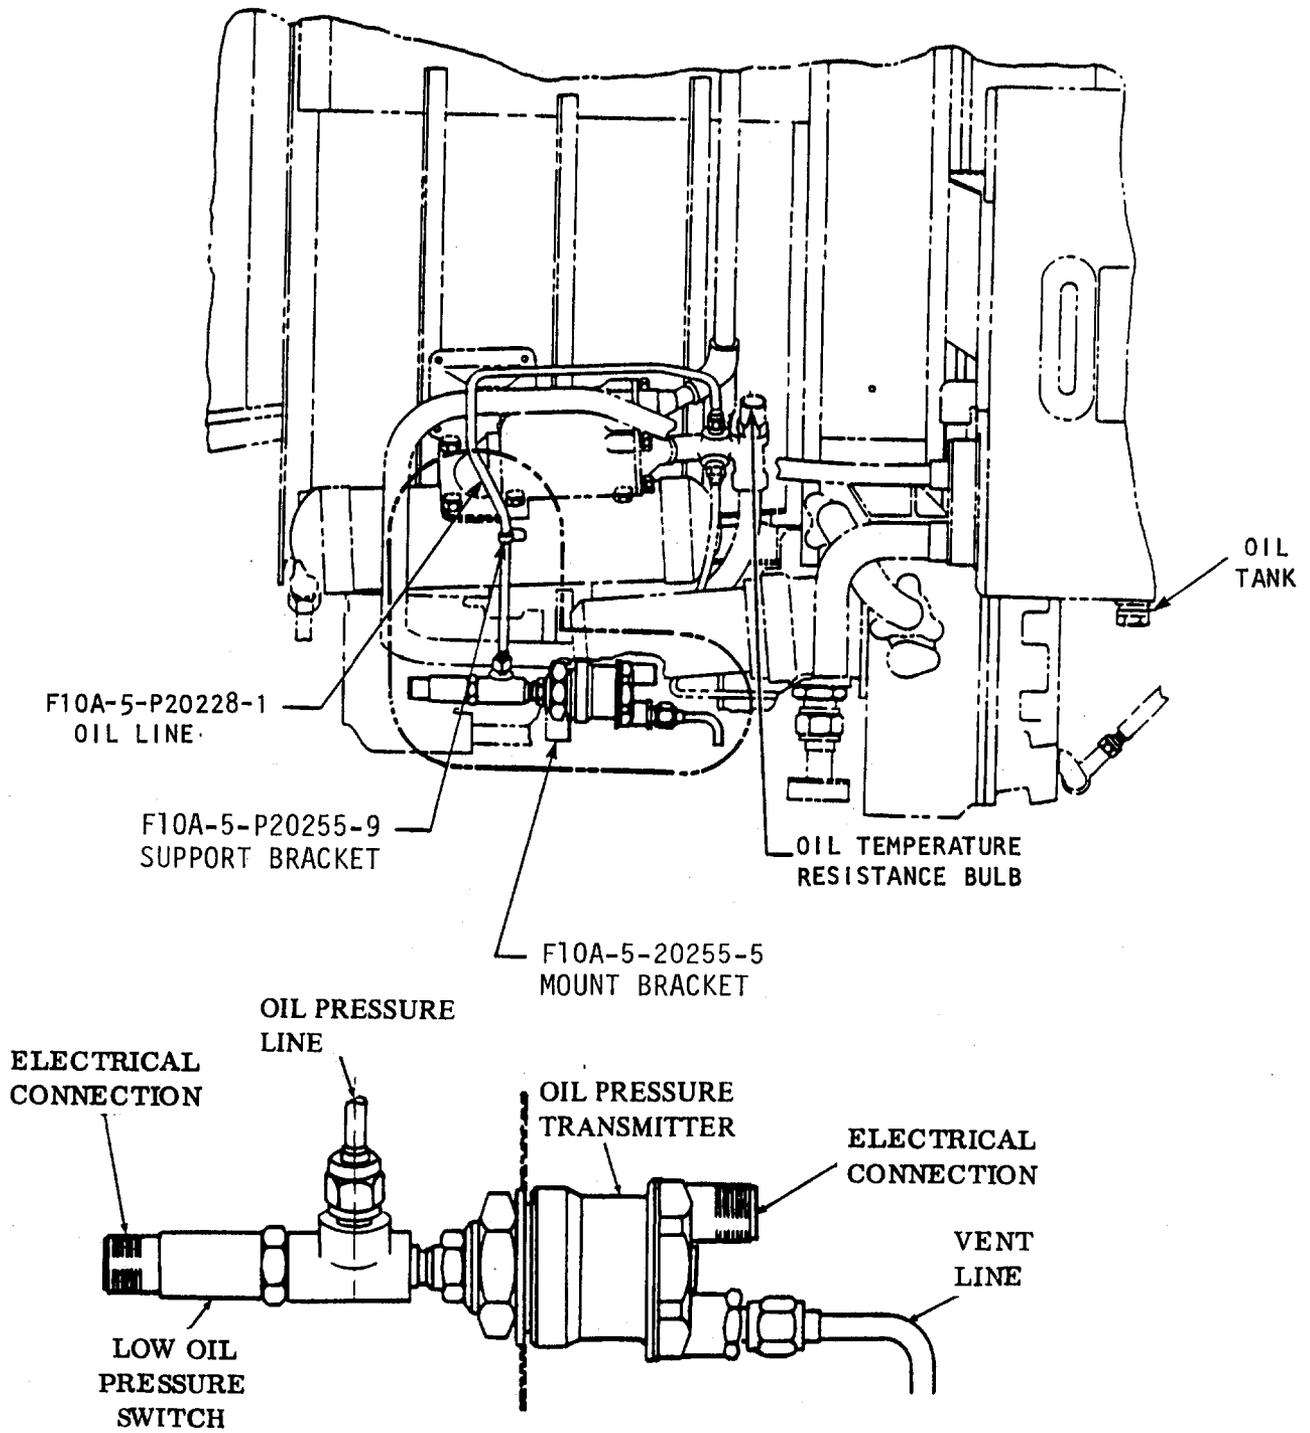
FIGURE 1

To check for defects (chafing, leakage) in engine oil pressure line, P/N F10A-5-P20228-1, install improved and additional engine oil pressure component brackets and support clamping.

- (1) Gain access to engine oil pressure indication system components at lower right side of left and right engines.
- (2) Inspect oil pressure line, P/N F10A-5-P20228-1, for leakage, condition, security, and clearance. Refer to Figure 1.

EXISTING ENGINE OIL PRESSURE SYSTEM INSTALLATION

- (3) Replace leaking, chafed or damaged lines with new unit.
 - (a) Perform leak check as required when oil line is disturbed.
- (4) Reinspect each 50 hours until Part B is accomplished.

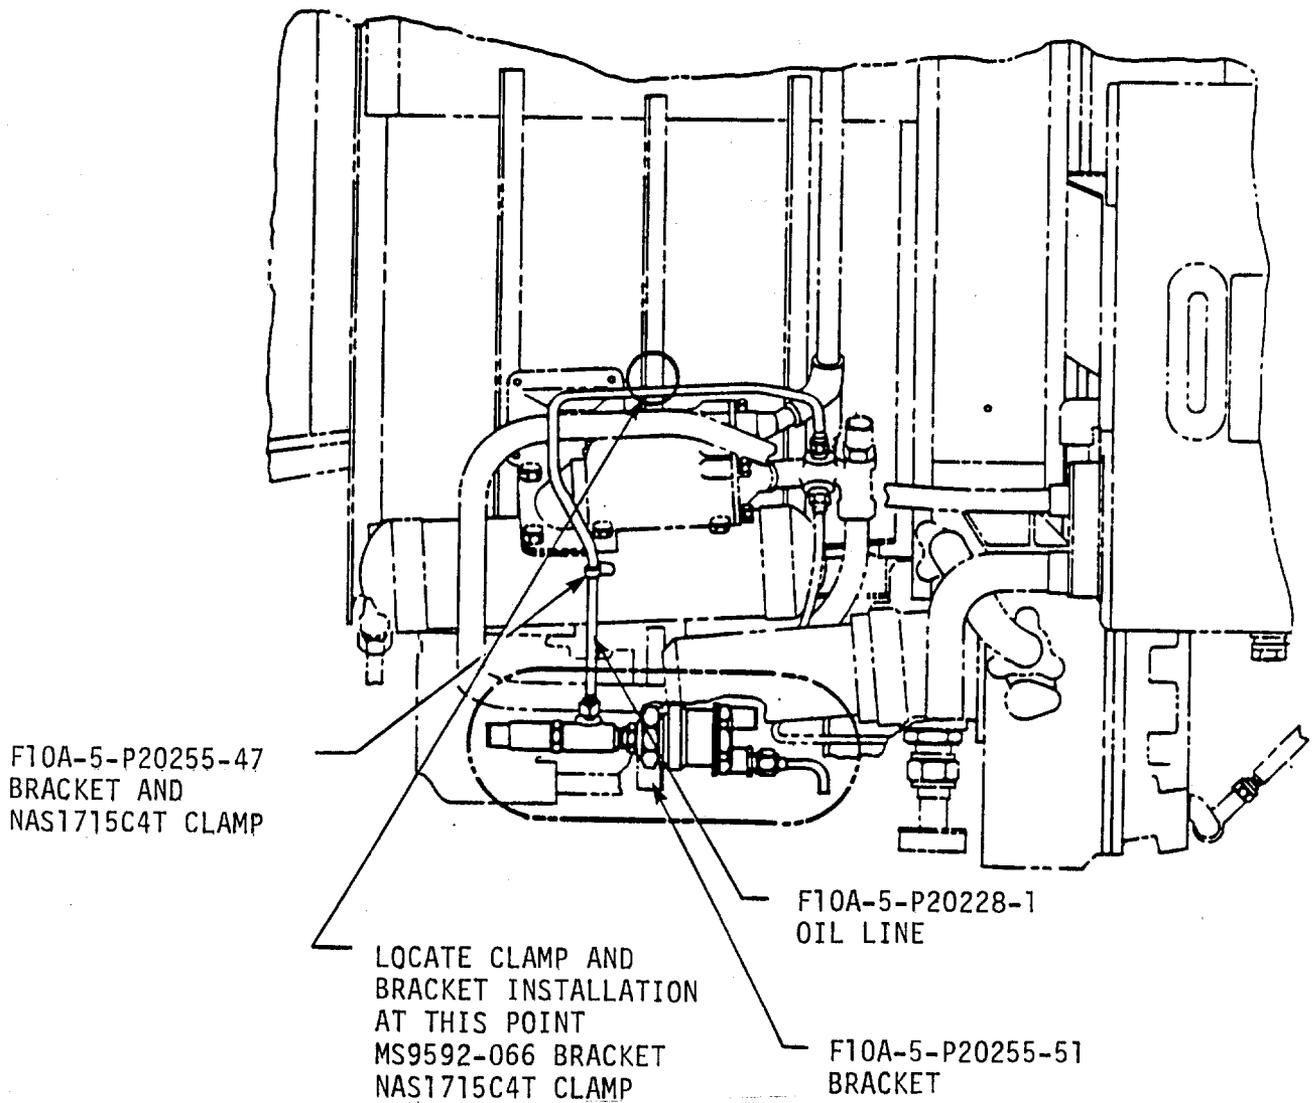
FIGURE 2

NEW ENGINE OIL LINE INSTALLATION

- (10) Recheck oil pressure line "B" nuts for proper torque (135-150 inch-pounds).
- (11) Perform leak check during ground engine run-up of oil pressure line installation.
- (12) Service engine oil.
- (13) Return aircraft to service.

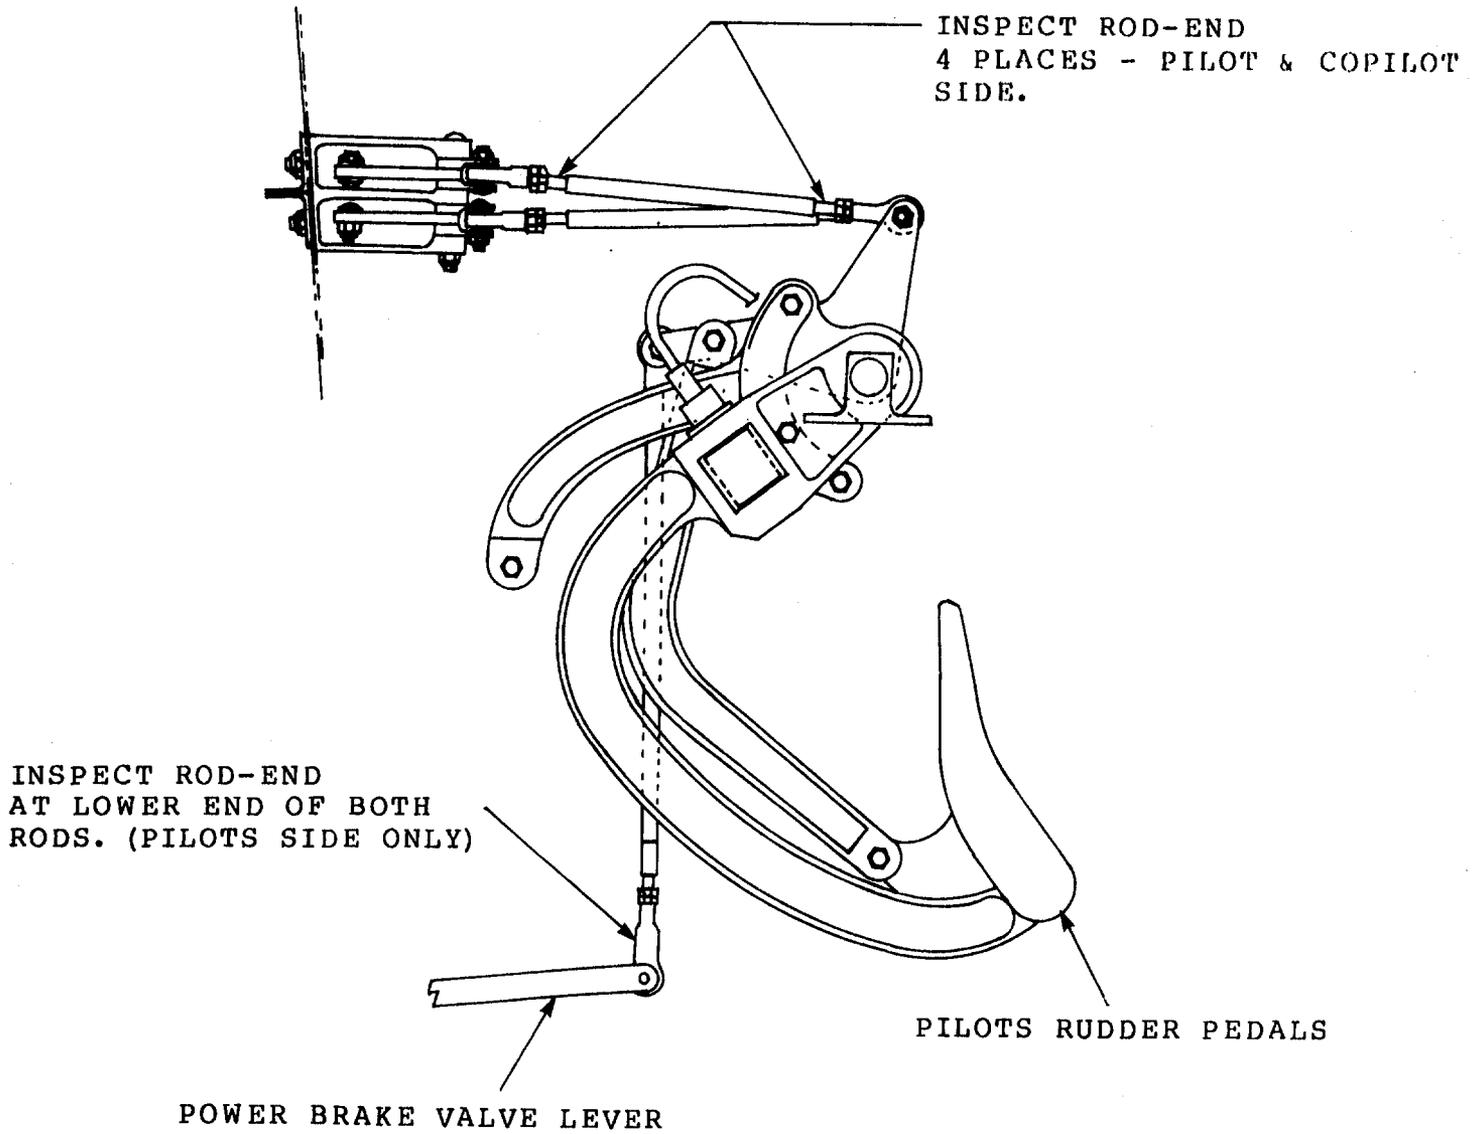
FIGURE 1

PILOTS RUDDER PEDAL INSTALLATION

- A. Gain access to rod-ends installed in the rudder pedal installation (see Figure 1) and right aileron servo tab installation (see Figure 2).
- B. Inspect rod-ends to determine if witness holes are present.
- C. If rod-ends have witness holes, no further action is required.
- D. If rod-ends do not have witness holes, remove and replace with P/N F44-14MT in accordance with 1124/1124A Maintenance Manual chapters 27-10-00 for aileron servo tab, and 27-20-00 for rudder pedals maintenance practices.

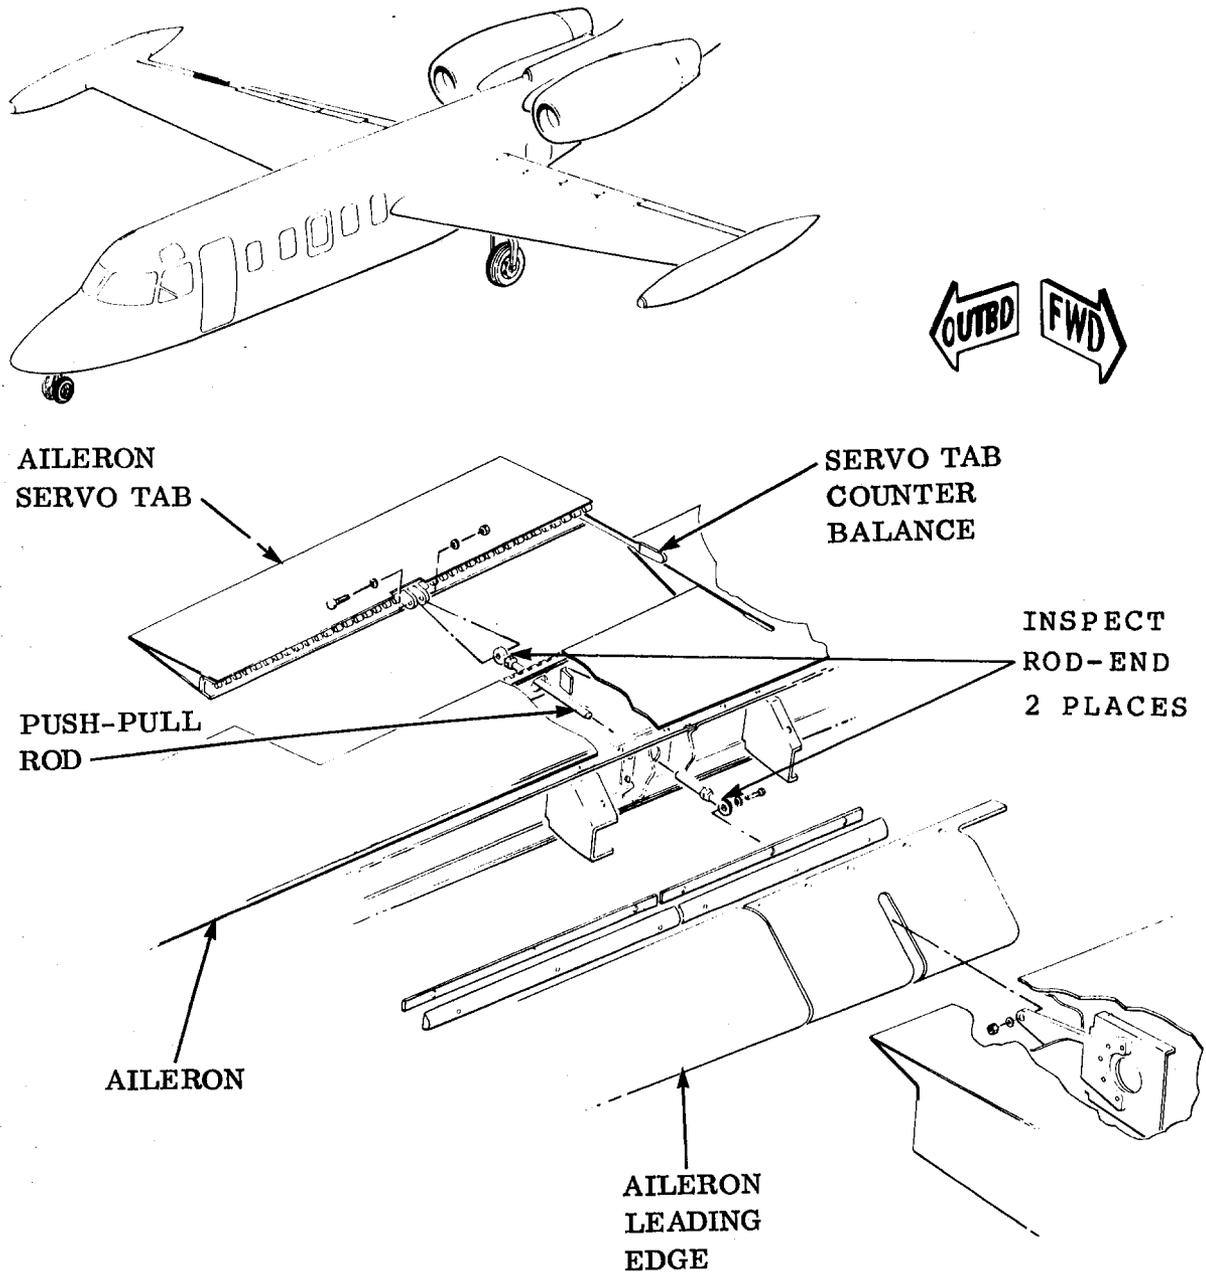
FIGURE 2

AILERON SERVO TAB

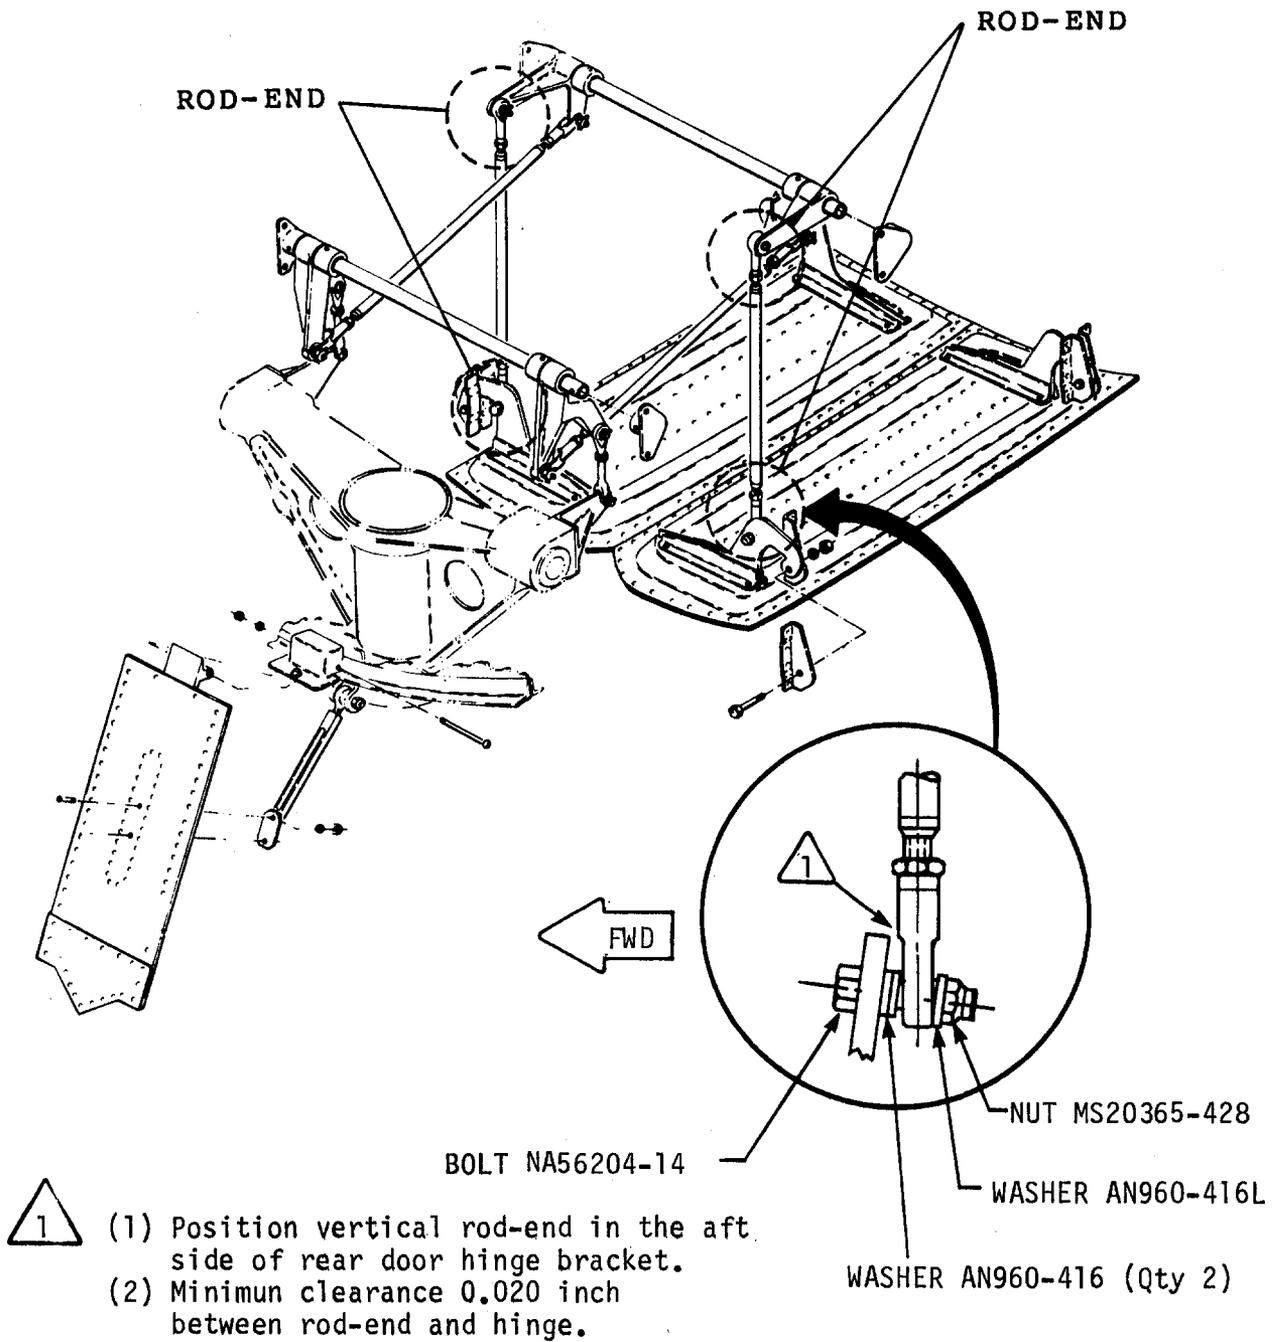
FIGURE 1

NOSE GEAR DOORS

- A. Gain access to rod-ends installed in NLG door system (see Figure 1).
- B. Inspect rod-ends to determine if witness holes are present.
- C. If rod-ends have witness holes, no further action is required.
- D. If rod-ends do not have witness holes, remove and replace with rod-ends P/N F44-14MT in accordance with 1124/1124A Maintenance Manual chapter 32-20-00 maintenance practices.

Ensure that rigging of NLG doors are not altered during replacement (see Figure 1).

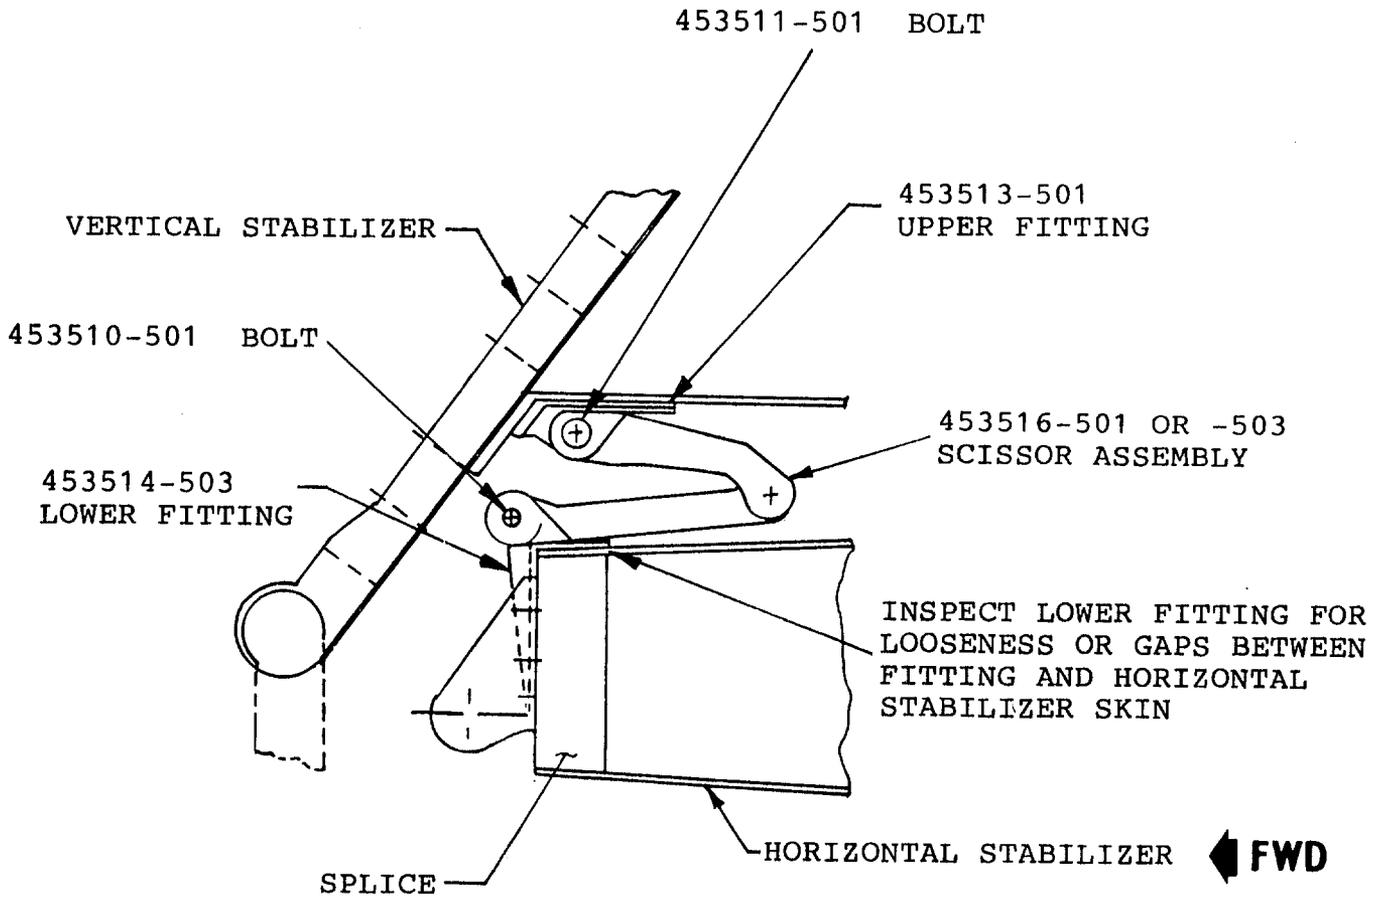
Several cracked and/or loosened lower fittings of scissors assembly have been detected in service.

SCISSORS ASSEMBLY INSTALLATION
FIGURE 5

- D. Inspect lower fitting (P/N 453514-503) for loose rivets or gaps between fitting and horizontal stabilizer skin (see Figure 5).
- E. If looseness and/or gaps between lower fitting and stabilizer skin are found, remove the scissors arms by removing the 2 bolts (P/N 453511-501) and bolt (P/N 453510-501).

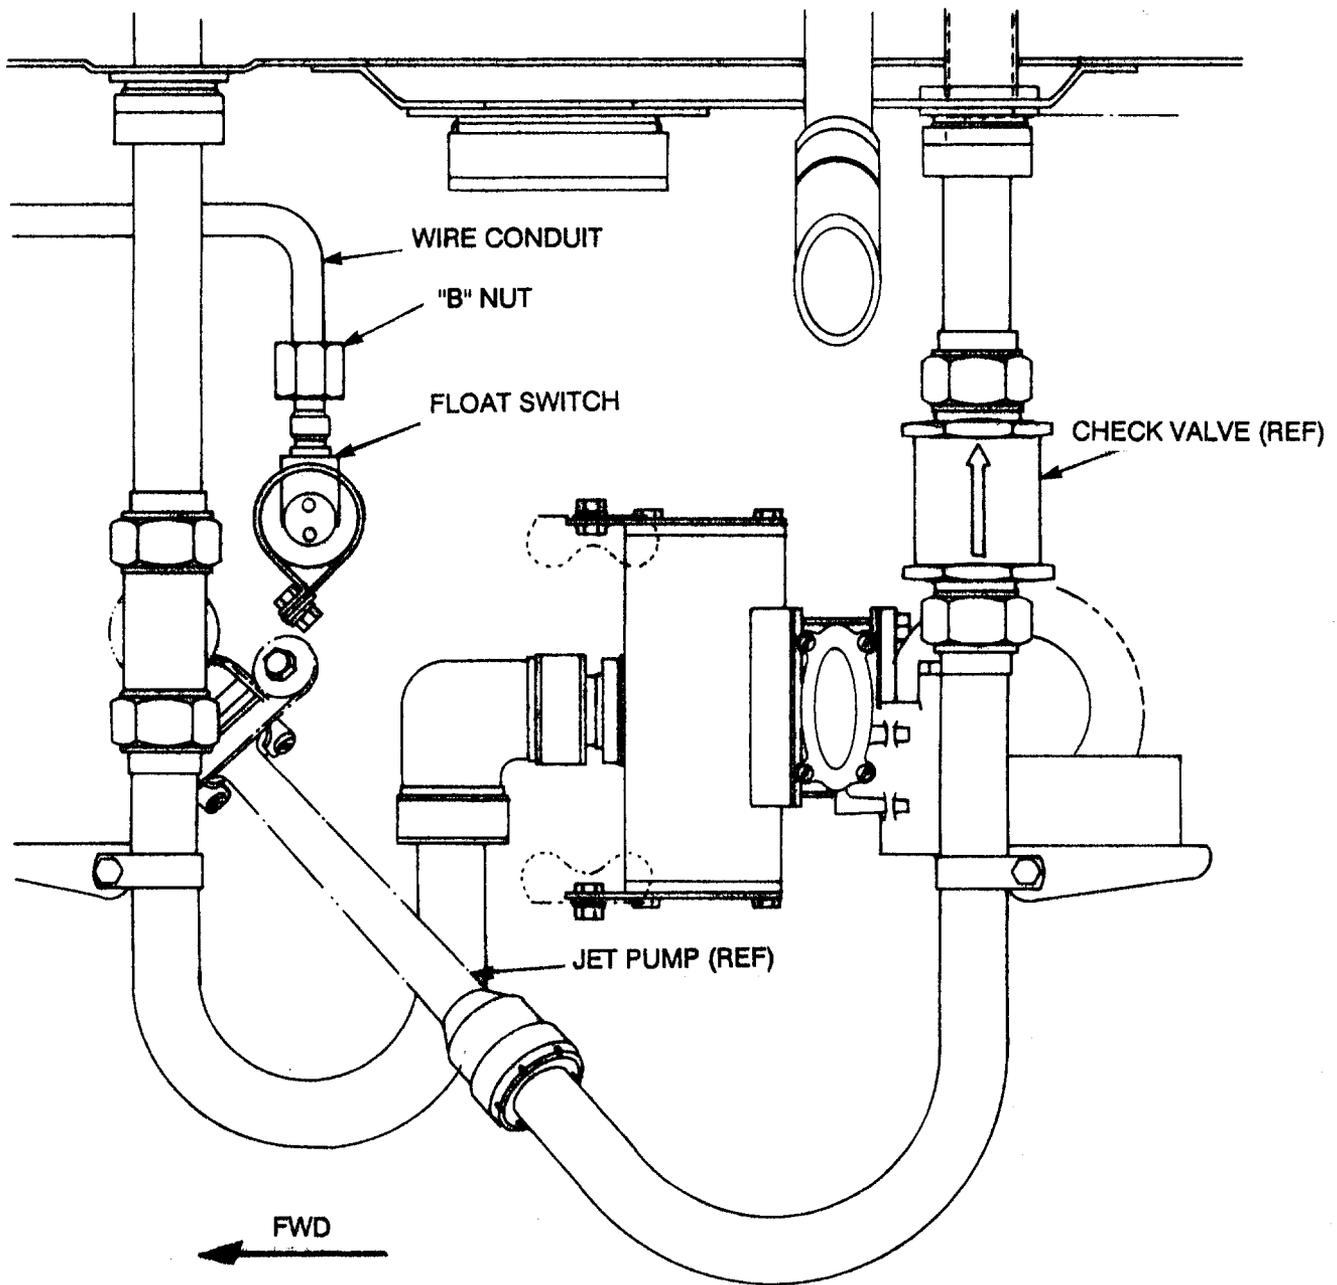
FIGURE 1

To prevent moisture from entering wiring conduit which could freeze and subsequently rupture conduit, causing fuel leakage.

This service bulletin provides instructions for the purging of accumulated moisture and sealing of the tip tank float switch wire conduit.
