1124 AND 1124A WESTWIND SERVICE BULLETIN INDEX

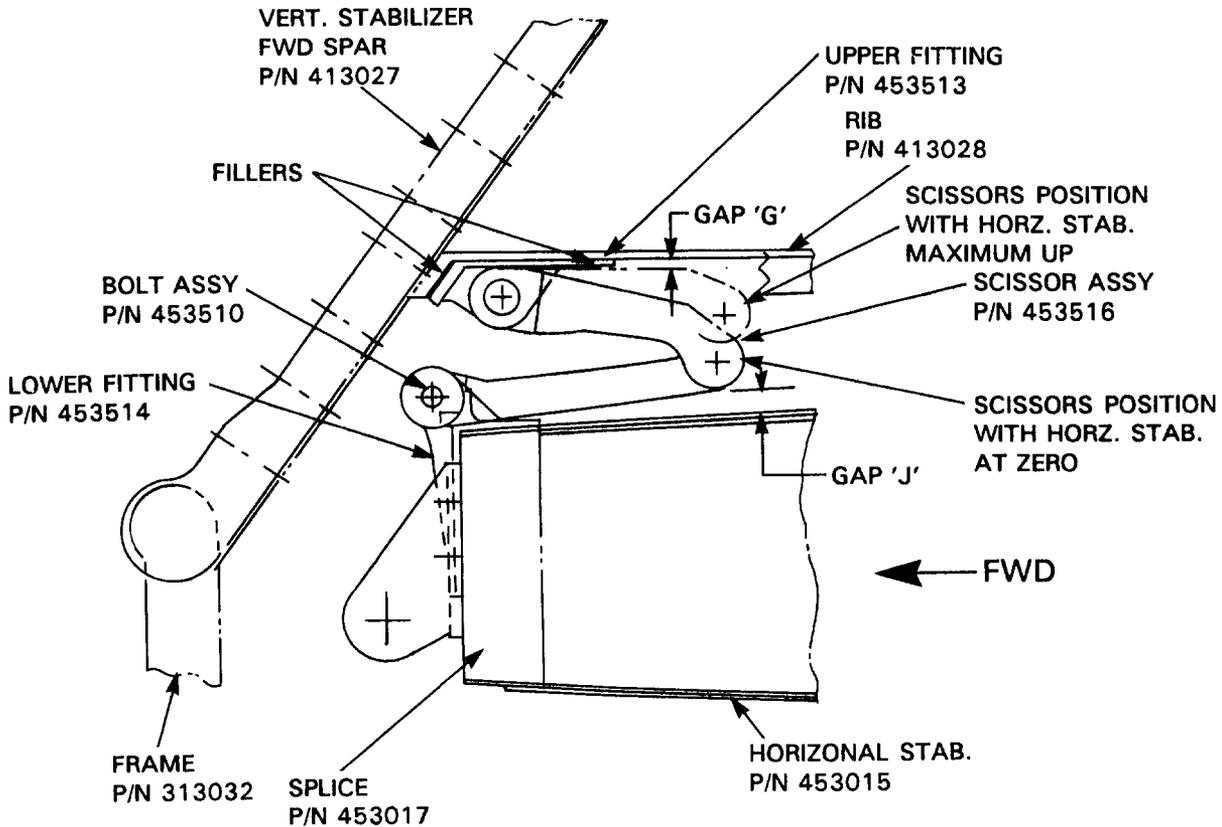
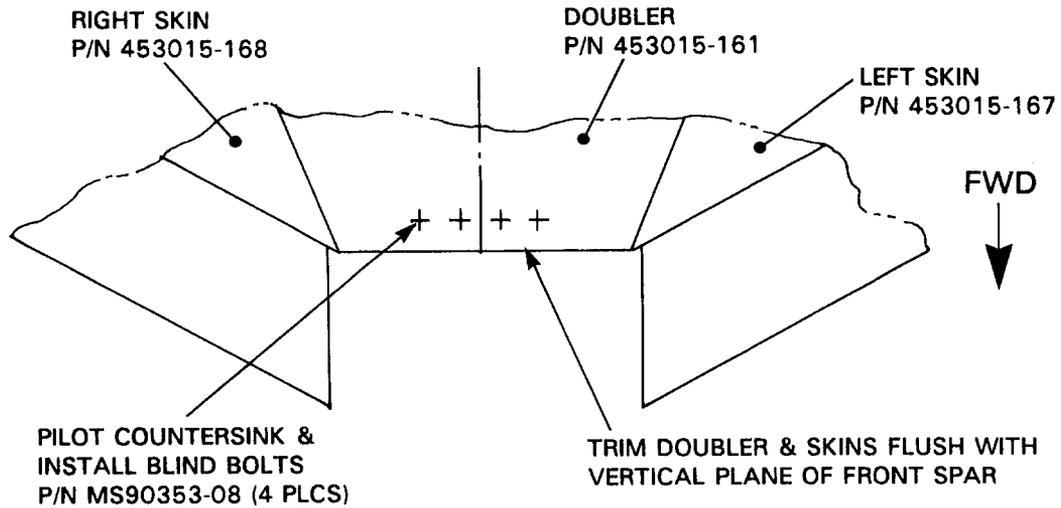
FIGURE 2

Reports from the field indicate that some stabilizer lower scissor fittings P/N 453514 have loosened or cracked in service. Reference Service Bulletin No. 1124-55-097.

- (6) Drill out all fasteners attaching lower scissor fitting P/N 453514 to horizontal stabilizer.
- (7) Pilot countersink four (4) holes in doubler, P/N 453015-161 on top of stabilizer. Inspect hole condition. Refer to Figure 2 View "B".
- (8) Clamp-up doubler, P/N 453015-161 and skins, P/N 453015-167, left hand and -168 right hand. Refer to Figure 2 View "B".
- (9) Install four (4) blind bolts, P/N MS90353-08 or -U08, grip as required. If necessary use first standard over size. Fasteners are to be installed wet with sealant P/N PR1422. Refer to Figure 2 View "B".
- (10) Ensure that upper and lower doublers and skins are trimmed flush with vertical plane of the forward spar, P/N 453017, to clear new scissor/actuator fitting, P/N 453504.

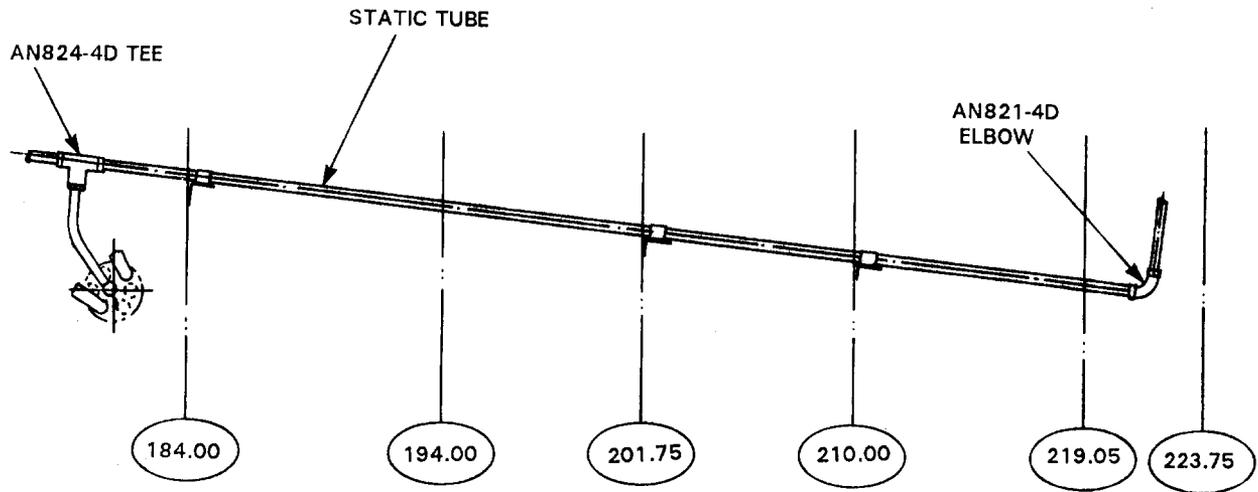
INCORRECT SLOPE

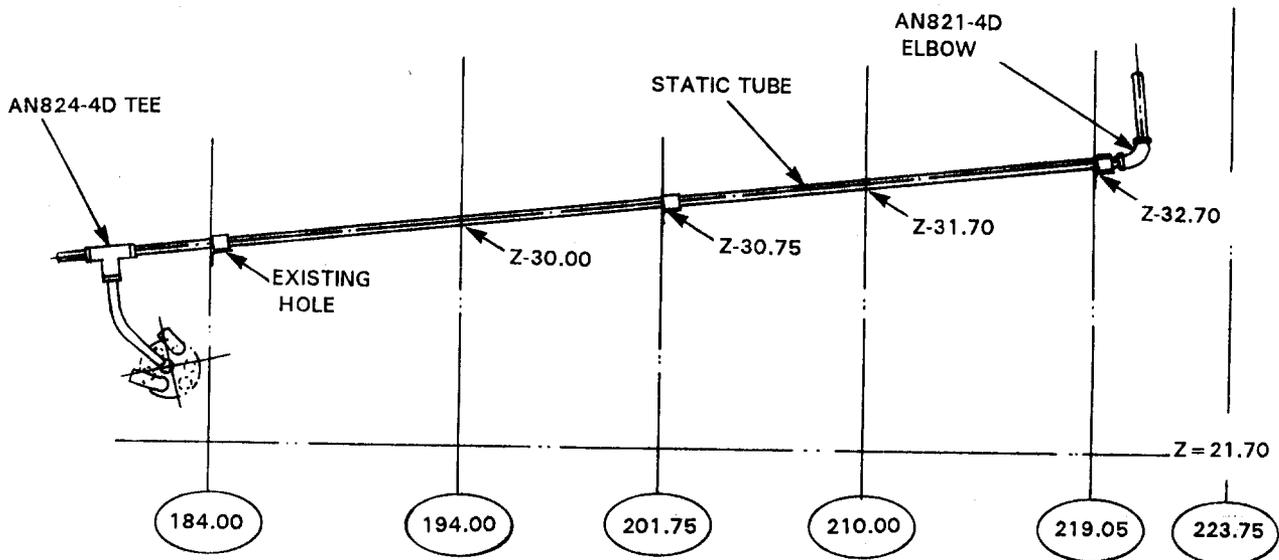
CORRECT SLOPE

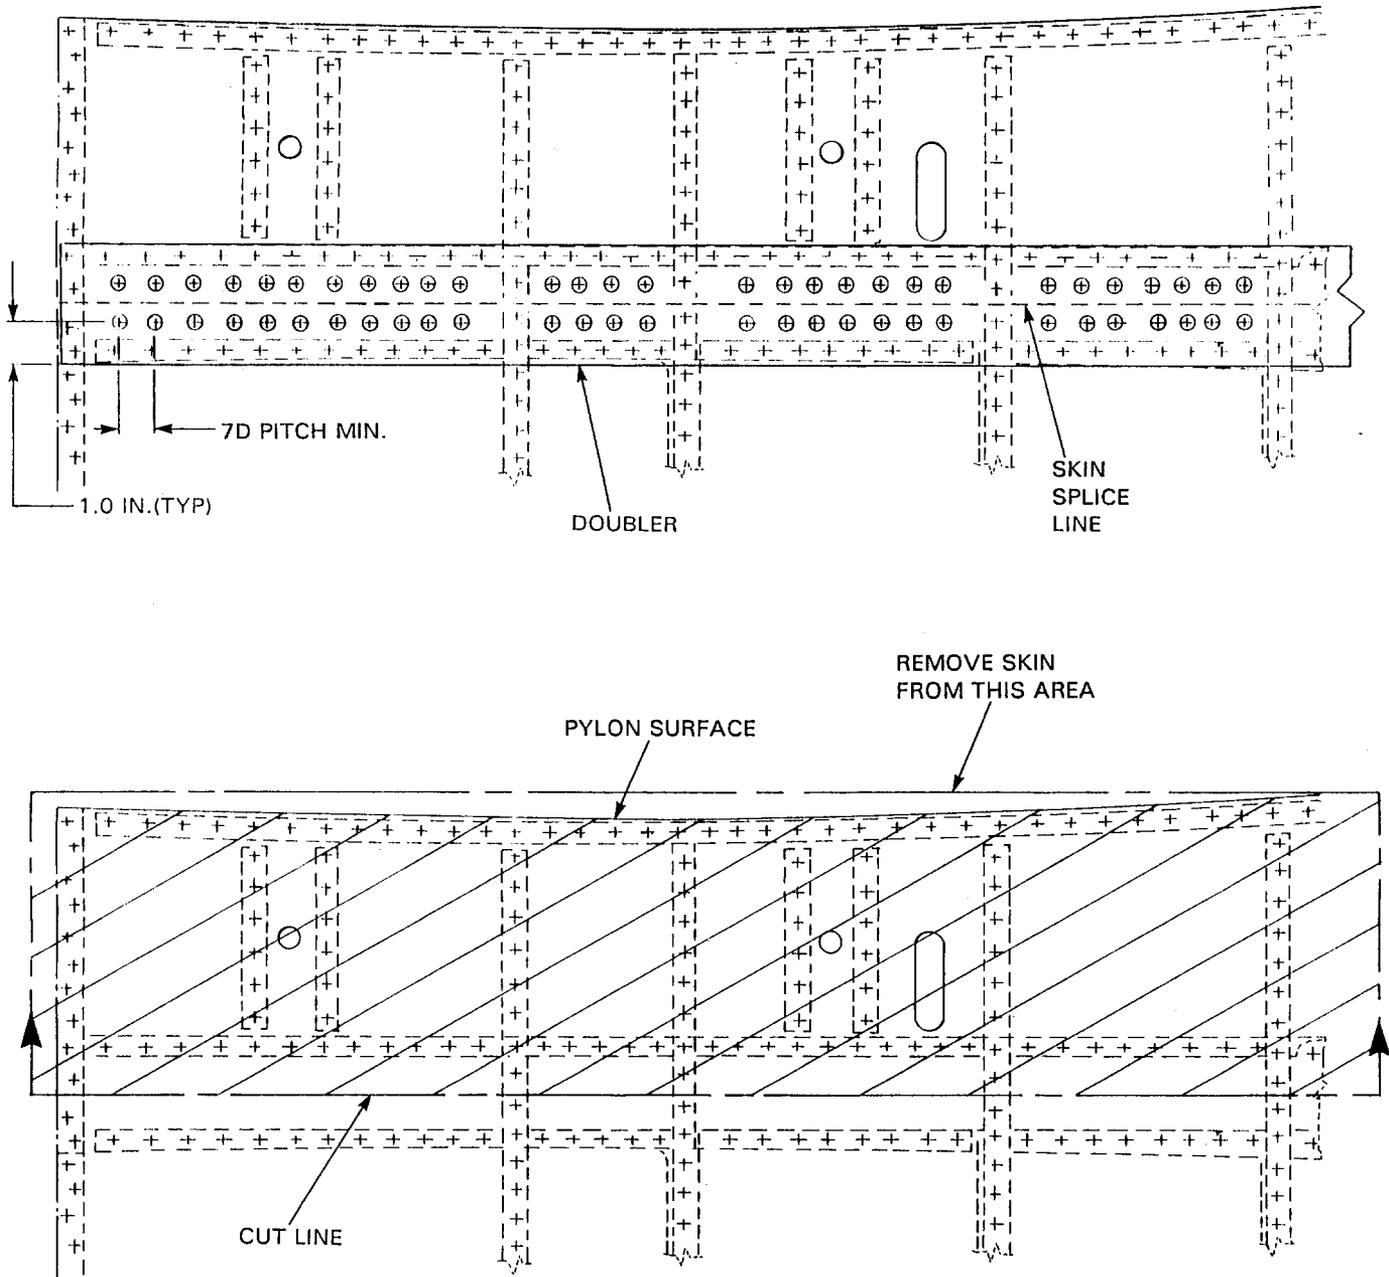
FIGURE 1

Grumman Aerospace has received reports from various model aircraft operators that corrosion has been found in cowl door skins in the area covered by stainless steel fire shields. Westwind engine cowlings are of similar design to those affected by corrosion.

- (1) Repair door by splicing a new section of skin.
- (2) Remove stainless steel fire shield and set aside for re-use.
- (3) Pull old skin as far away from substructure as possible to prevent damage to the substructure when cutting away old skin.
- (4) Cut off old skin following a line half way between the second and third rows of rivets. Care should be taken not to damage skin as it will be used as a template to cut new skin section. Refer to Figure 1.

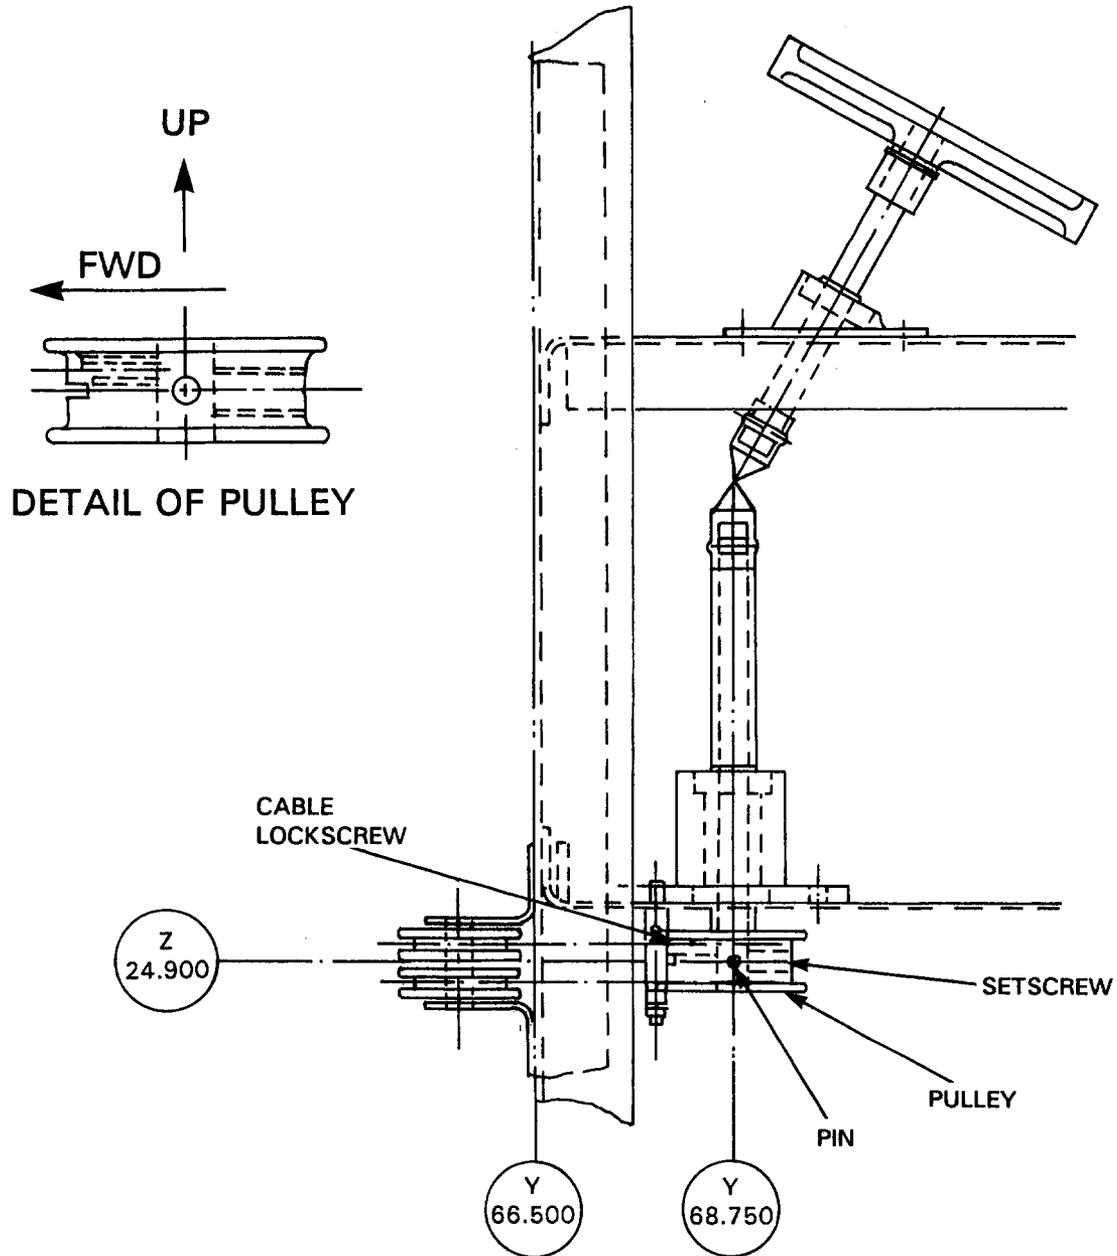
View Looking Inboard
FIGURE 1

Steering cable drums have been found incorrectly installed in the fleet.

- (2) If installation is not as shown. Remove steering cable drum and assemble as shown.
 - C. Perform Steering System Rigging. Reference 1124/1124A Maintenance Manual Chapter 32-50-00, Maintenance Practices.
 - D. Install cockpit interior furnishings removed.
3. RECORD COMPLIANCE
- A. Make the following entry in the aircraft log book:

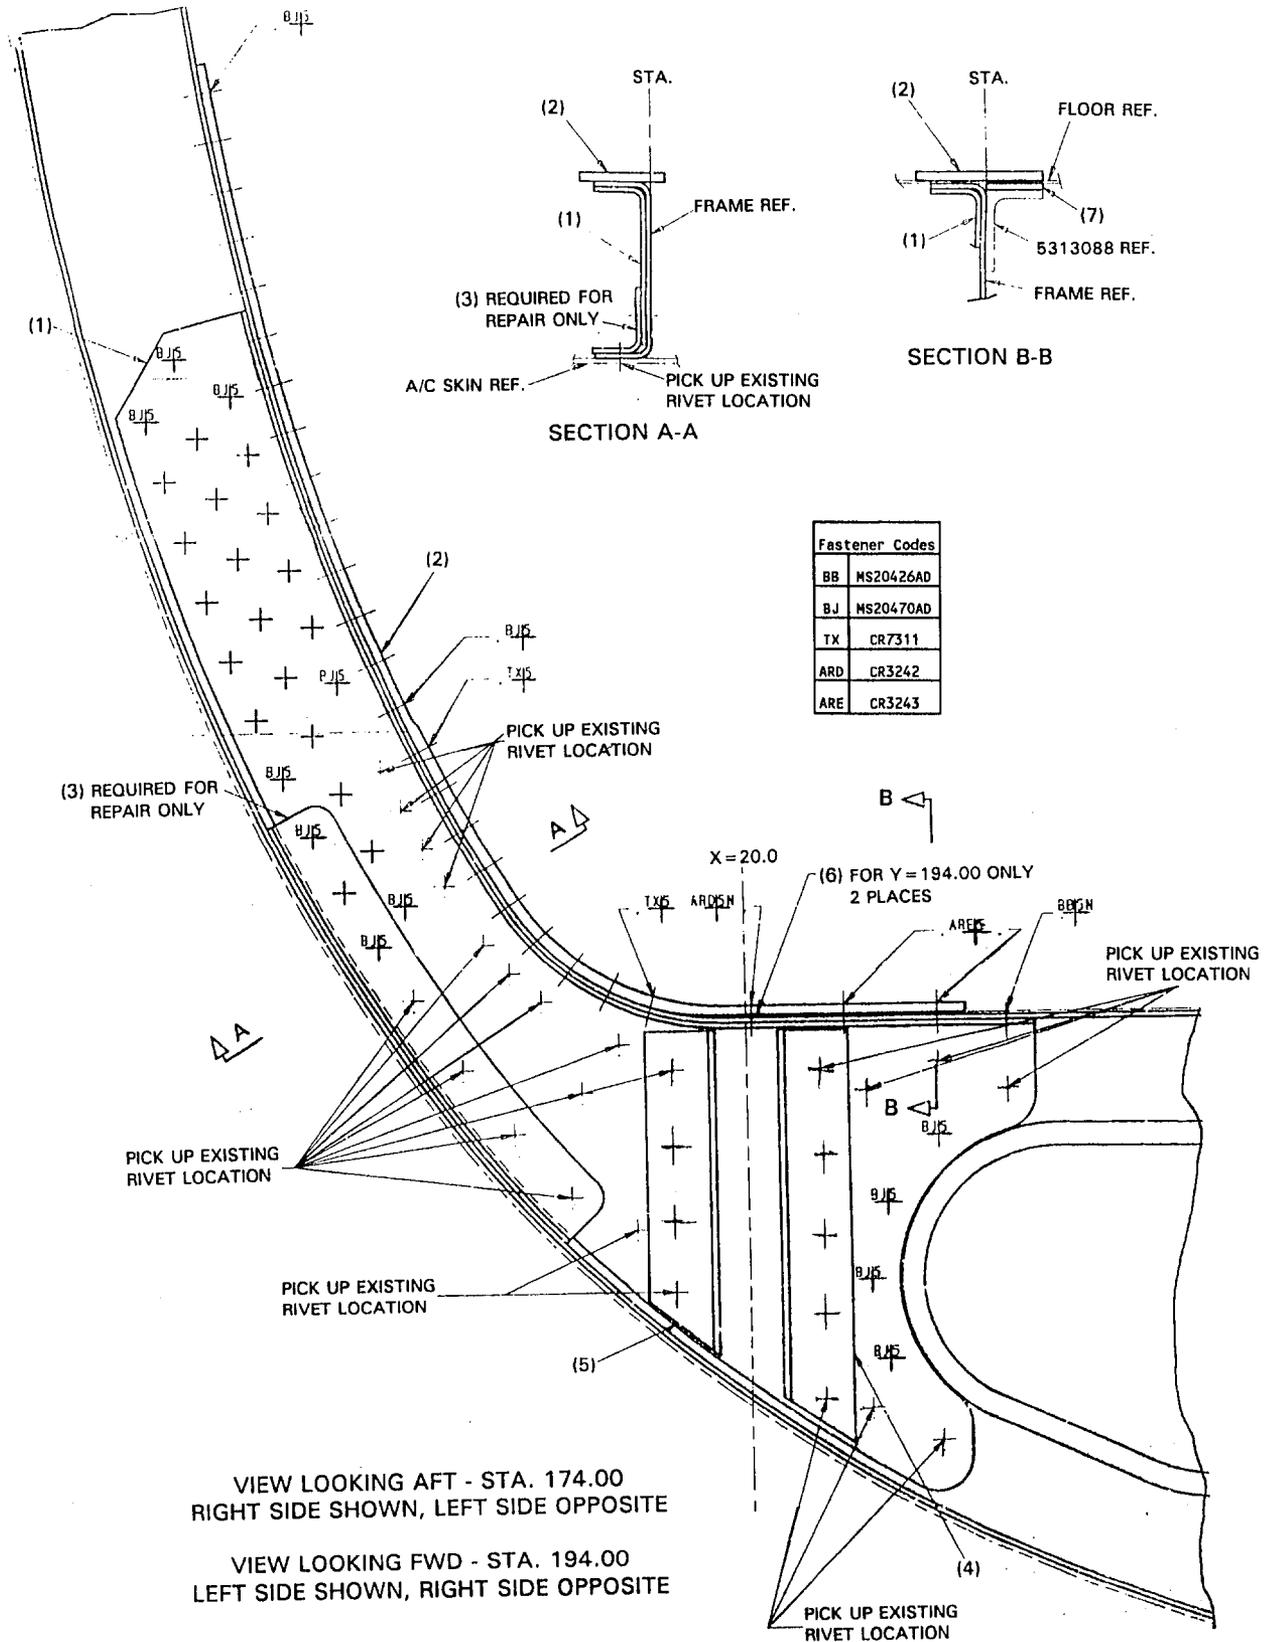
FIGURE 1

To provide a structural repair and reinforcement installation for left and right fuselage sta. 166.25 through 219.05 frames inspected during the Structural Inspection Program.

- A. Remove inboard and outboard seat tracks. Remove fasteners securing floor panels from sta. 149.75 to sta. 223.75 and remove panels.
- B. Prior to installation of repair components, all cracks in frames must be stop drilled to .125", deburred and finished with epoxy primer.
- C. Place bracket (1) in place on forward side of sta. 174.00 frame and mark existing rivets requiring removal.

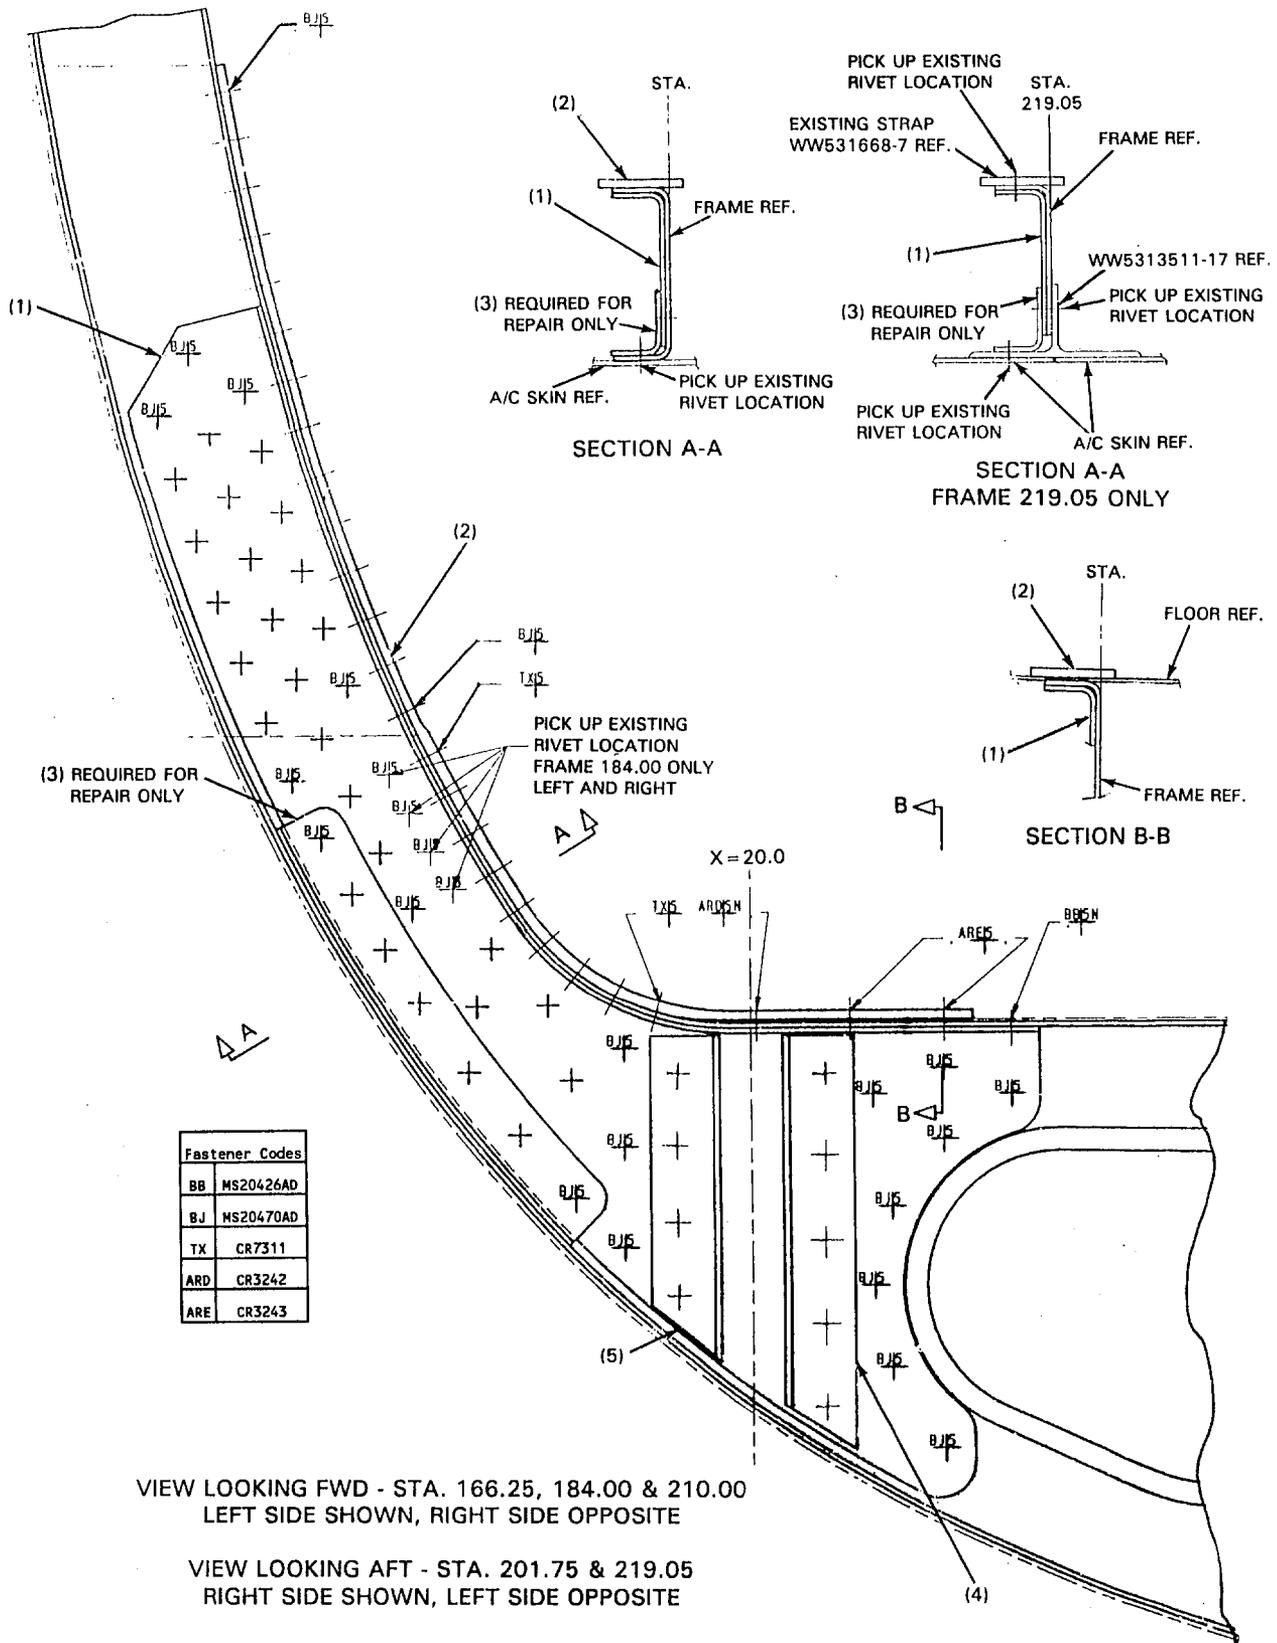
FIGURE 2

NOTE: Refer to Figure 3 for top view of (2) strap inst'l and part numbers of items (1) - (7).

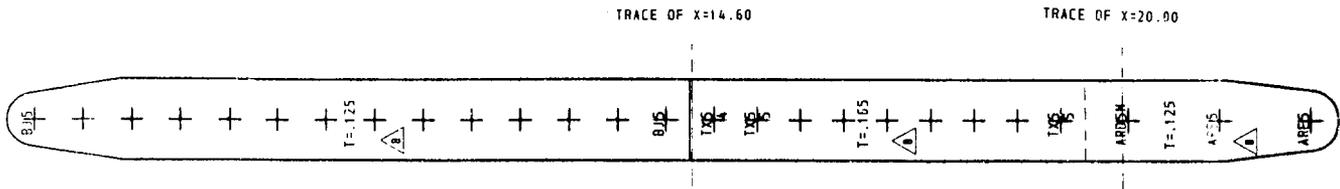
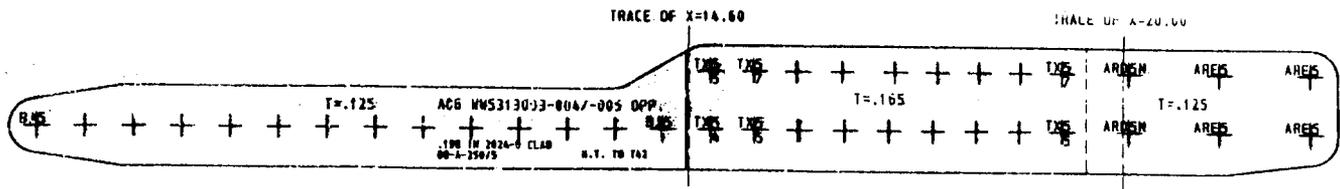
STRAP INTALLATION
FIGURE 3

STA. 166.25, 184.00, 201.75, 210.00 & 219.05 FRAMES

STA. 174.00 & 194.00 FRAMES

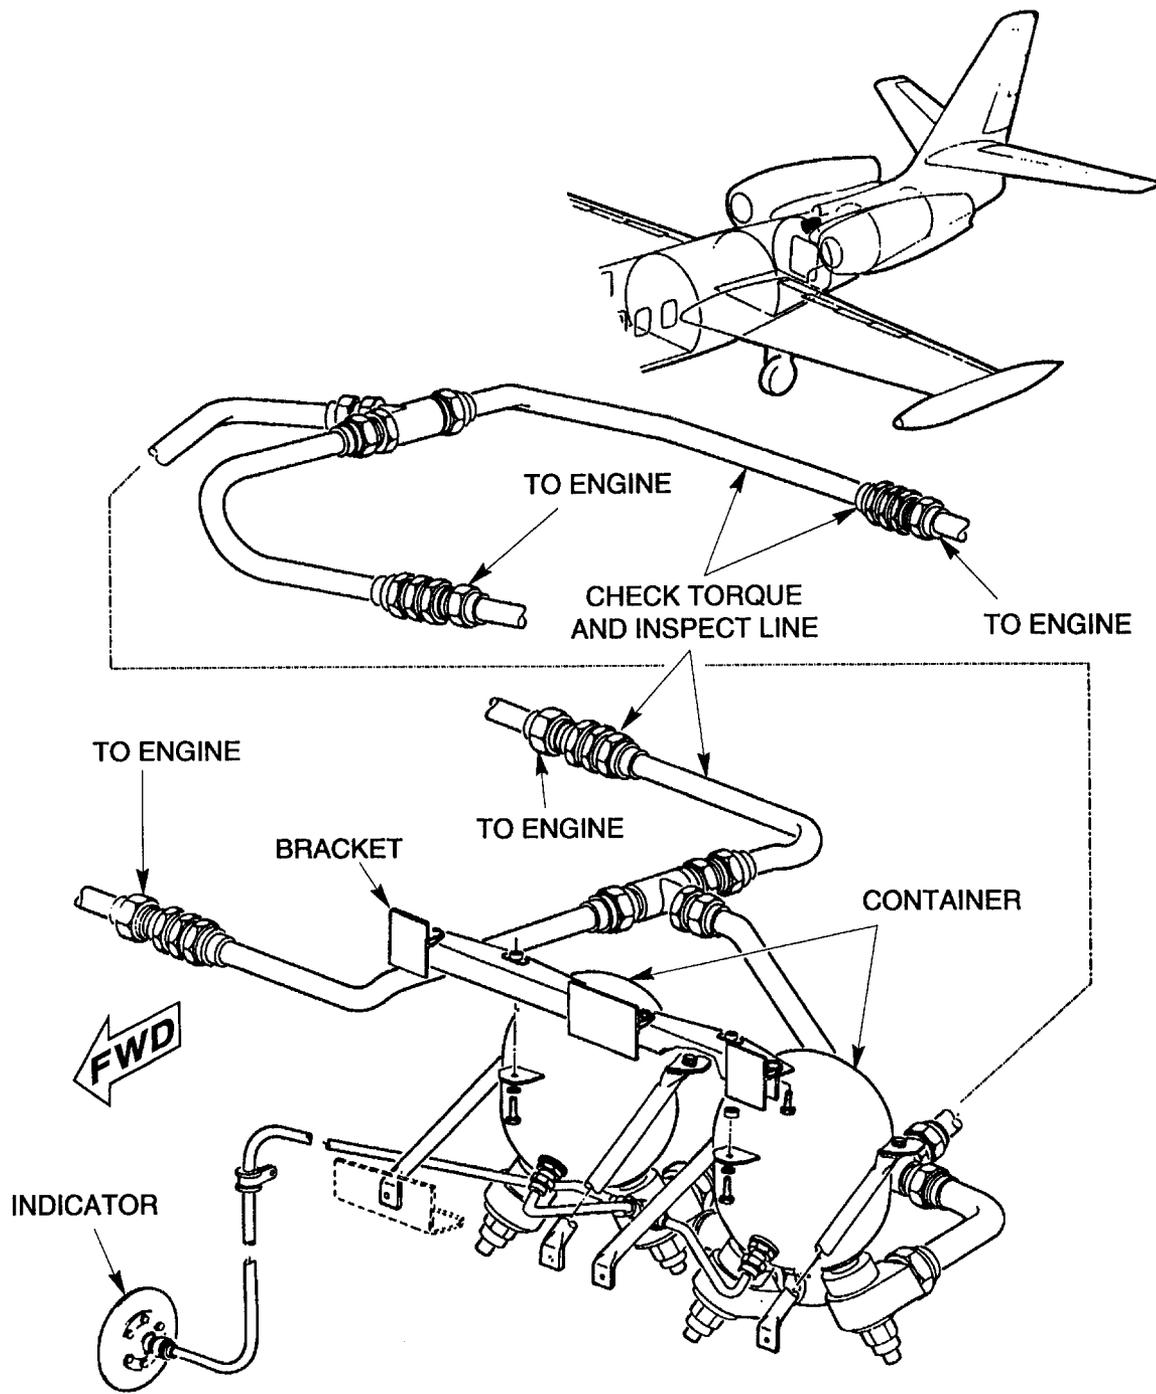
FIGURE 1

Field experience has revealed that the B-nut attached to firewall fitting inside pylon may be loose.

- (1) Gain access to fire extinguisher lines by removing forward wall from aft baggage area.
- (2) Using a flashlight and mirror inspect lines for signs of external damage. Refer to Figure 1.
- (3) Using a 7/8 inch crows foot, 24 inch extension and ratchet, verify lines are tight on bulkhead fittings.
- (4) Install panel.

- (1) Gain access to fire extinguisher lines by removing oval panels on firewall. Refer to Figure 2.
- (2) Inspect lines for any signs of external damage. Refer to Figure 1.
- (3) Using a 7/8 inch wrench, verify lines are tight on bulkhead fittings.
- (4) Install panel.

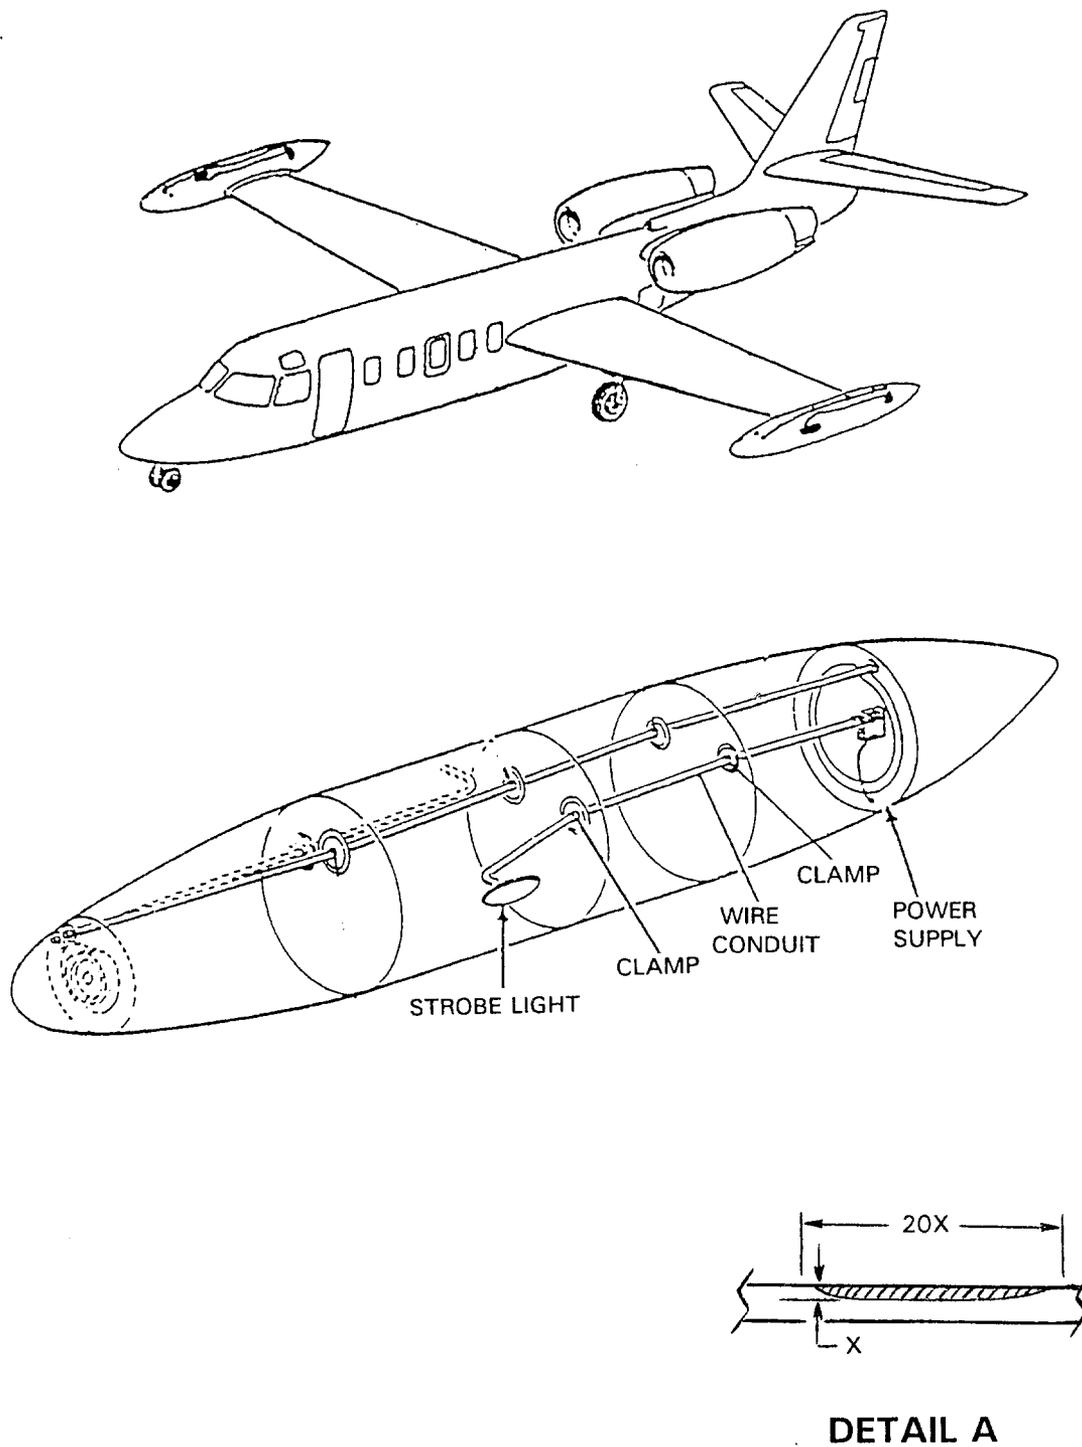
FIGURE 1

- C. Inspect routing of strobe light wire conduit (hose) from strobe light to power supply for possible contact with surrounding structure.
- D. If no contact with structure is found, proceed to step "F".
- E. If contact with surrounding structure is found, proceed as follows:
 - (1) Inspect conduit to determine if any steel strands are worn through.
 - (2) If any strands are worn through, conduit must be replaced.
 - (3) If no strands are worn through, loosen clamps securing conduit, and reposition conduit as necessary to prevent further contact with surrounding structure. Tighten clamps.
 - (4) Inspect area of tip tank skin where conduit was making contact.
 - (5) If depth of wear does not exceed .010 inch, coat exposed surface with protective coating P/N PR1005L (MIL-S-4383).

NOTE: If wear is not smooth, blend out area without deepening damage.
Refer to Figure 1, Detail A.
 - (6) If wear exceeds .010 inch, contact Astra Jet Corporation Technical Services.
- F. Install access panel removed in step "B".

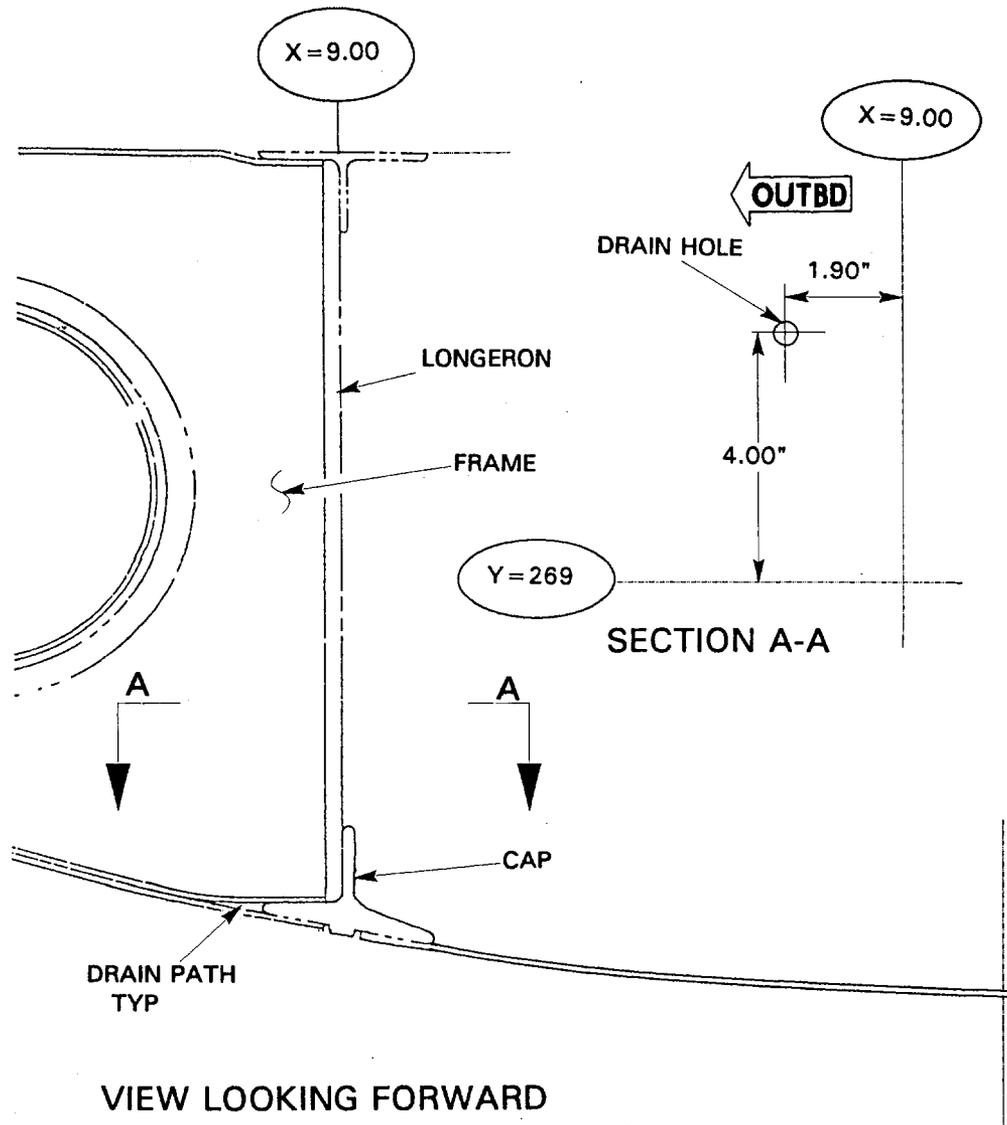
FIGURE 1

Corrosion has been found under cabin deck on some aircraft.

- B. Carefully remove debris or sealant found in a drain path with appropriate instrument, using caution to avoid damage to longeron cap, frame, or skin. A tool made from phenolic, wedge shaped to match opening is helpful.

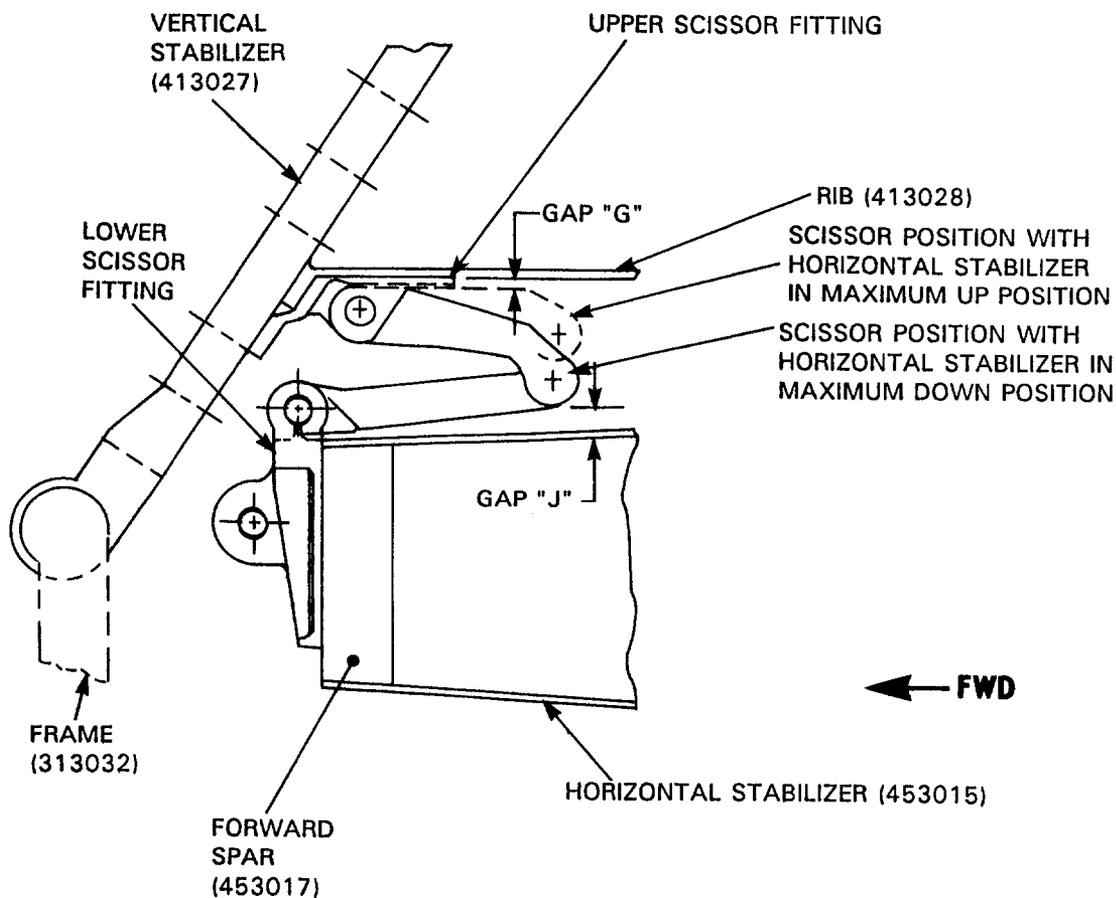
FIGURE 1

Reports from the field indicate some stabilizer upper scissor fittings P/N 453513-501 have loosened or cracked in service. Reference Service Bulletin No. 1124-55-021.

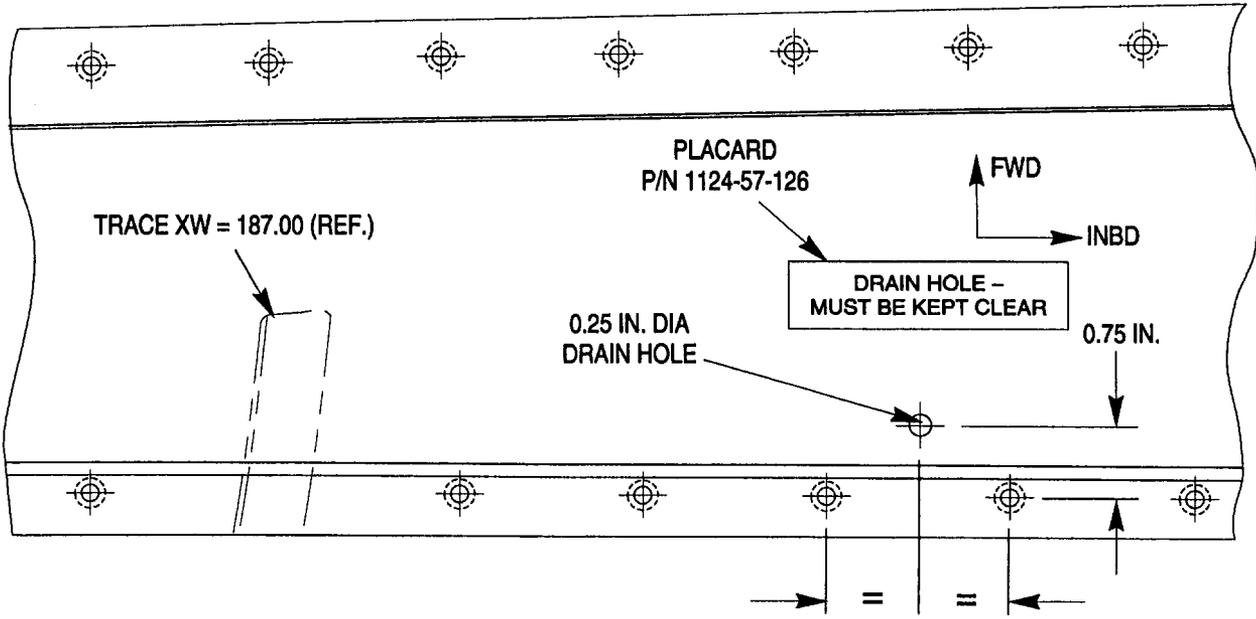
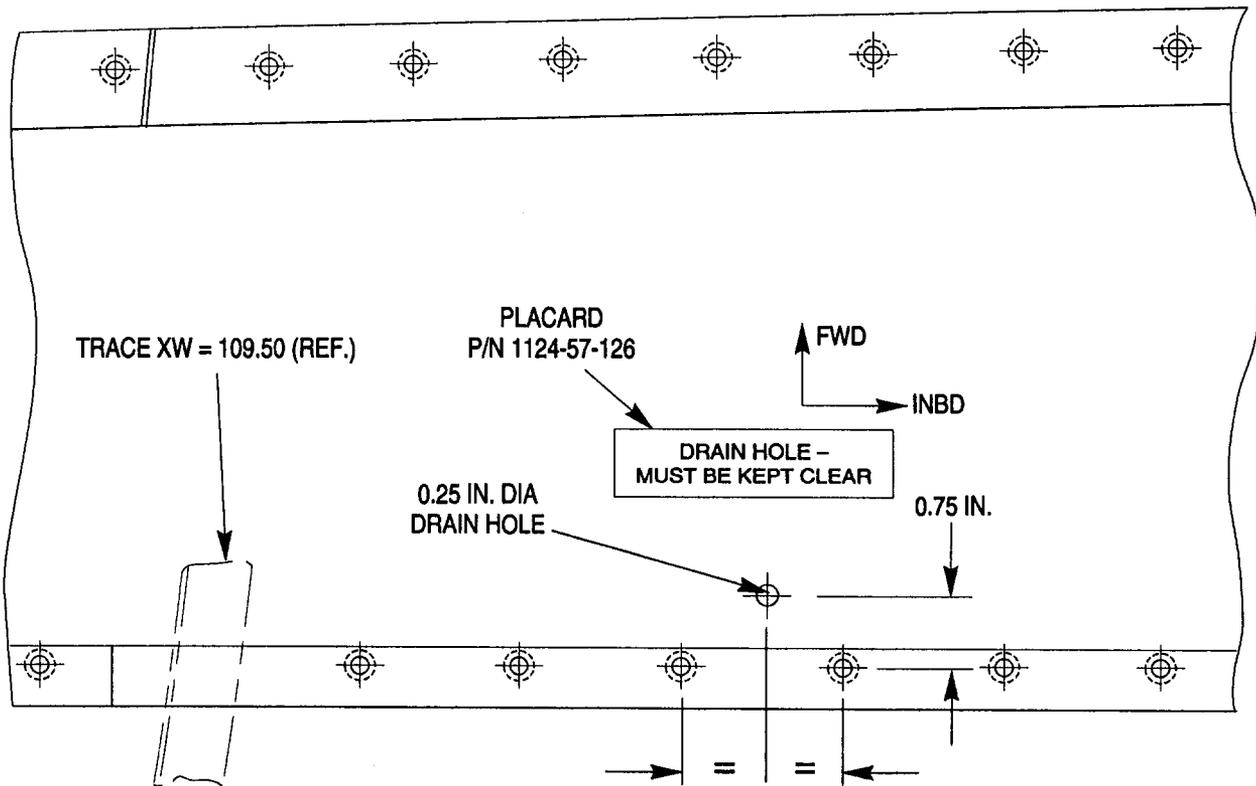
**Wing Leading Edge Extension
View Looking Up, Right Side, Left Side Opposite
FIGURE 1**

Reports from the field indicate corrosion has been found on wing skin and leading edge extension (droop section) during maintenance. In addition, fuel seepage from wing integral fuel tank has caused damage to deicer boots, requiring premature replacement.

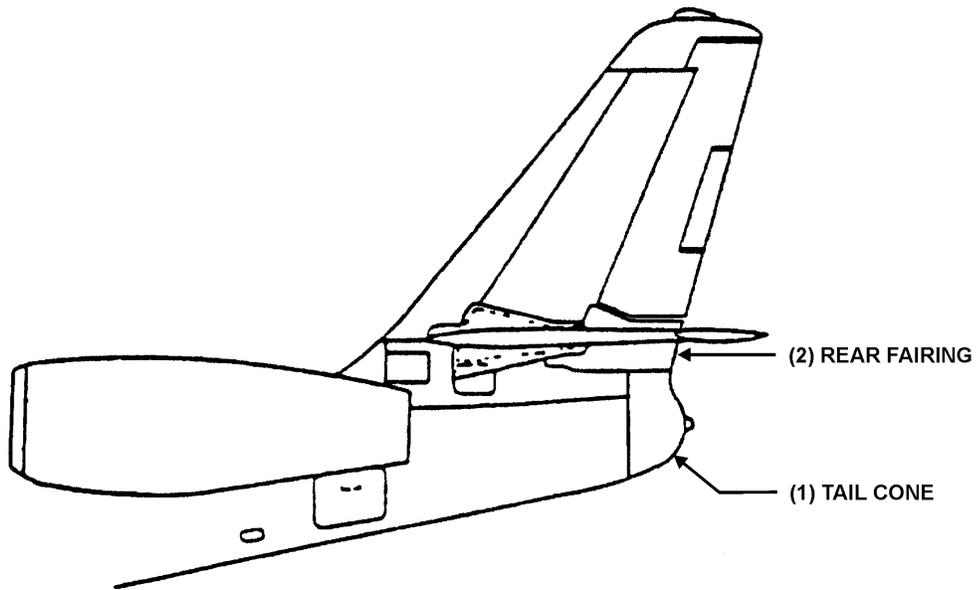
Tail Cone and Rear Fairing Location
FIGURE 1

Chafing of aft empennage fairing on frame sta. 521.75 has been found on some aircraft. Investigation has shown that elongation of attach points in fairing can reduce clearance of fairing to fitting, and cause interference.

This service bulletin provides instructions to blend any damage found on the frame and to modify the existing rub plates on the rear fairing to allow sufficient clearance between the rub plate and the frame.

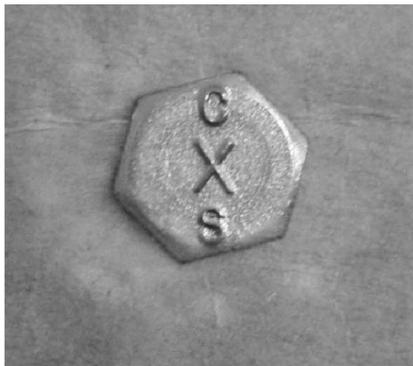
AN3 BOLT
UNAPPROVED PART NUMBER

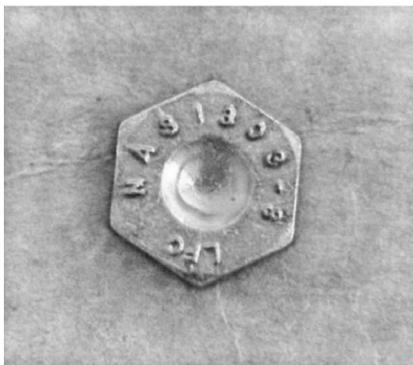
NAS1303 BOLT
APPROVED PART NUMBER

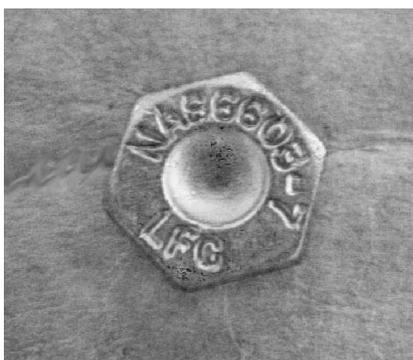
NAS6603 BOLT
APPROVED PART NUMBER

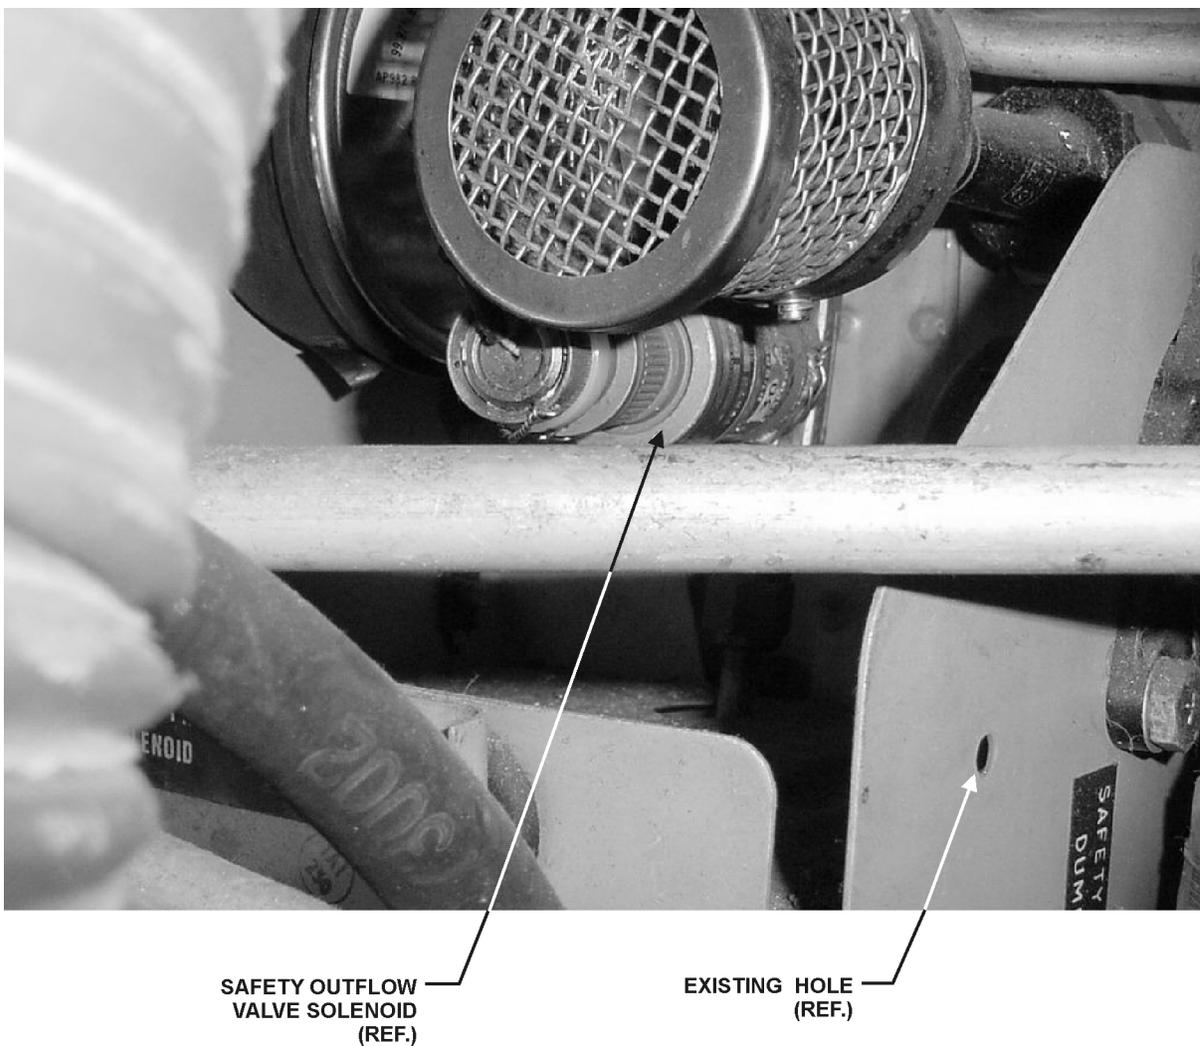
If necessary, lengthen the wires connected to the new RCCB as follows:

The solenoid valve used to control the pressurization safety outflow valve has been found to operate intermittently due to an insufficient electrical ground.

14. Treat exposed area with epoxy primer.
15. Check the resistance between the safety outflow solenoid valve and airframe ground. Maximum resistance is .0025 ohms.
16. Check for proper operation of the pressurization safety outflow valve by ground pressurizing the aircraft during an engine run using the GROUND PRESSURE pushbutton switch. Refer to 1124 Westwind Airplane Flight Manual.
17. Install pedestal panels.
18. Install co-pilot seat.
19. Make the following entry in the aircraft log book: Westwind Service Bulletin No. 1124-21-143, dated September 17, 2001, titled "Air Conditioning - Safety Outflow Solenoid Valve - Installation of Jumper Wire for Improved Electrical Grounding" has been accomplished this date _____.
20. Complete the attached Certificate of Compliance and return to Gulfstream Aerospace LP in Fort Worth, Texas.
