1124 AND 1124A WESTWIND SERVICE BULLETIN INDEX

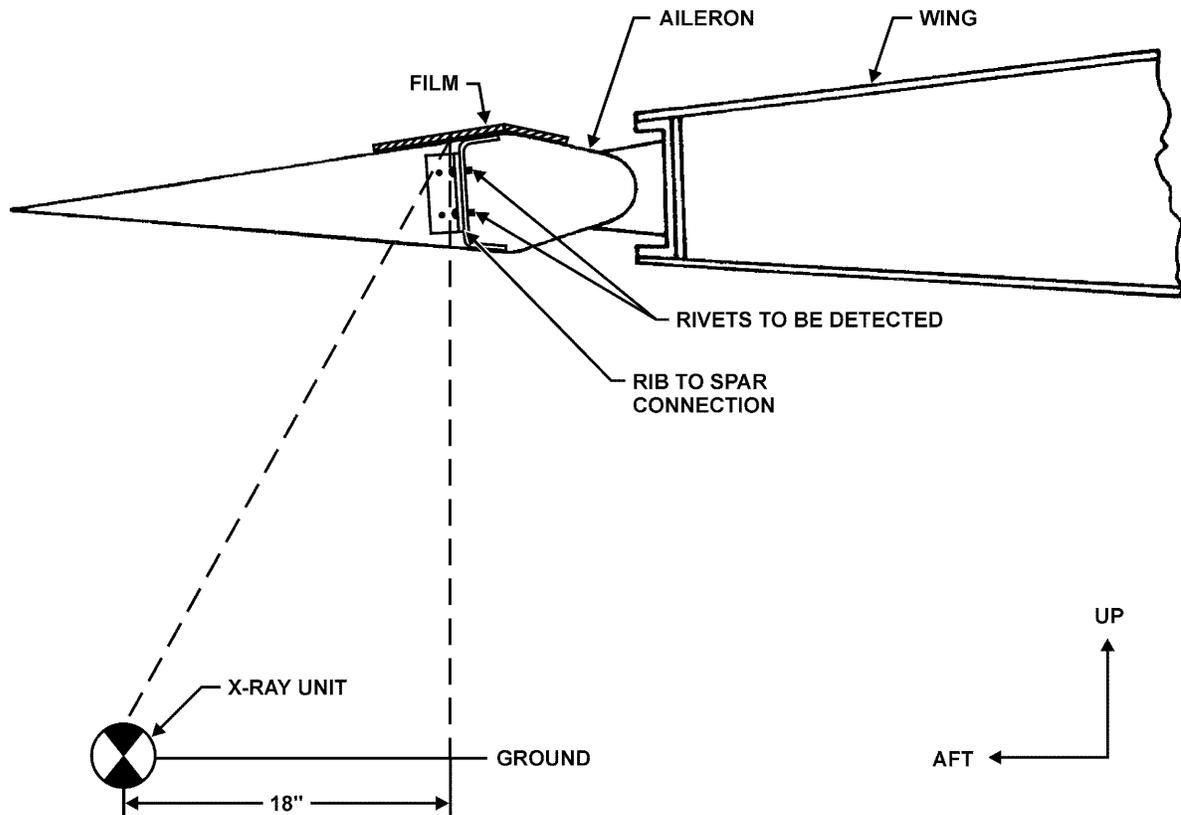
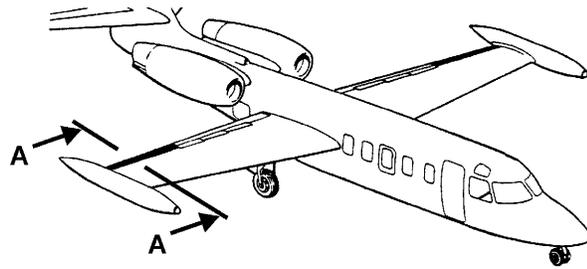
Aileron X-Ray Inspection
Right Aileron Shown, Left Aileron Opposite
FIGURE 1

An 1124A Westwind was found to have 5 out of the 13 ribs not riveted to the spar on one of the aileron assemblies.

2. Perform an x-ray inspection on the left and right aileron ribs (WS 158.00 to WS 246.00) for possible missing rivets at the rib to spar connections using the following x-ray technical data: (Refer to Figure 1)

3. If any rivets are found missing, contact the Customer Support Group at Galaxy Aerospace Company, LP for repair instructions.

NOTE: If rivets are found to be missing, the aircraft must be grounded until the aileron has been repaired or replaced.

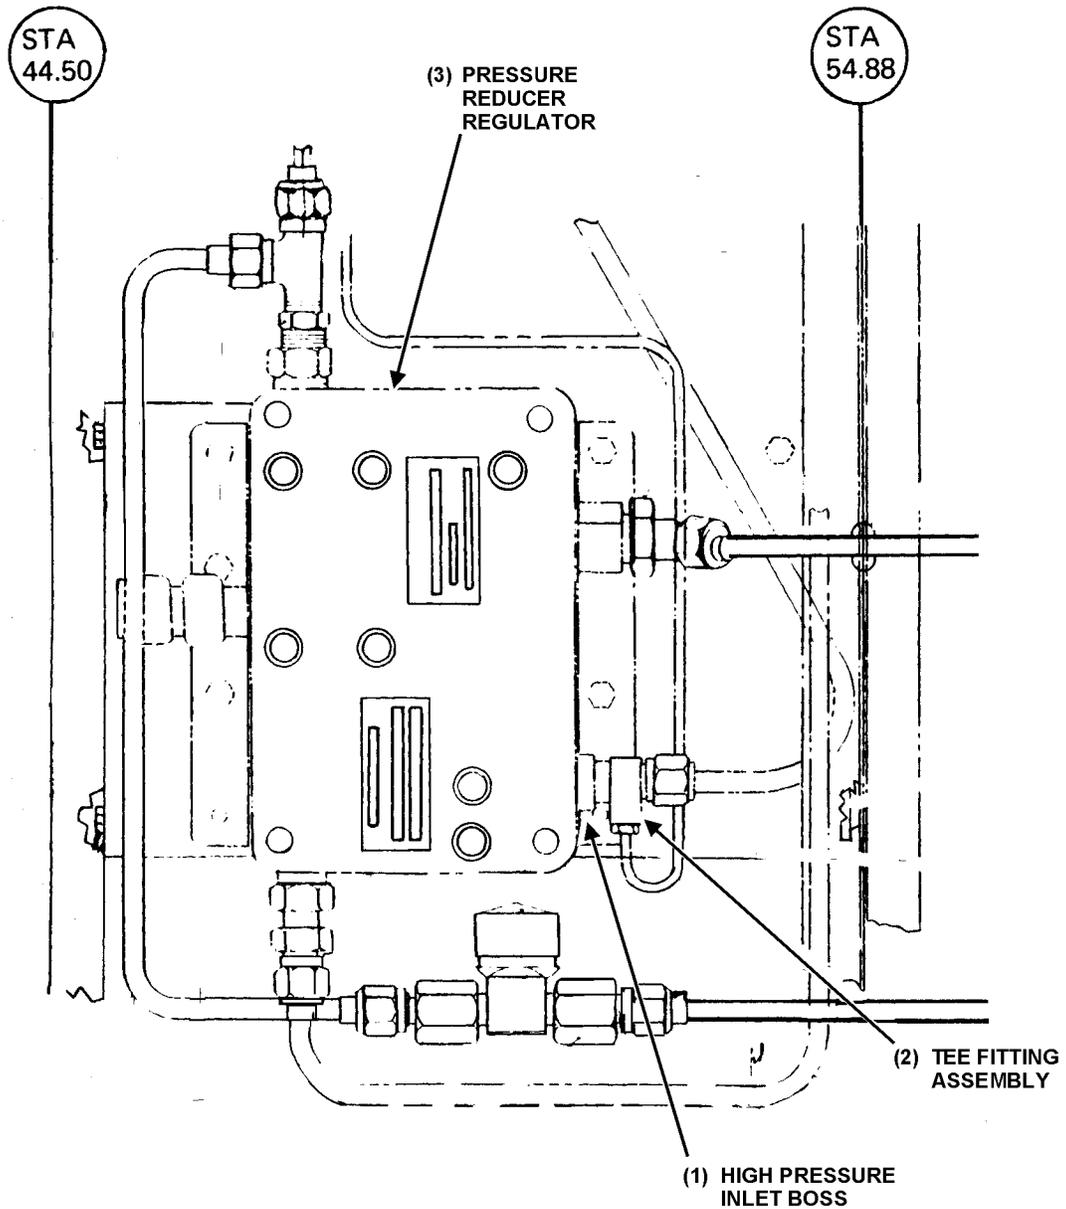
Pressure Reducer Regulator
Figure 1

Cracks have been discovered in the high-pressure inlet boss of the oxygen pressure reducer/regulator assembly.

5. Inspect the high pressure reducer inlet boss (1) for cracks and leaks as follows (Refer to Figure 1):
 - A. Ensure the oxygen supply pressure is normal (1850 PSIG).

- B. Visually inspect the high-pressure inlet boss (1) with a magnifying glass for cracks at or near the tee fitting assembly (2).
 - C. Apply MIL-L-25567B Type I leak detector solution to high-pressure inlet boss (1).

- D. If no cracks or leaks are discovered, proceed to Step 6.
 - E. If cracks or leaks are discovered, remove and replace the pressure reducer/regulator assembly. Refer to the Aircraft Illustrated Parts Catalog, Chapter 35, and Aircraft Maintenance Manual, Chapter 35 for details.

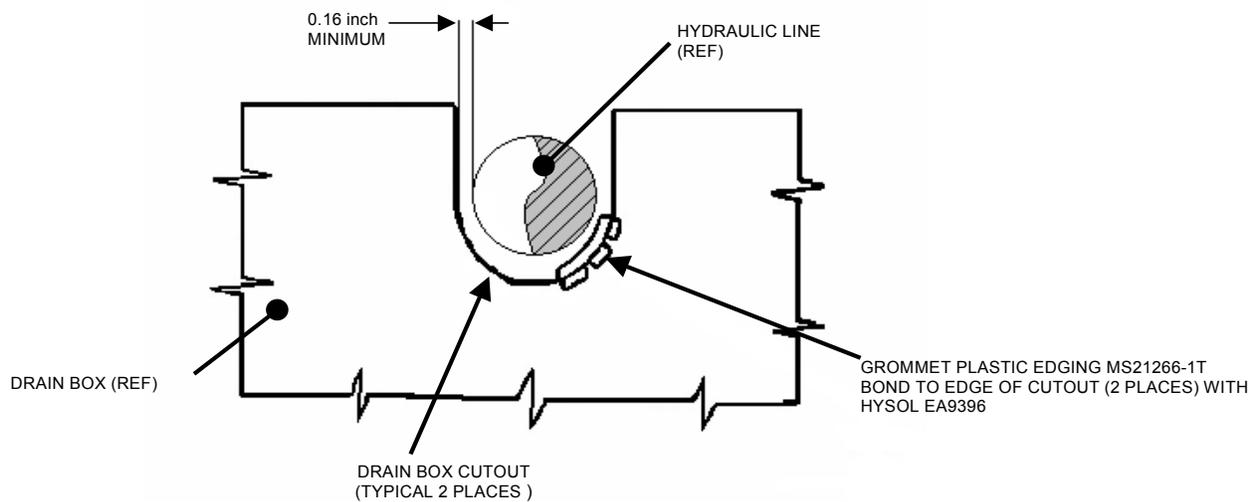
Drain Box Cutout
Figure 1 Sheet 2 of 2

NOTE:
BEFORE BONDING OF GROMMET P/N MS21266-1T, ENSURE A MINIMUM OF 0.16" CLEARANCE EXISTS BETWEEN THE DRAIN BOX CUTOUTS AND ALL HYDRAULIC TUBE ASSEMBLIES

9. Install grommet P/N MS21266-1T on drain box cutouts using epoxy adhesive P/N EA9396.
10. Ensure work area is clean and clear of foreign objects (FOD).
11. Install reservoir access panel in the main baggage compartment rear wall. Refer to Aircraft Maintenance Manual, Chapter 29.
12. Record compliance with this service bulletin, in the aircraft's permanent maintenance records and return the aircraft to flight status.
13. Complete the attached Certificate of Compliance and return to General Dynamics Aviation Services, Dallas, Texas.

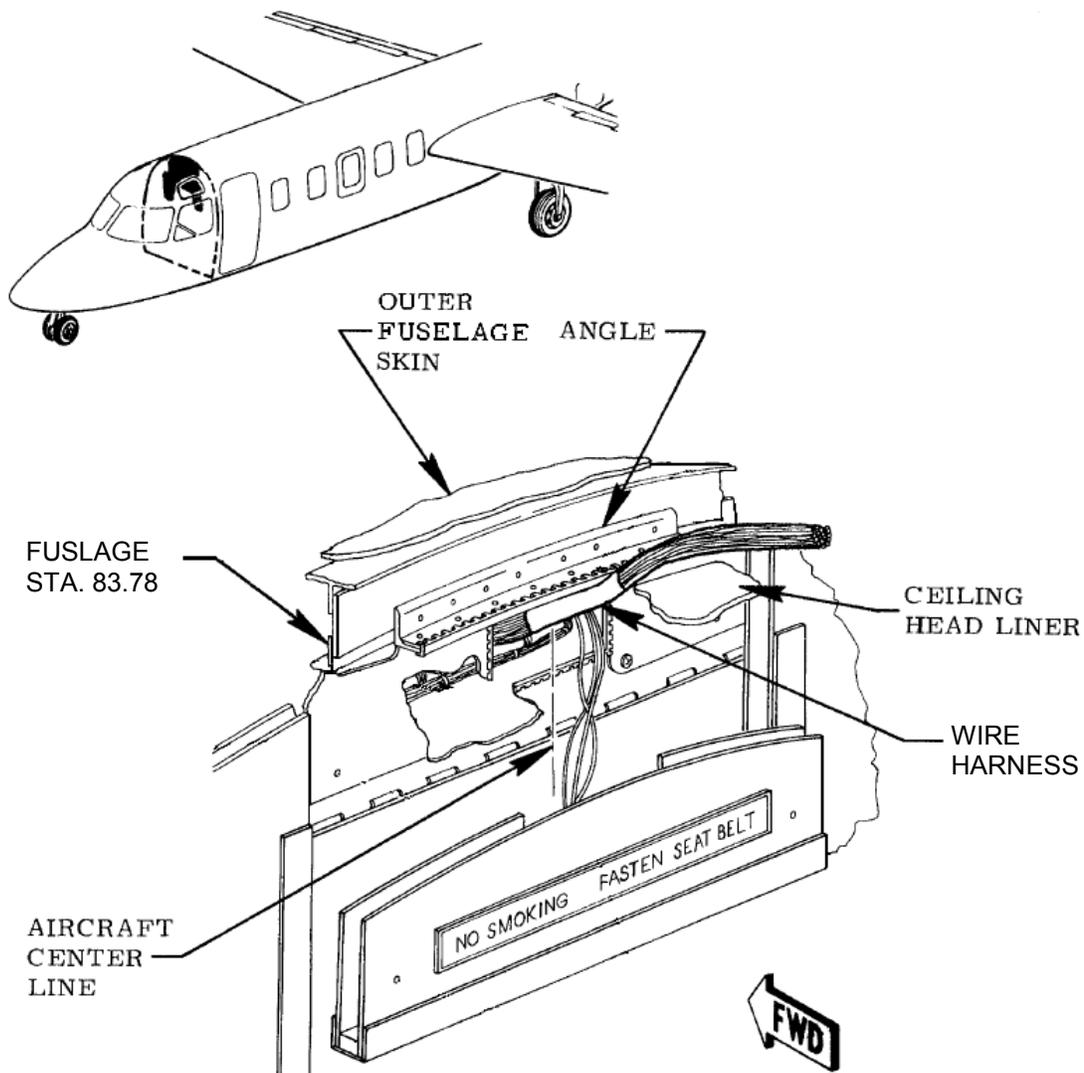
Overhead Wire Bundle Inspection Area at Fuselage Station 83.78
Figure 1

**ELECTRICAL POWER (ATA 24) OVERHEAD ELECTRICAL PANELS - ONE TIME INSPECTION
OF WIRE BUNDLE ROUTED ABOVE THE "NO SMOKING - FASTEN SEAT BELT" SIGN FOR
CHAFING**

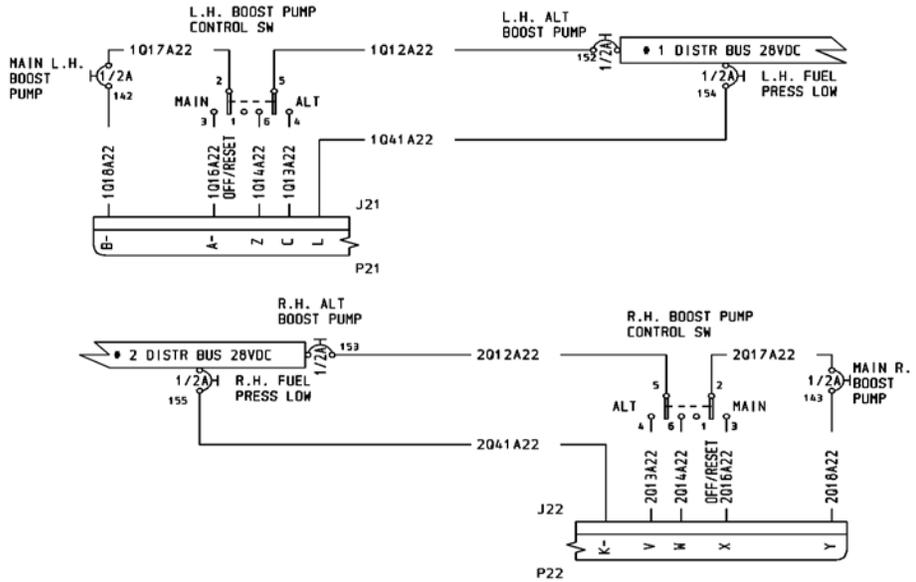
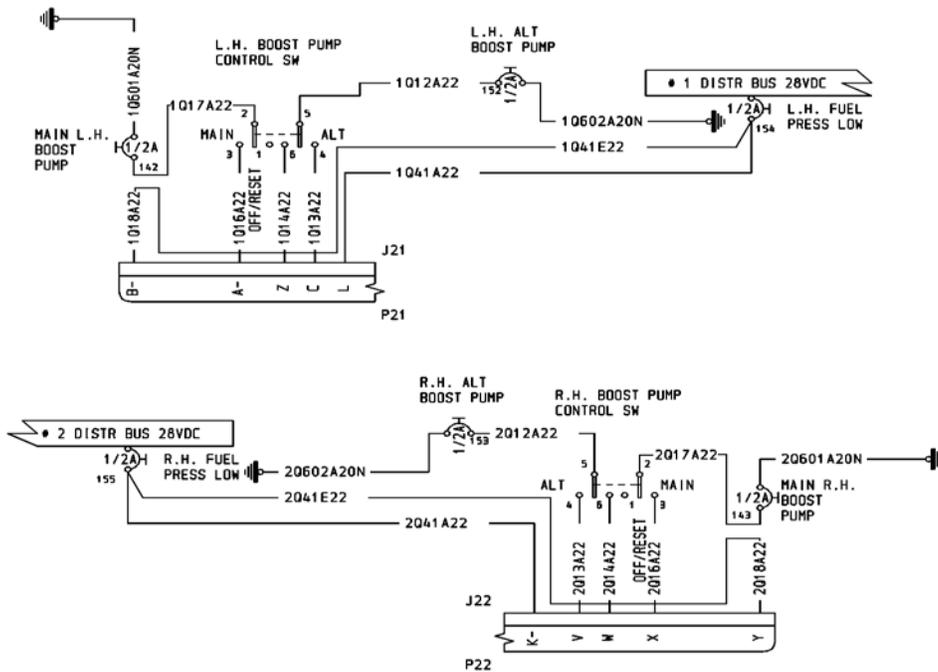
FIGURE 1

As a result of investigation of smoke and burning of the boost pump wiring on Westwind aircraft during maintenance, it was concluded to replace existing RCCB's with units that provide better protection against overload situations.

- D. Route the wires 2Q604A22 and 1Q604A22 through existing grommets into RH DC Contactor Box.
 - E. Connect wire 2Q604A22 to RCCB2-4 pin S3 in RH DC Contactor Box, use pins P/N M39029/1-100.
 - F. Connect wire 1Q604A22 to RCCB2-5 pin 3 in RH DC Contactor Box, use pins P/N M39029/1-100.
 - G. Close the LH and RH DC contactor box covers.
13. Perform operational check of boost pumps (Ref Chapter 28).
14. Record compliance of this Service Bulletin in the aircraft's permanent maintenance records. State in Aircraft Log Book "Service Bulletin 1124-28-155, Rev 2, Dated JUN 20, 2008, has been completed on this aircraft on this date".
15. Complete the attached "SERVICE BULLETIN CERTIFICATE OF COMPLIANCE" form and FAX to Worthington Aviation Corporation in Eagan MN.

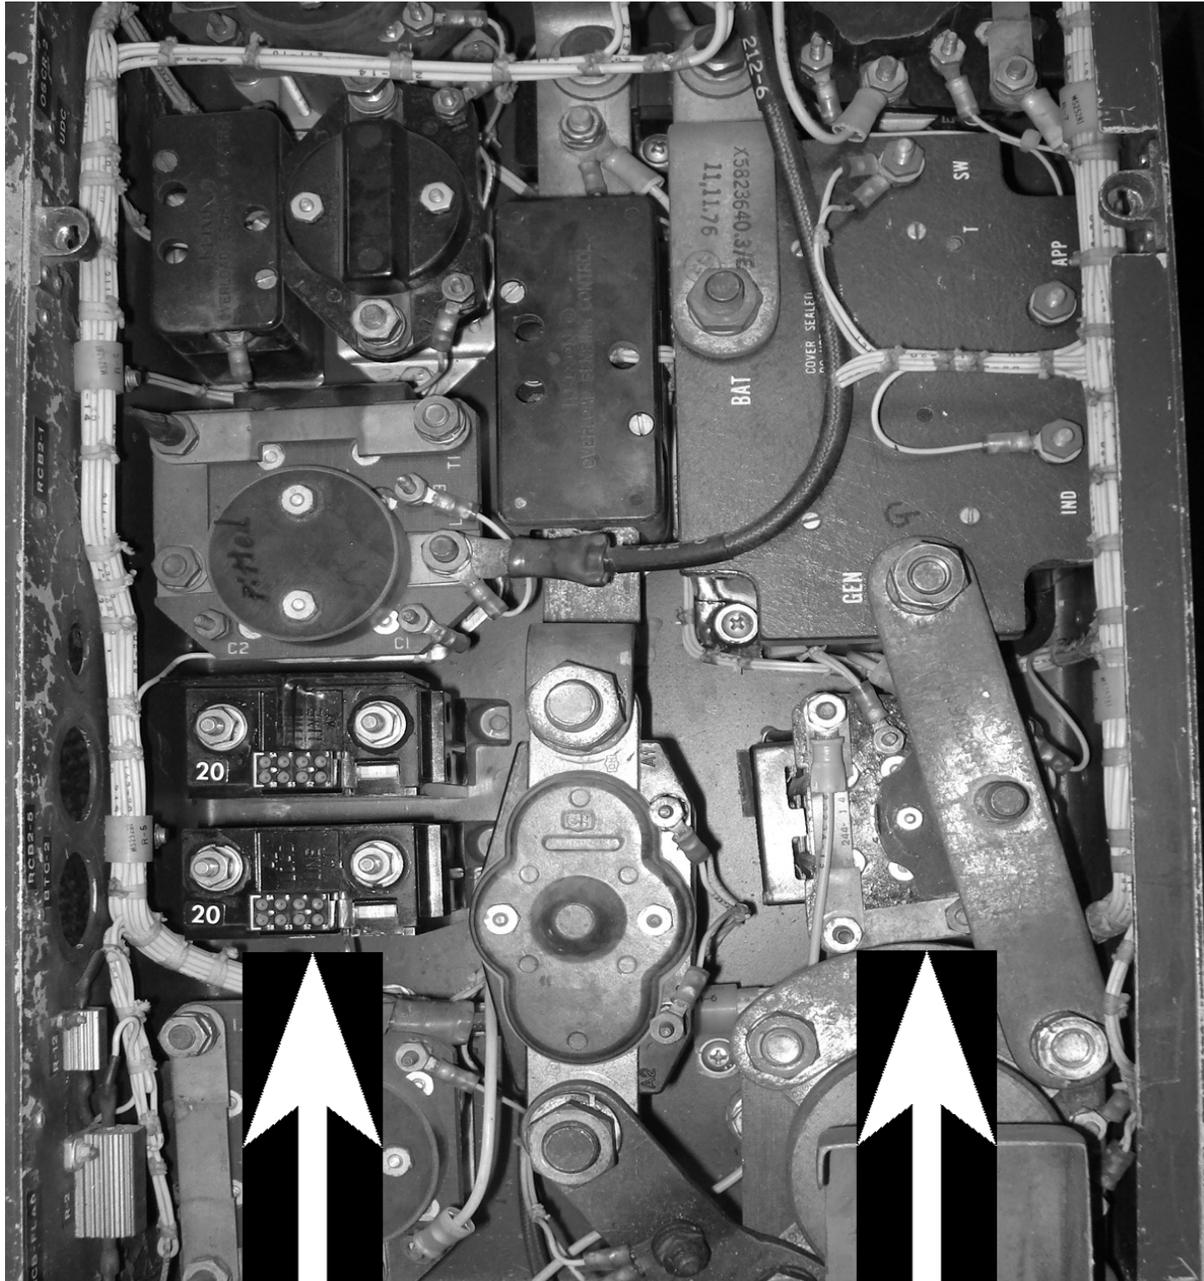
REMOVE EXISTING RCB2-5 THIS LOCATION
INSTALL NEW RCCB2-4 AND 2-4 THIS LOCATION
REMOVE EXISTING NUT PLATES AND INSTALL NEW
NUT PLATES PN MS21075-08 WITH RIVETS
MS20426AD3-2D (4 PLACES)

REMOVE EXISTING RCB2-4 THIS LOCATION
DISCARD THIS ITEM IT WILL NOT BE REUSED

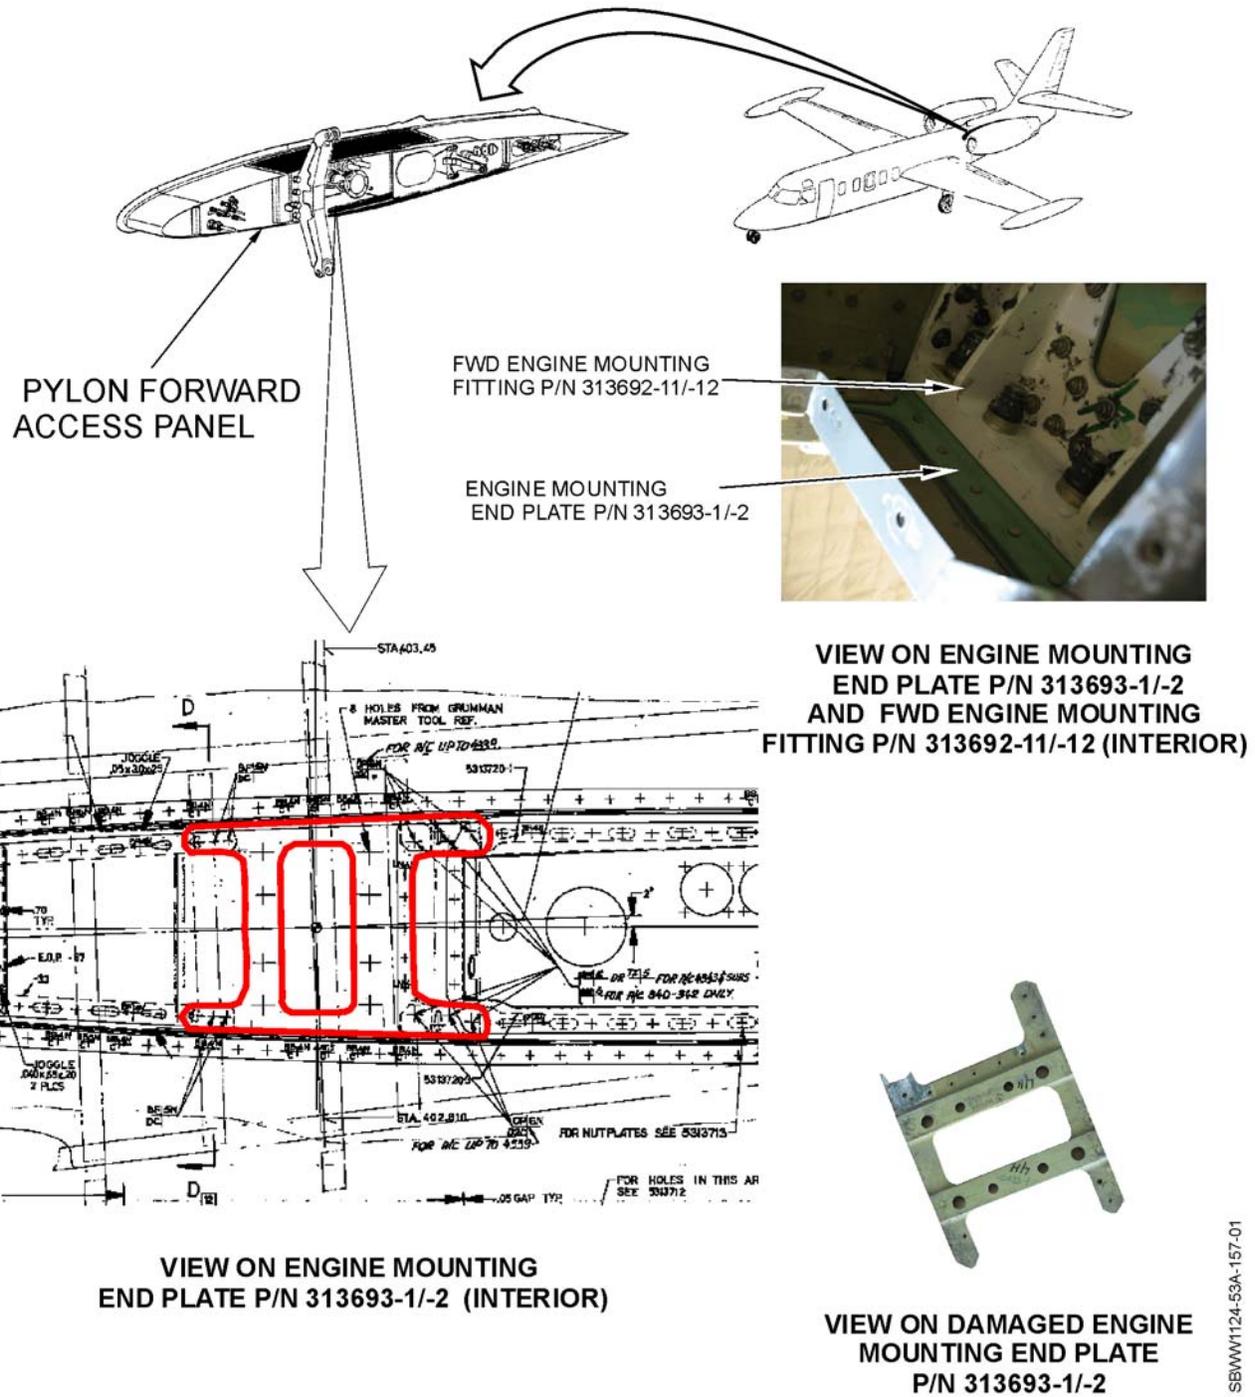
Engine Mounting End Plates Inspection
Figure 1

FUSELAGE - ENGINE MOUNTING END PLATE AND VERTICAL STABILIZER
FRONT AND REAR FITTING ASSEMBLY -
ONE-TIME INSPECTION FOR CORROSION

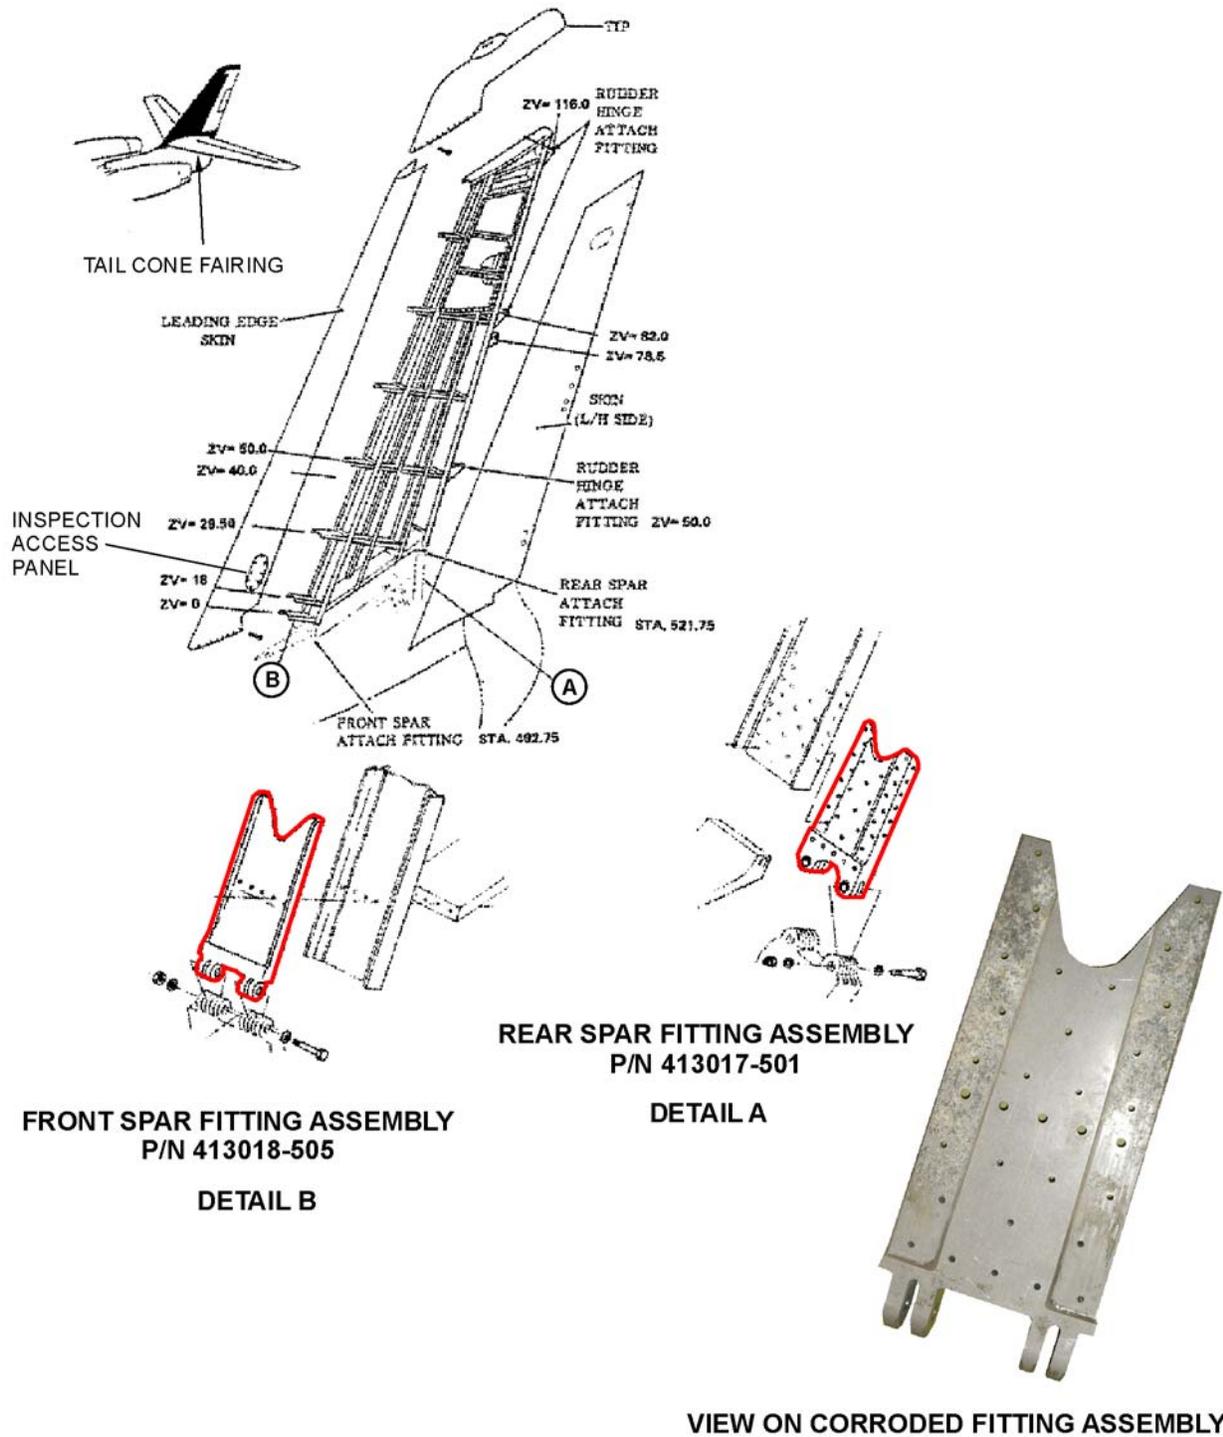
**FRONT SPAR FITTING ASSEMBLY
P/N 413018-505
DETAIL B**

**REAR SPAR FITTING ASSEMBLY
P/N 413017-501
DETAIL A**

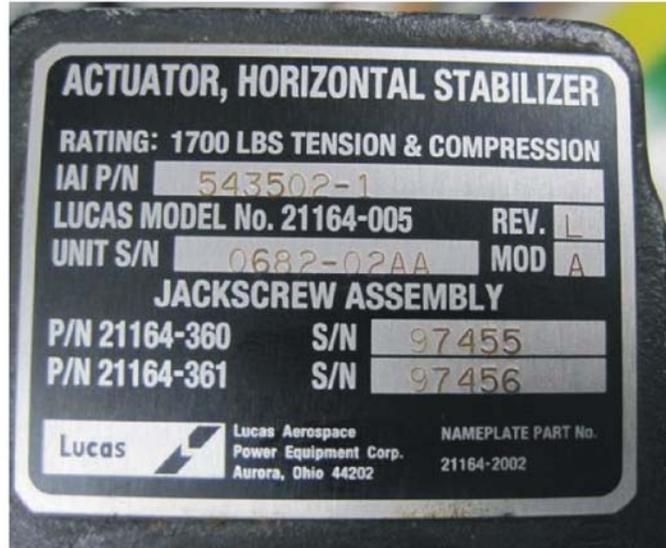
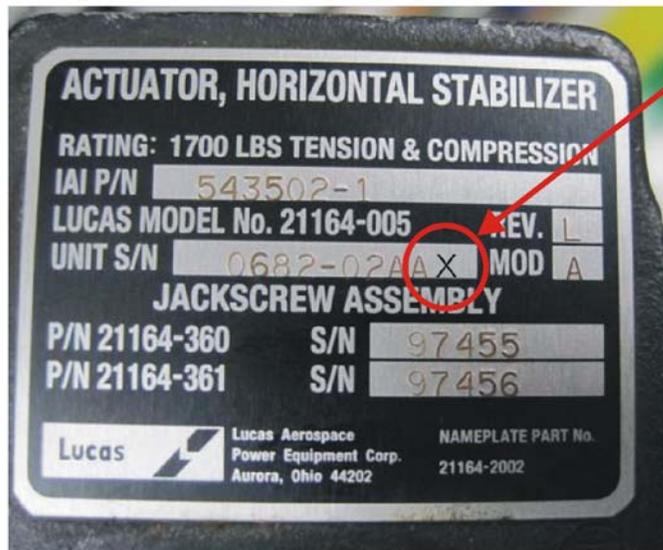
Horizontal Stabilizer Trim Actuator - Identification Plate
Figure 1

**STABILIZERS - HORIZONTAL STABILIZER TRIM ACTUATOR P/N 543502-1/-501 -
REPLACEMENT OF MOTORS WITH INCORRECT PART NUMBER BRUSHES**
