A Quarterly Publication Regarding the Maintenance and Operation of Westwind Aircraft

December 19, 2003 Volume 2, Issue 1

(ATA 30): Reminder of Upgraded Engine HP Bleed Manifold Assembly

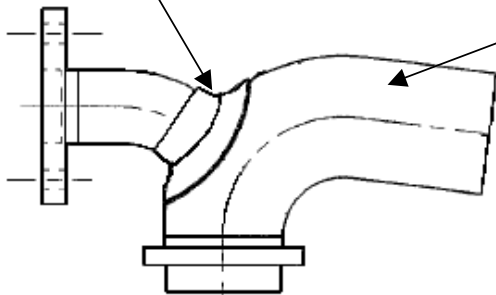
F10A5P20242-9
Manifold Duct

Recently, a Westwind operator discovered damage to the aluminum bypass duct of a 731-3 engine. Upon further investigation, the cause was determined to be a failed HP bleed manifold assembly, P/N F10A5P20242-7, with the subsequent hot bleed air damaging the fan bypass ducts that cannot be repaired. The failure occurred near the 12:00 plenum mount boss.

We would like to remind operators of the availability of the F10A5P20242-9 bleed manifold assembly and that the Maintenance Manual, Chapter 5-20-07 maintenance practices call out a 200-hour inspection interval of the engine, nacelle, and pylon. Step 1.E. provides specific instructions to inspect the low- and high-pressure bleed ducts for leaks, cracks, fit, and general condition. Additionally, it has a note instructing the operator to inspect the manifold assembly during an engine Major Periodic Inspection or whenever the after body is removed. The bypass duct should also be inspected for any discoloration of the shroud. The flight crew will notice a rise in Interstage Turbine Temperature (ITT) if a manifold assembly has failed.
